Kingston and Arthur's Vale Historic Area Safety Hazard Scoping Study

Department of Infrastructure, Regional Development and Cities

June 2018

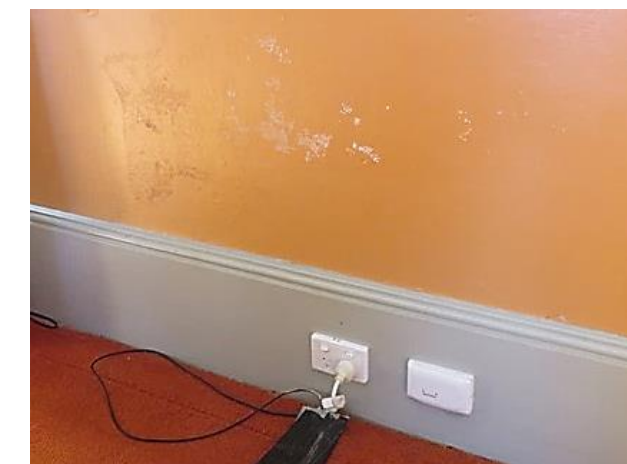
Issues relating to building services were raised in the Susan Allen and Associates report and the Building Services report by AECOM. A recent incident involving shorting out of a power point in the courtroom of the Old Military Barracks was reported by court staff.

Electrical point affected by damp and salt in wall, court room in the Old Military Barracks.

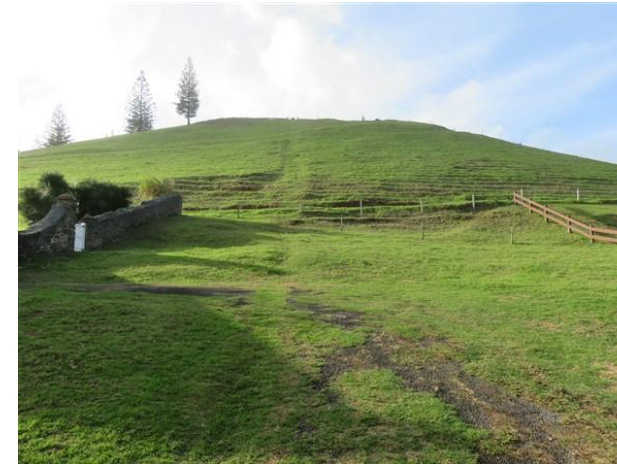
Several locals reported torrential rain falling in 1998, resulting in flooding of houses in Quality Row. Water was reported to have flowed down the hill behind the houses, through No. 5 Quality Row, and Quality Row being under water to the extent that people were able to ride jet skis along it. Site investigations identified a possible flow path down the hill from Queen Elizabeth Lookout on the road above the houses and some evidence of landslip near the bottom of the hill between house No's 4 and 5.

Hill behind Nos 4 and 5 Quality Row showing landslip in the area between the houses.

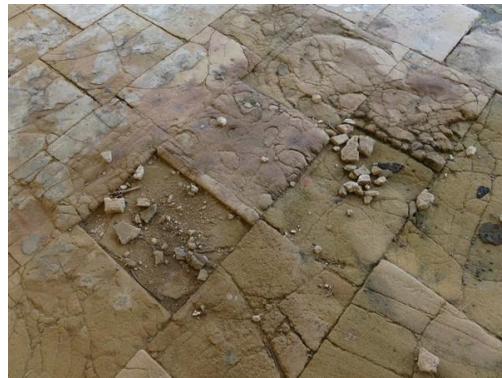
Loose material should be removed, but the verandah flagging should be retained in situ, Old Military Barracks.

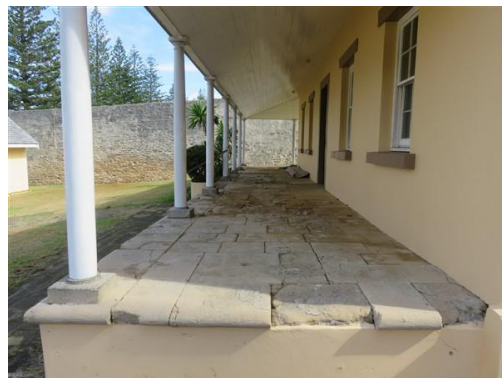
Decayed margin stones may need replacement to provide protection to the verandah walls, Old Military Barracks.

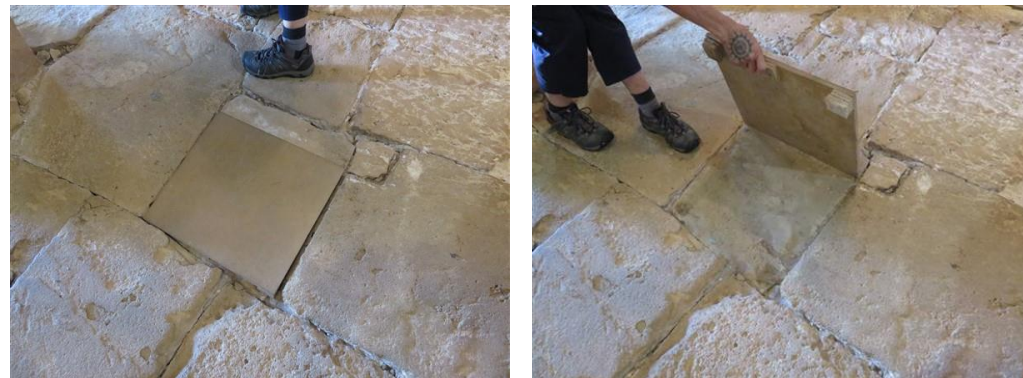
Plywood infill panel to level a hollow stone in the floor of the Commissariat Museum.

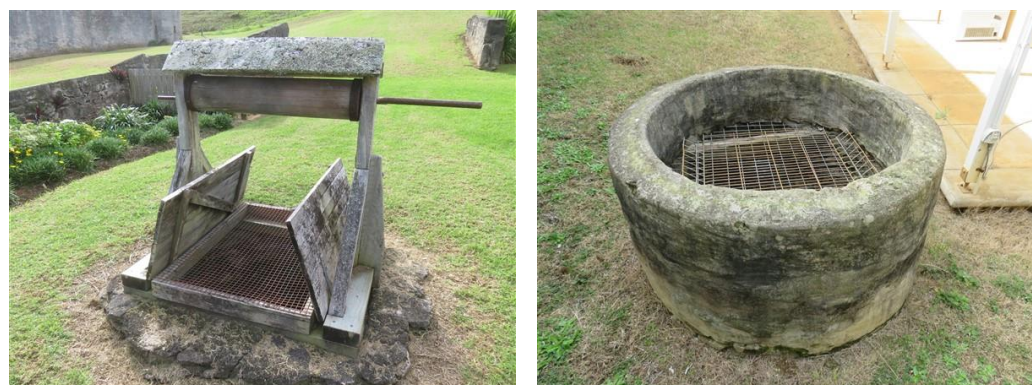
Wells at No. 10 Quality Row and the Old Military Barracks.

It is recommended that a standardised, robust, durable and heritage sensitive grating be developed to replace the existing well covers when they reach the end of their life.

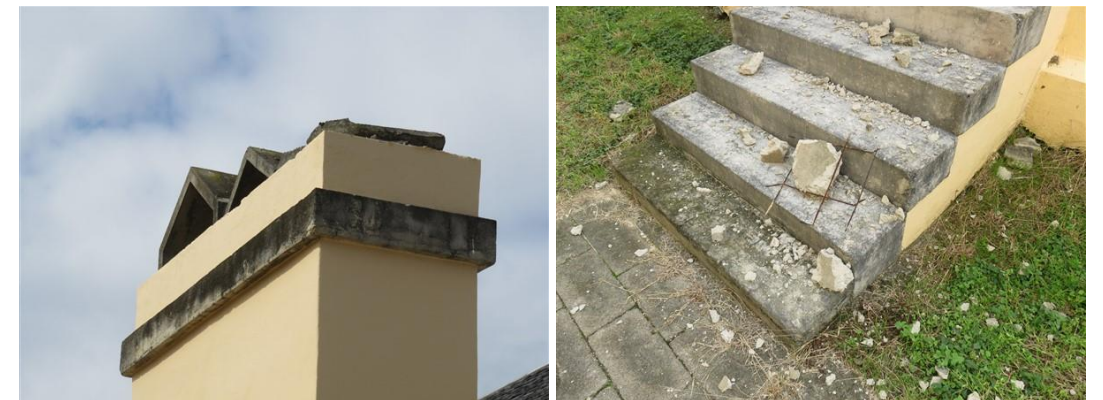
It is noted that some replacement elements employed at the site since the 1960s, such as the chimney caps, are made of reinforced concrete, which is now reaching the end of its life due to corrosion of the steel reinforcement. These elements, which will fall from a considerable height, pose a serious safety risk if they fail and must be monitored closely and replaced as necessary.

Failed reinforced concrete chimney caps which have fallen on the entrance steps to the neighbouring building, Old Military Barracks, 4 May 2018.

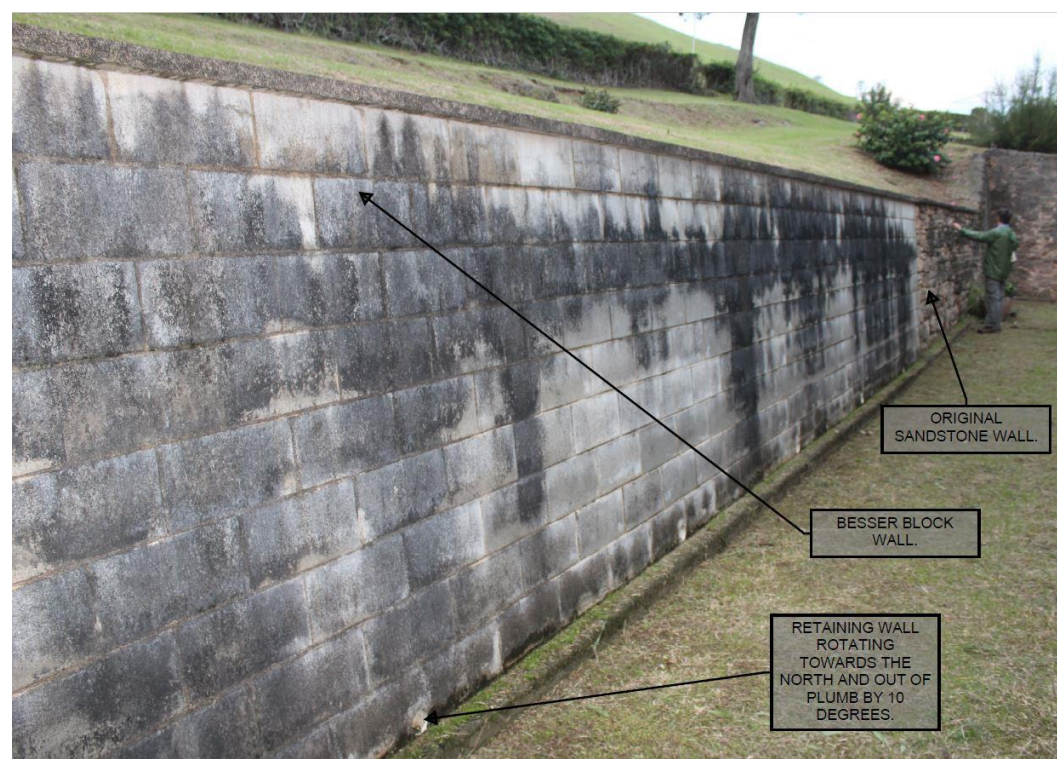
Retaining wall behind the Research Centre, No. 9 Quality Row.

Retaining walls should also be included in the annual inspections of the site to monitor movement and potential failure.

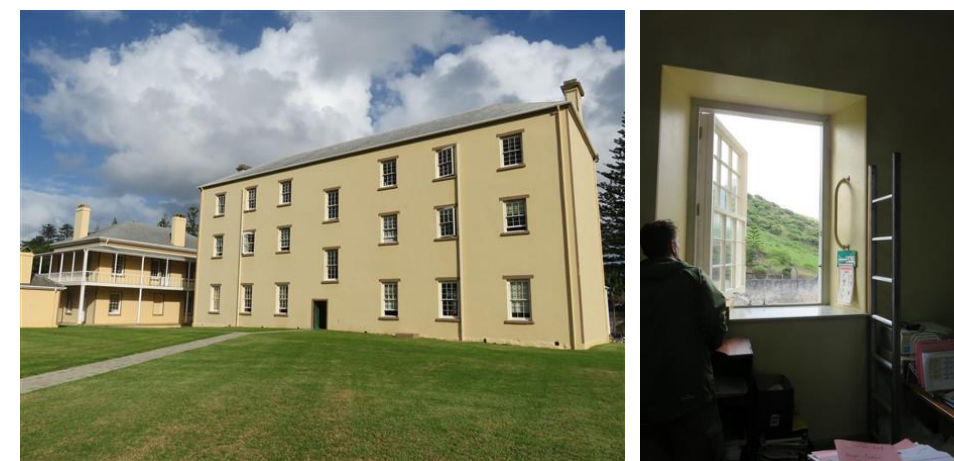
Pull out ladders are fixed to the rear wall of the Old Military Barracks to provide an alternate fire escape. Access to the ladders is through the windows.

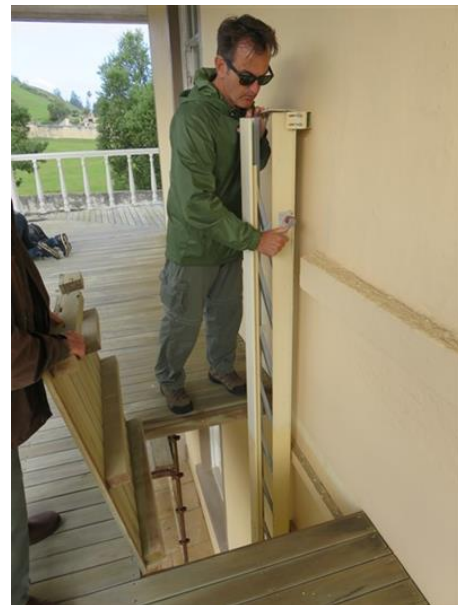
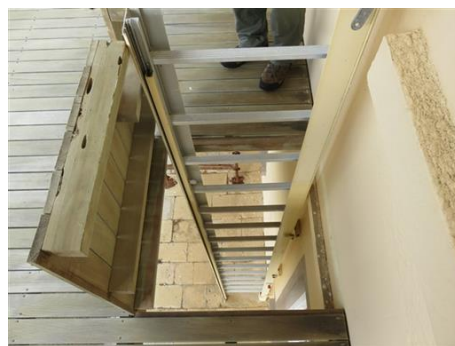
Access to the secondary escape ladder in the Administrator's Office involves squeezing around the edge of the primary egress stair which may be on fire and use of the fire escape ladder, which requires practice to set up safely.

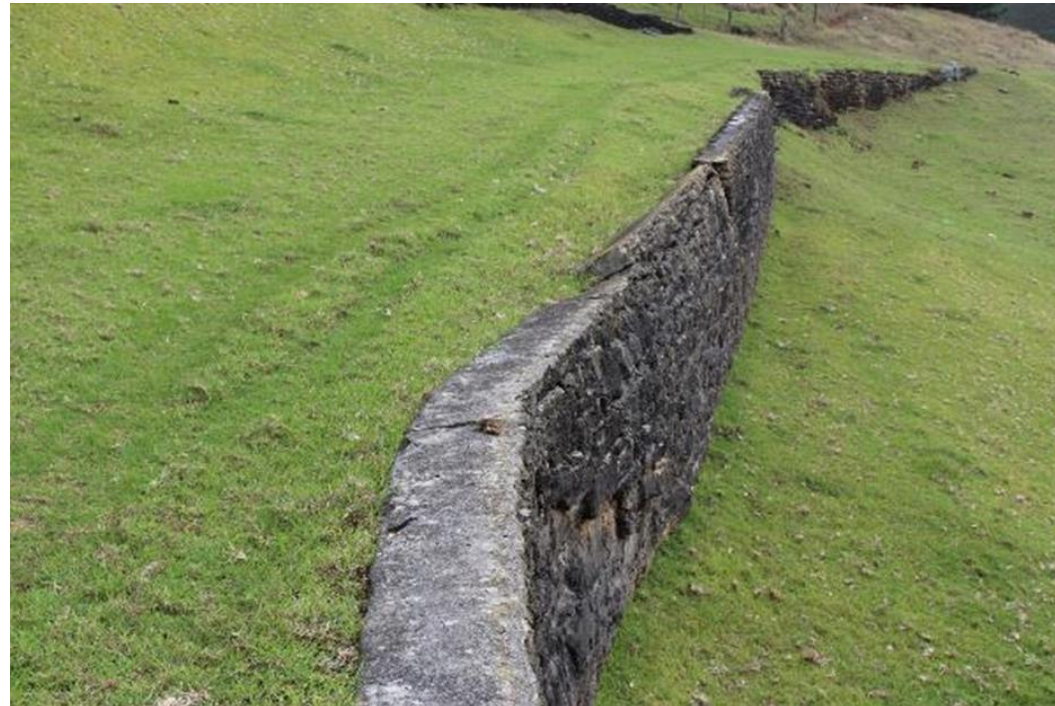
These issues suggest that the wall has technically failed as a retaining element. There is extreme concern that the wall could collapse imminently. In the short term, it is recommended that appropriate signage be erected to ensure visitors and residents are aware of the dangers of entering the area and that they are prevented from doing so. Vehicles trafficking the ground immediately south of the retaining wall would be particularly onerous as this would apply a lateral surcharge to the wall which could easily result in a catastrophic collapse. In the long term, the wall will need to be rebuilt to ensure that the structural integrity is restored. A full remediation strategy will need to be developed which should include a detailed geotechnical investigation and structural engineering design.

Bulging retaining wall below Civil Hospital.

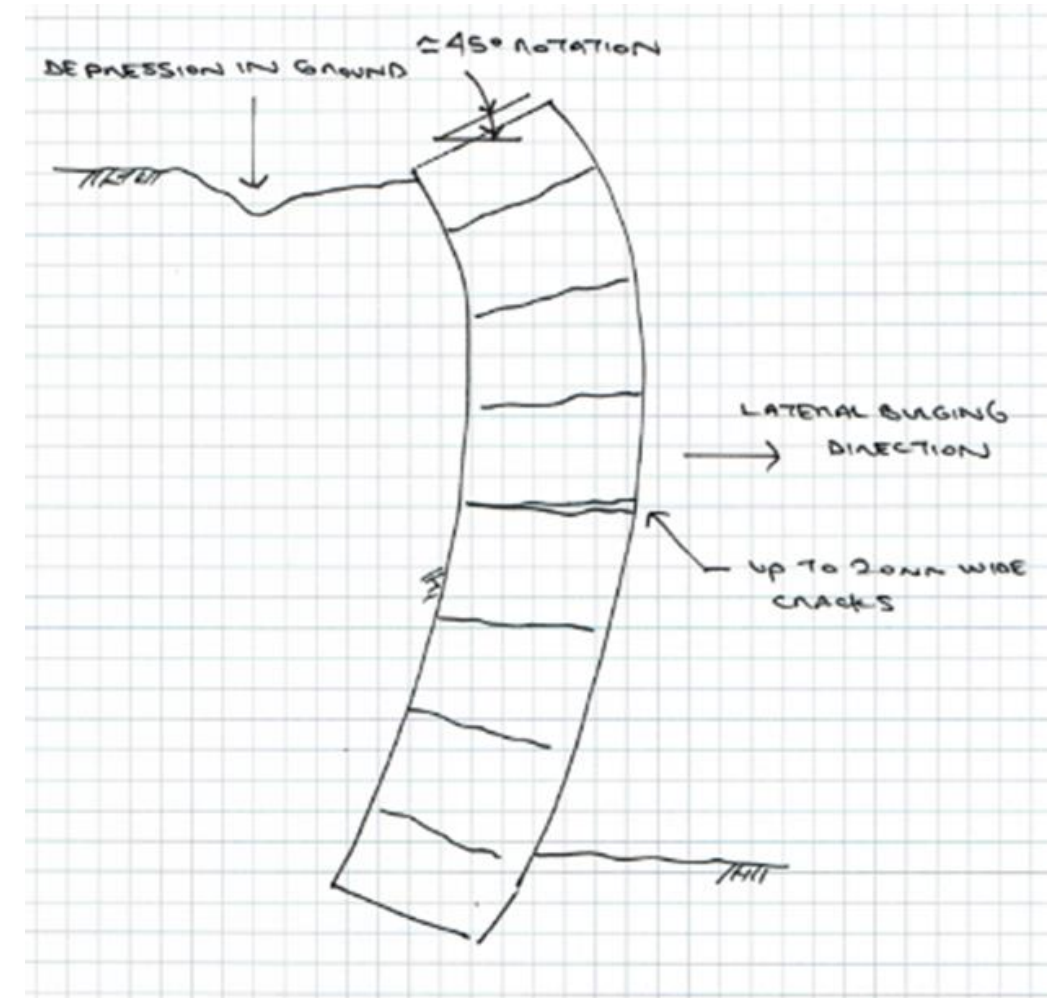
Bulging and rotating retaining wall. (Source: Rob McGowan, 2018)

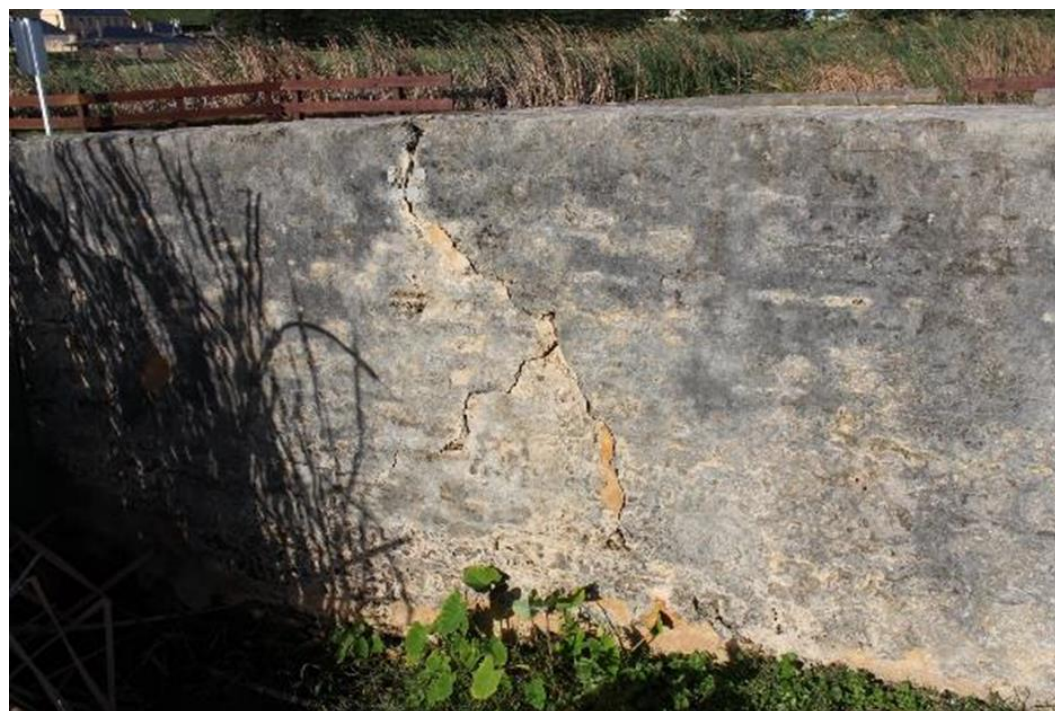
Given the nature of the above issues it is surprising that the bridge still has capacity to carry load. The recommendations of the Hughes Trueman report should be carried out without significant delay as a matter of priority to ensure the structural integrity of the bridge is restored and maintained.

Crack pattern on the western side of the Bounty Street Bridge.

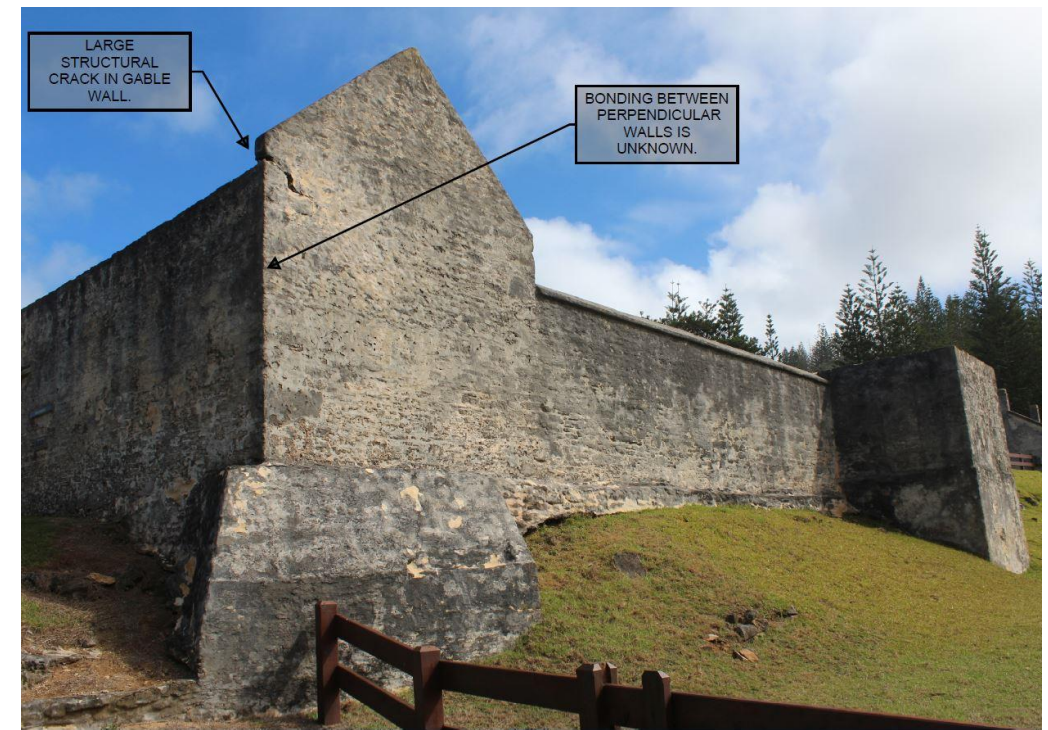
Northern gable end showing structural crack.

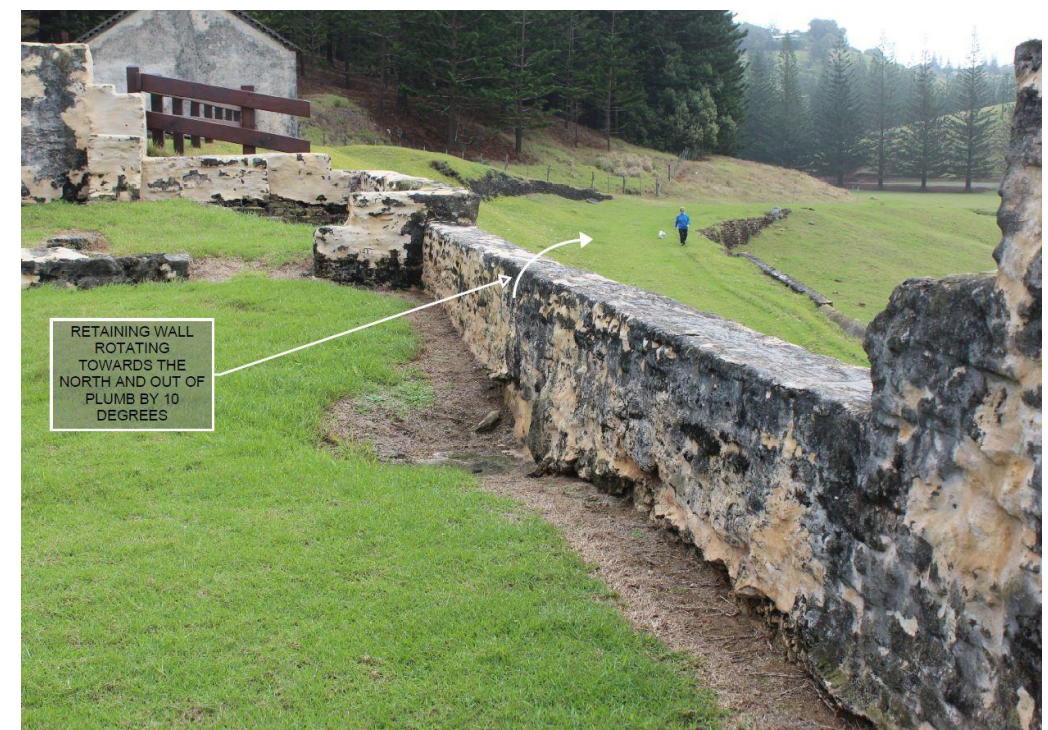
Northwest retaining wall showing rotation.

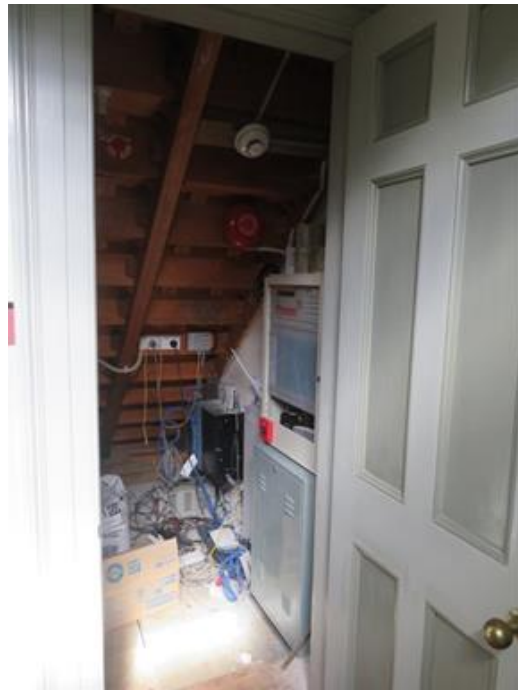
The stair in the Old Military Barracks is timber and not fire rated. The switchboard under the stair is a potential fire source.

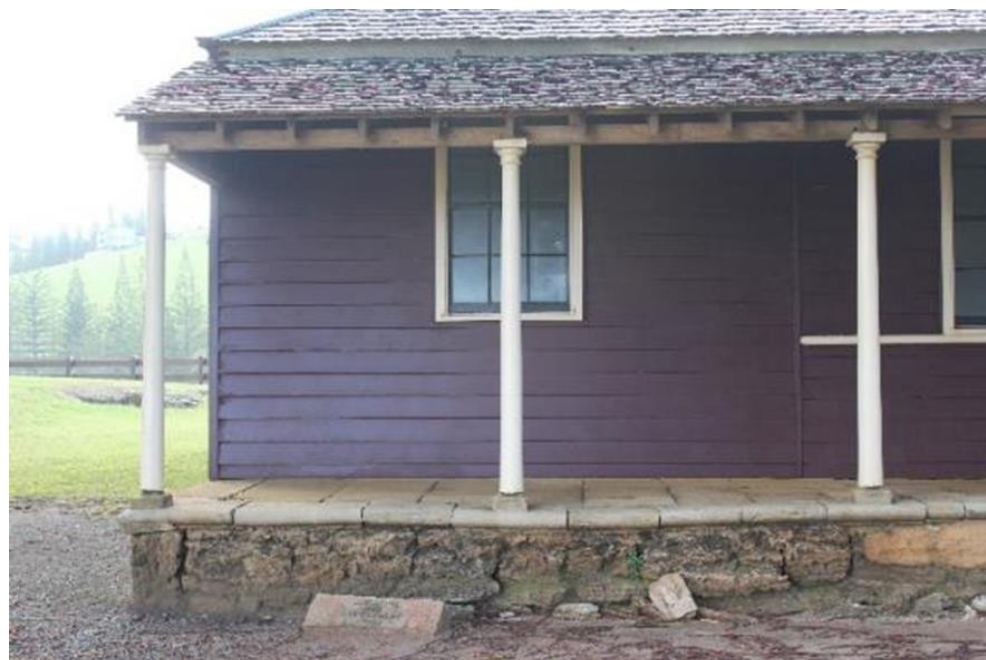
Southwestern end of verandah showing subsidence.

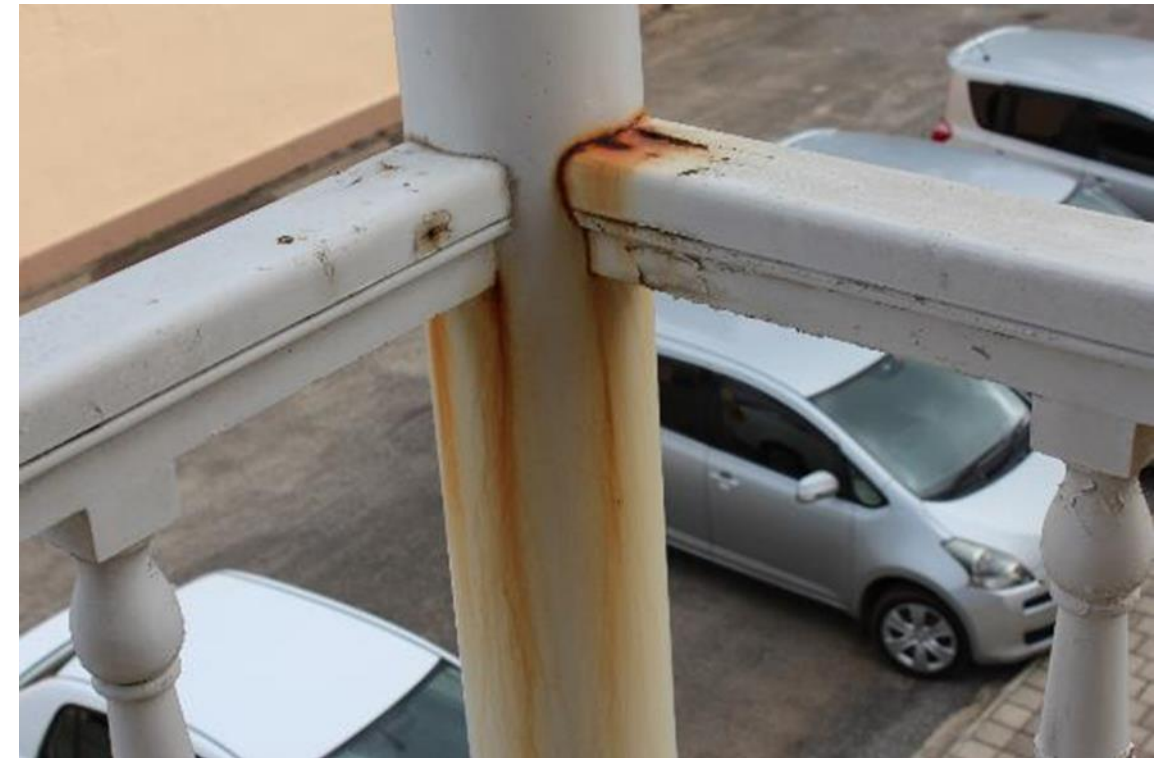
Corrosion staining on timber post from rusting steel fixings.

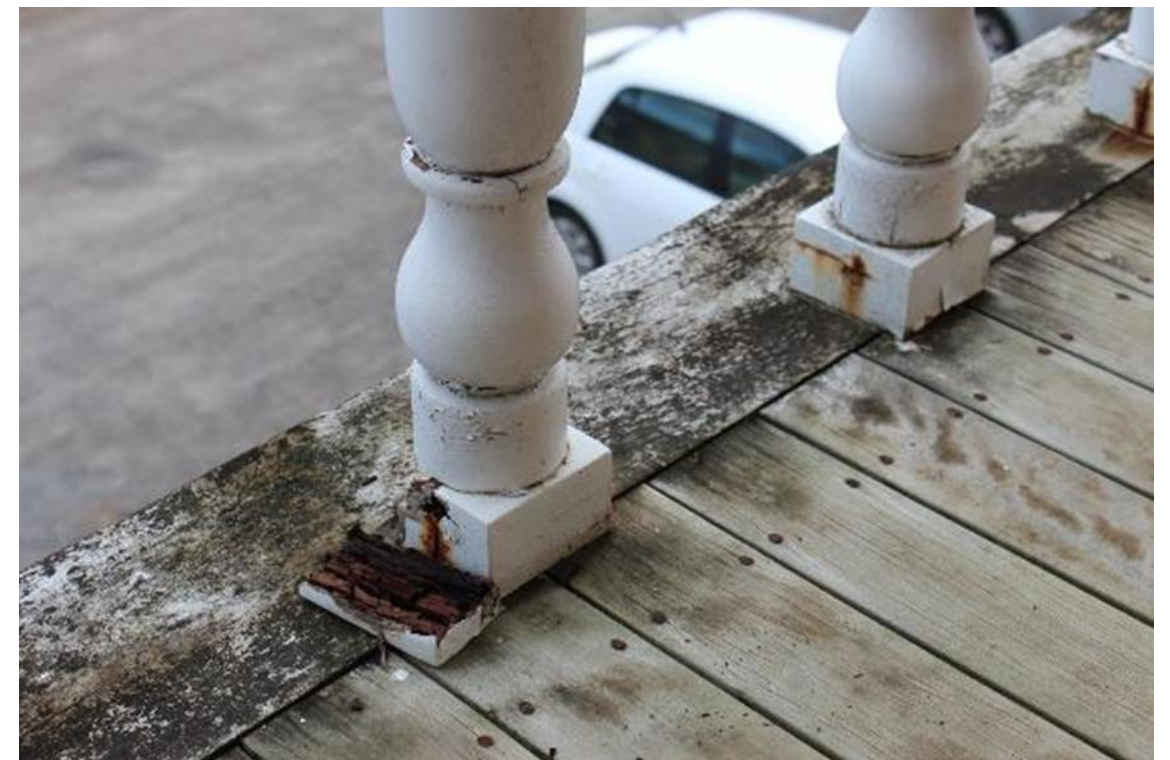
Decayed timber on vertical members of balustrade.

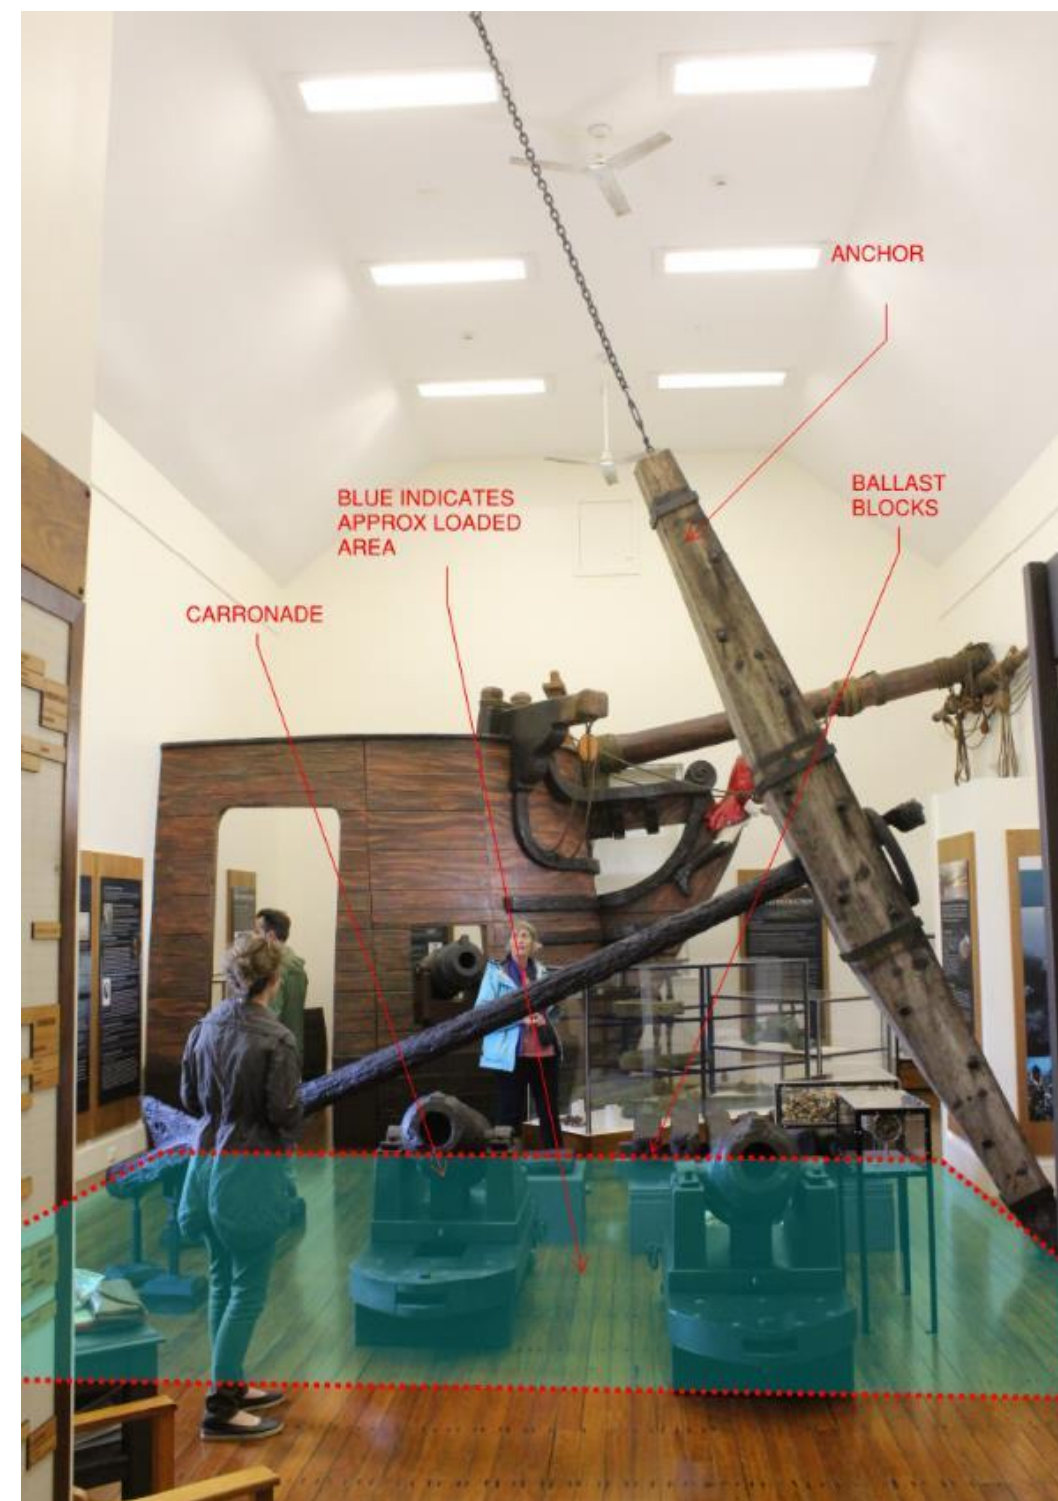
Illustration showing area of floor in Sirius Museum that is carrying excessive load from heavy items on display, including *Sirius* anchor and carronades.

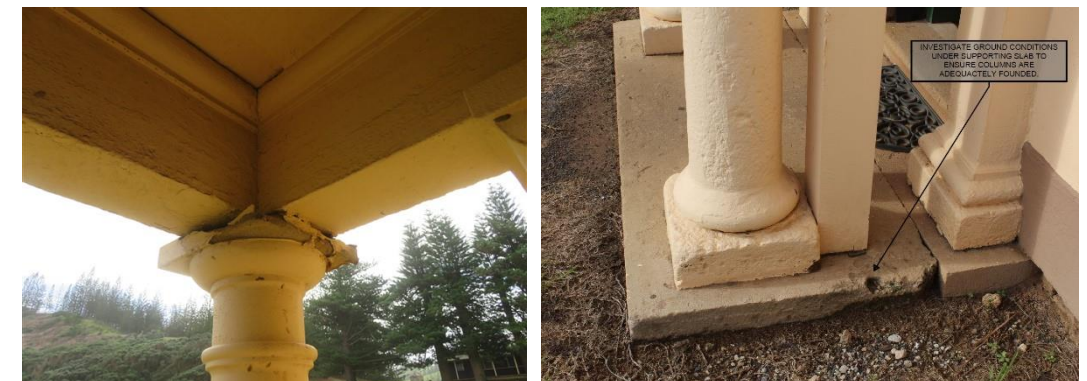
Decayed northern column capital and stone base to REO portico.

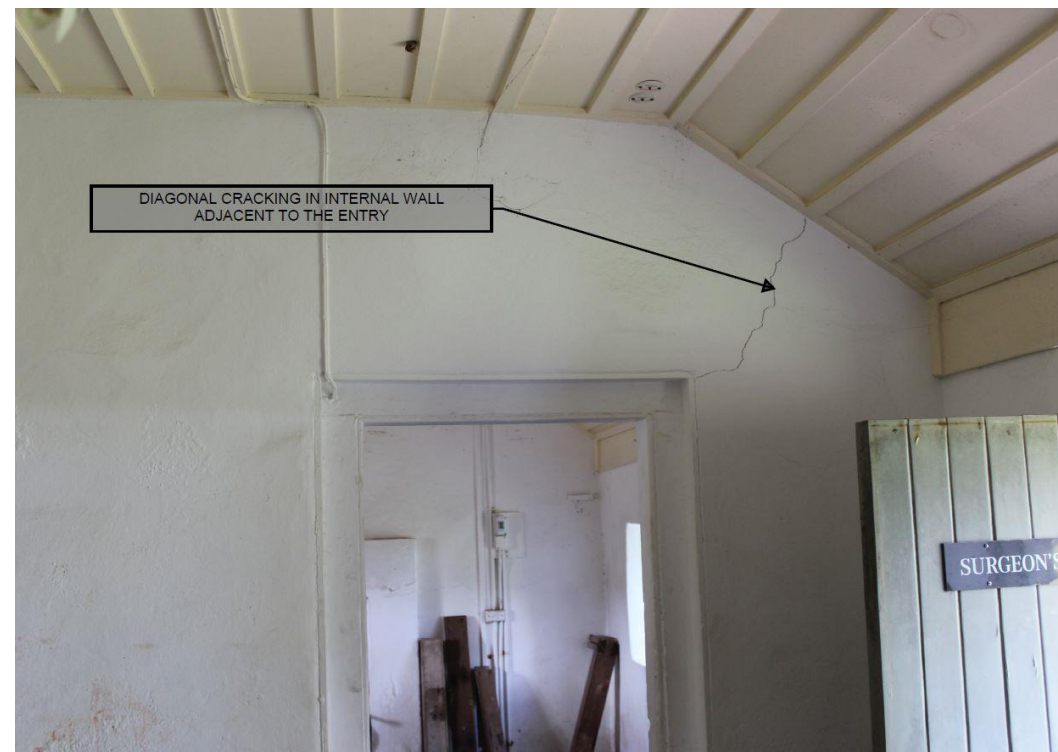
Internal wall cracking in Surgeons Quarters Kitchen.

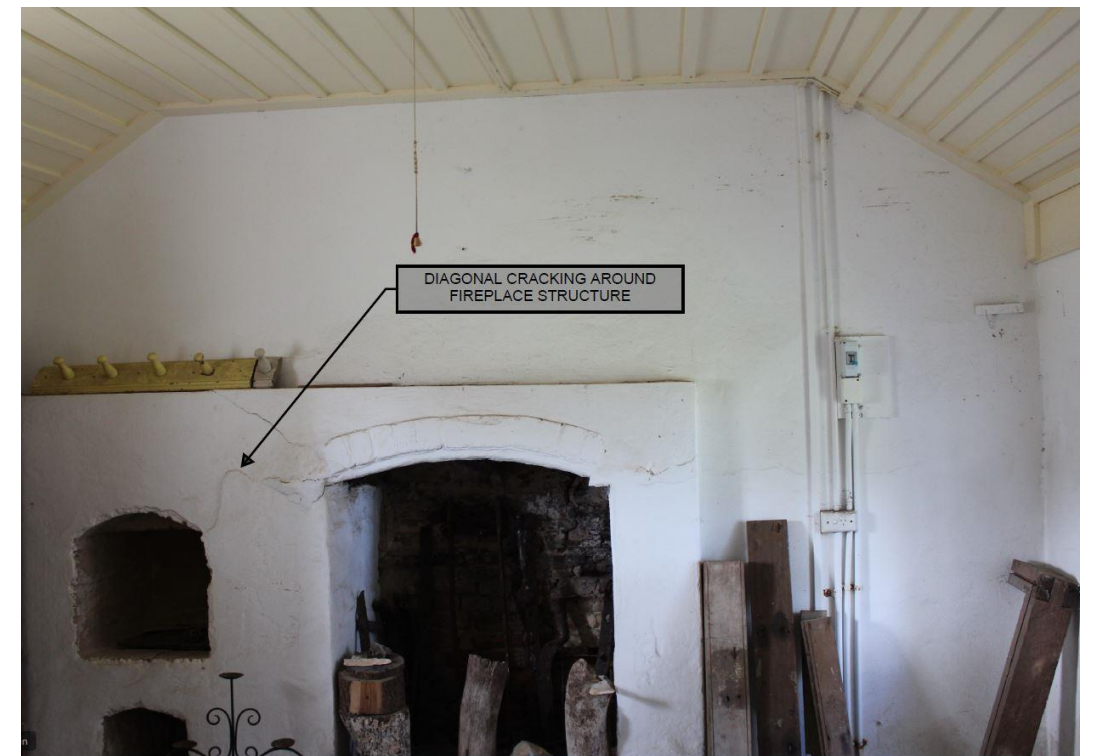
Internal wall cracking in Surgeons Quarters Kitchen.

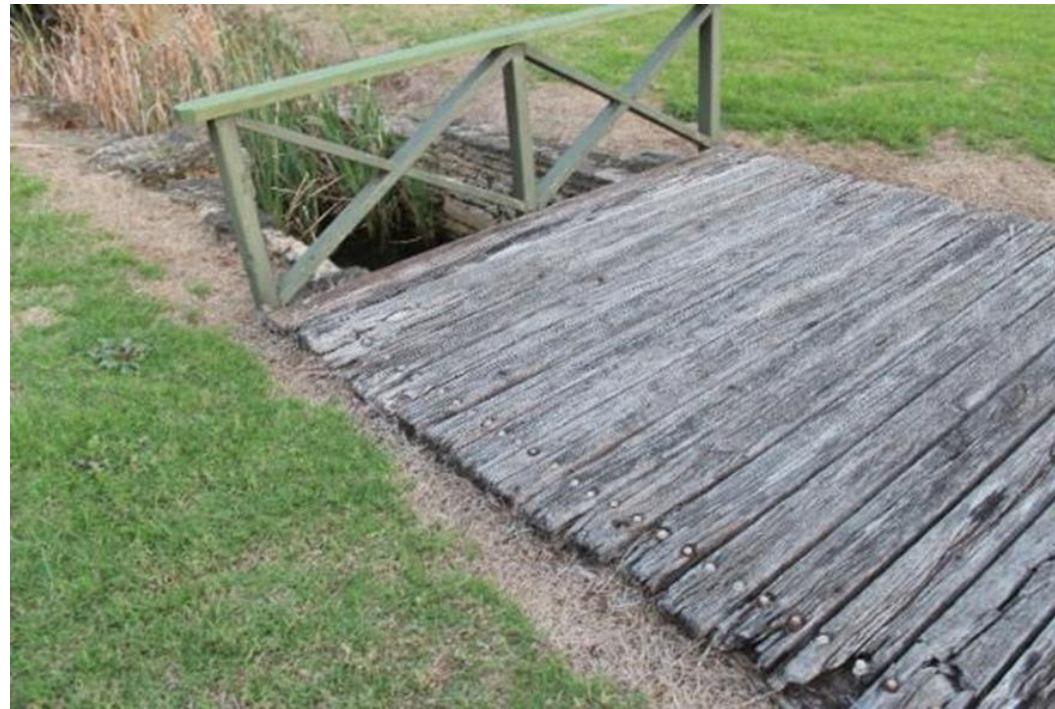
Decayed timber members spanning across the creek channel in the Government House Reserve.
