# Kingston and Arthurs Vale Safety Hazard Investigations

50% Concept Design Report - Very High Risk Items

Client: Department of Infrastructure, Regional Development and Cities

23-Nov-2018

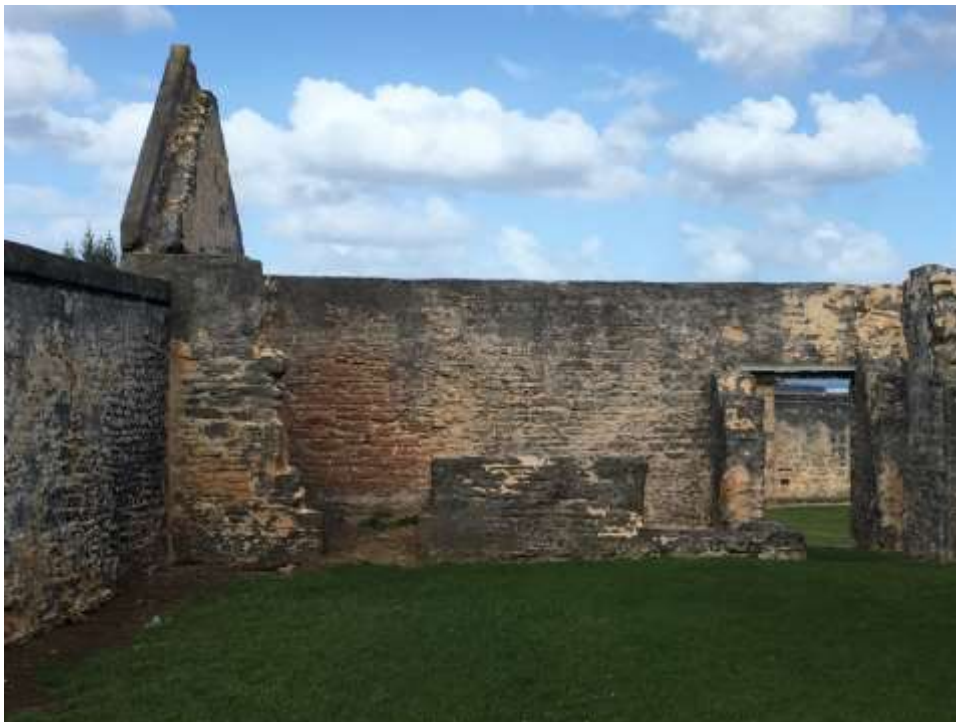
The main building is in a state of ruin, with the entire roof structure missing, leaving the northern gable unrestrained. This is a safety concern as the gable, which is approximately 5 m high, is left free standing and with no restraint the top of the gable. There is a large crack (>3 mm) running along the eastern corner of the interior face of the gable and a crack on the external face of the gable running down the eastern corner of the gable which appears to be separate to the internal crack. It is possible that a stone became loose due to weathering and hence propagated a crack in the mortar. The walls were extensively pointed with cement-based render in the 1960's due to erosion of the existing mortar. The pointing extended to ground level and on the northern side of the building the ground level has been lowered by erosion and cattle grazing which has left the stone base of the wall exposed. Probing of the northern side of the gable below the render line revealed voids, which extend up to 600 mm into the wall.

Figure 3 Civil Hospital northern gable ruins

The recommended solution to repair/rehabilitate the Civil Hospital gable is to restrain the gable wall and hence stabilize the structure. A method for the rectification of the gable is to build a structure behind the gable (to the south) to tie the wall back and prevent it overturning. This process is preferable as it will allow for the preservation of the wall, rather than allowing for it to collapse and destroy more of the heritage site. The Civil Hospital will be required to be closed for a period while the construction of the stabilising structure is taking place. It would be best to align the construction with a season of smaller tourism to minimise the impact this closure will have on tourist and guided tours.

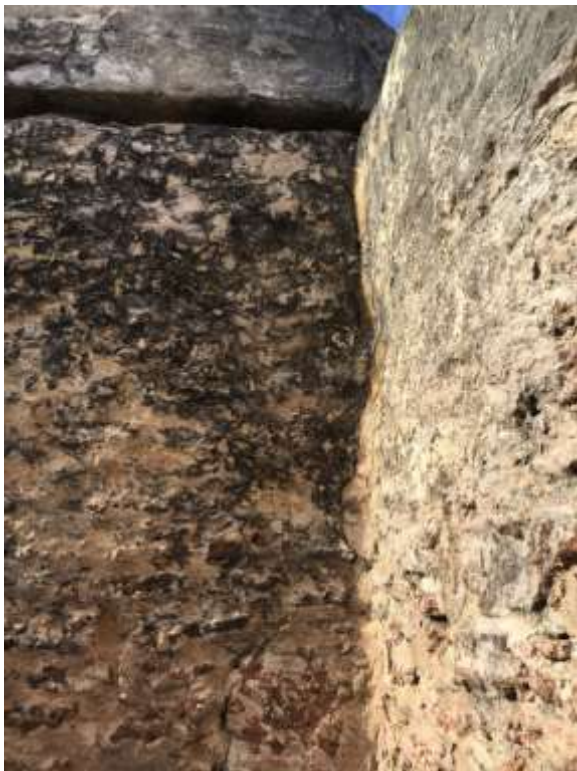
**Figure 6 Crack in the gable interior face top**

Cracking in the top of the eastern corner was most prominently found on the northern face of the gable and was hence inaccessible from the ground. There may be a loose stone on the northern face of the wall; but due to limited access it was impossible to determine whether the stone was in fact separated from the wall or if the mortar was cracked along only two faces of the stone. The loose stone may be responsible for propagation of further smaller cracks along the eastern corner of the gable. Proper evaluation of the cracking was impaired due to the inaccessibility of the cracks on the northern face and due to additional render/coating applied to the gable. The cracking alone was not of a severe nature and does not pose an immediate threat to the wall.

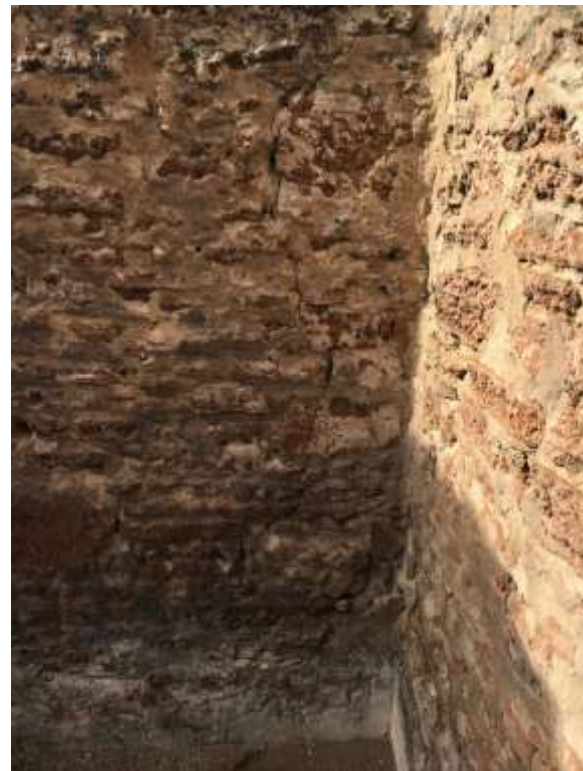
**Figure 7 Crack in the gable interior face bottom**

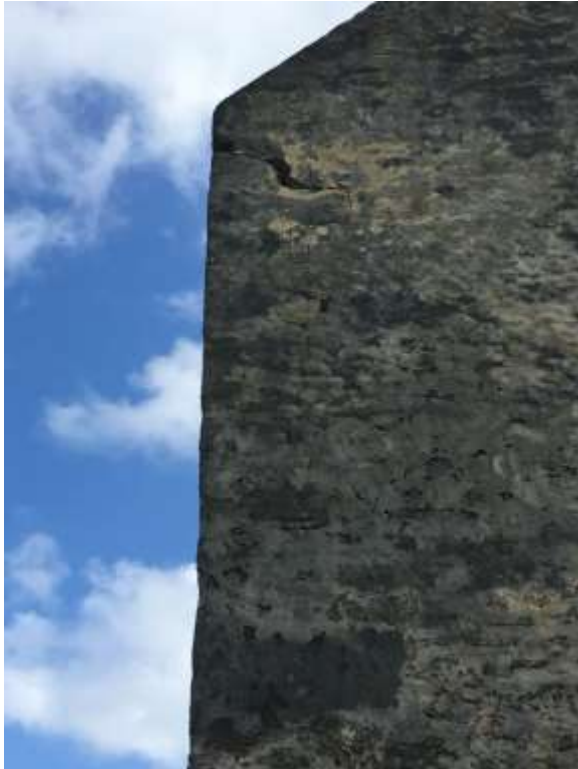
**Figure 8 Crack in the gable exterior face**

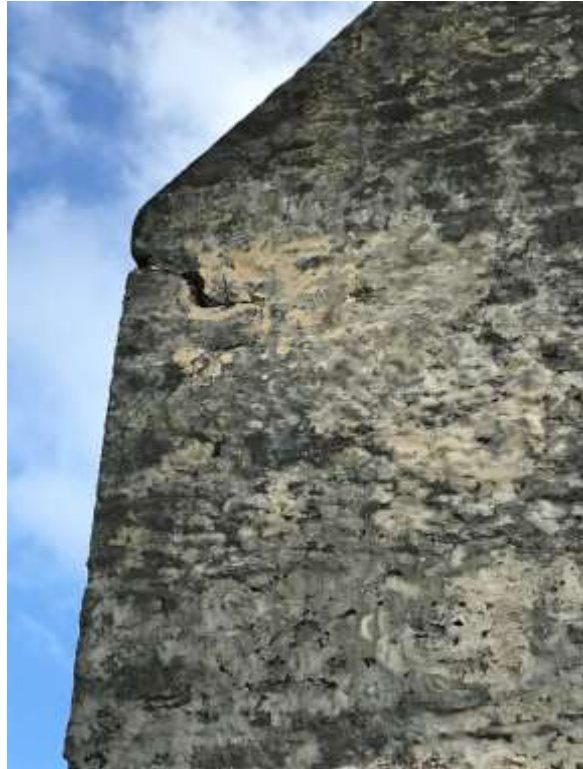
**Figure 9 Crack in the gable exterior face**

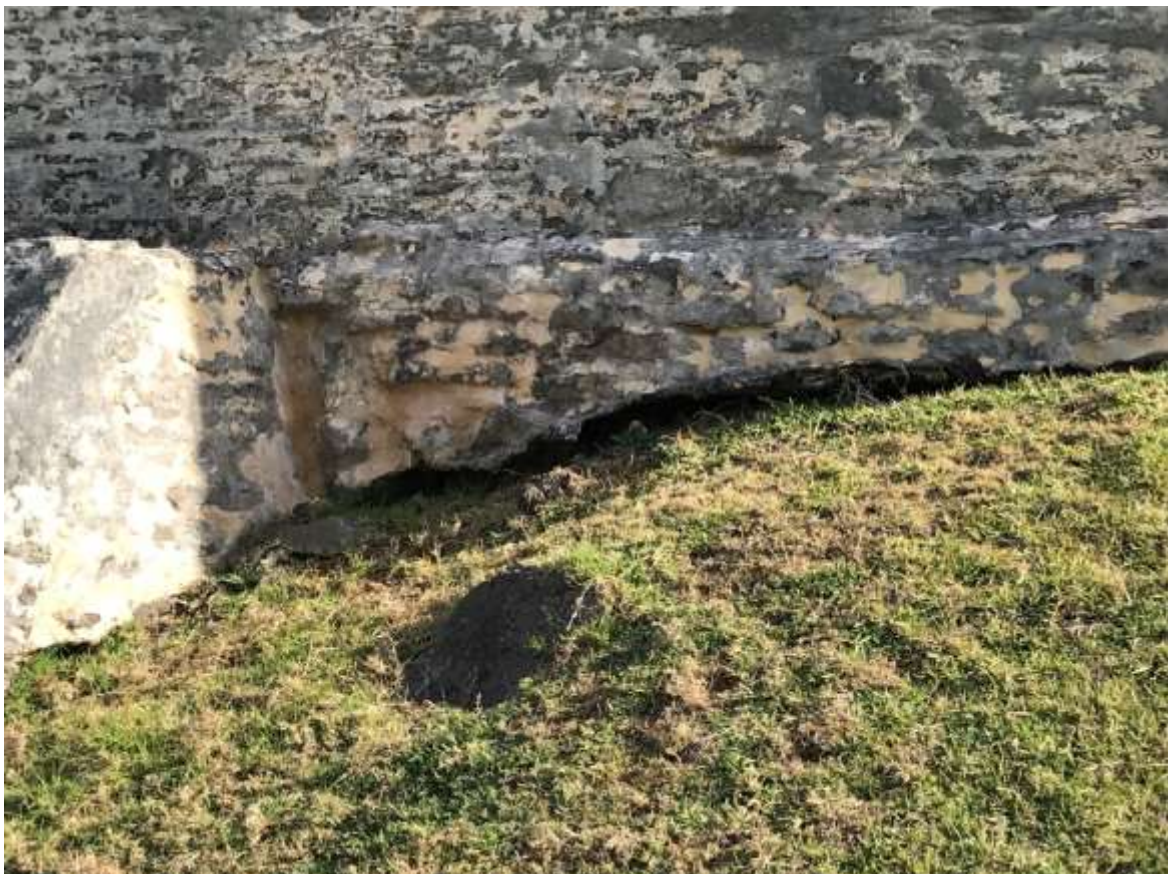
**Figure 10 Lowered ground line to the northern exterior of gable**

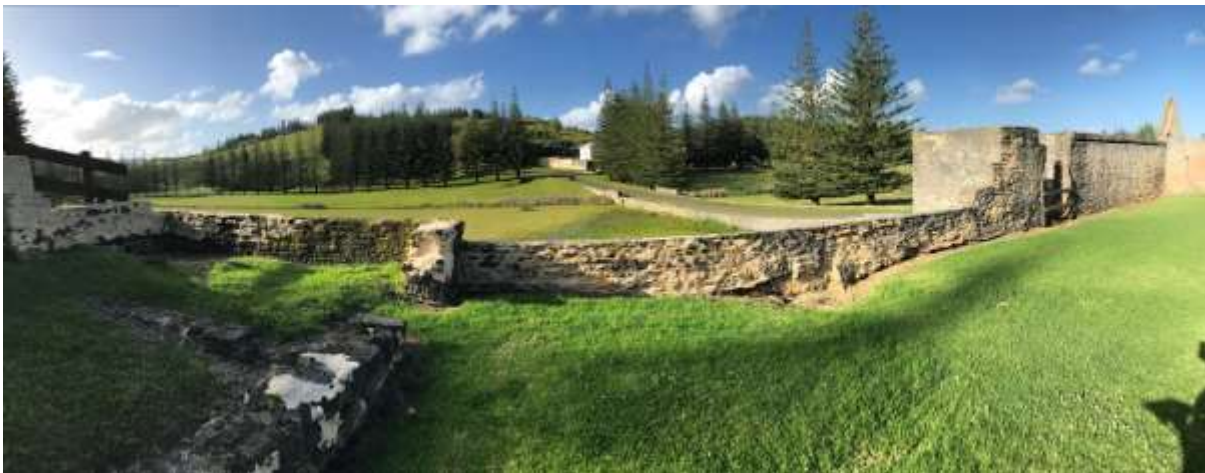
A drain is positioned in the centre of the retaining wall which drains rainwater from behind the wall to the lower terrace in front of the wall. It appears to still be functioning, but this needs to be verified and the drain maintained.

Figure 11 Civil Hospital retaining wall interior view

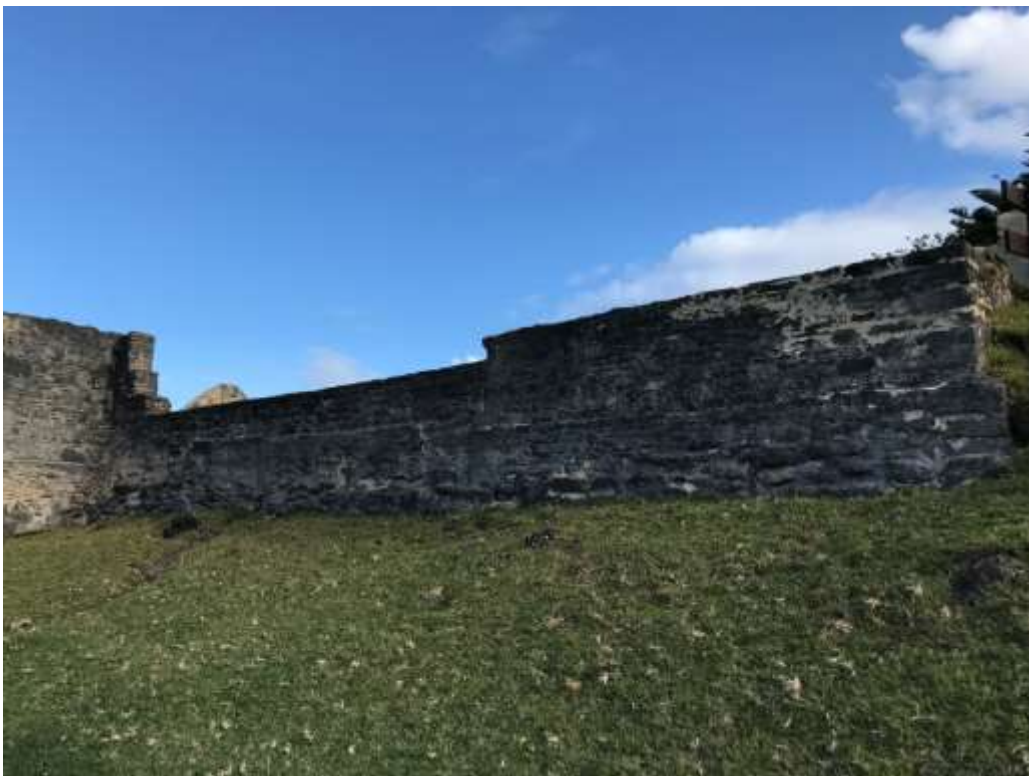
Figure 12 Civil Hospital retaining wall exterior view

With regards to the Civil Hospital retaining wall, the solution to 'do nothing' is a reasonable solution, especially for the immediate future. The retaining wall appears to be in good condition, with the top half of the wall remaining mostly vertical. It would suggest that the wall is no longer rotating and is structurally sound.

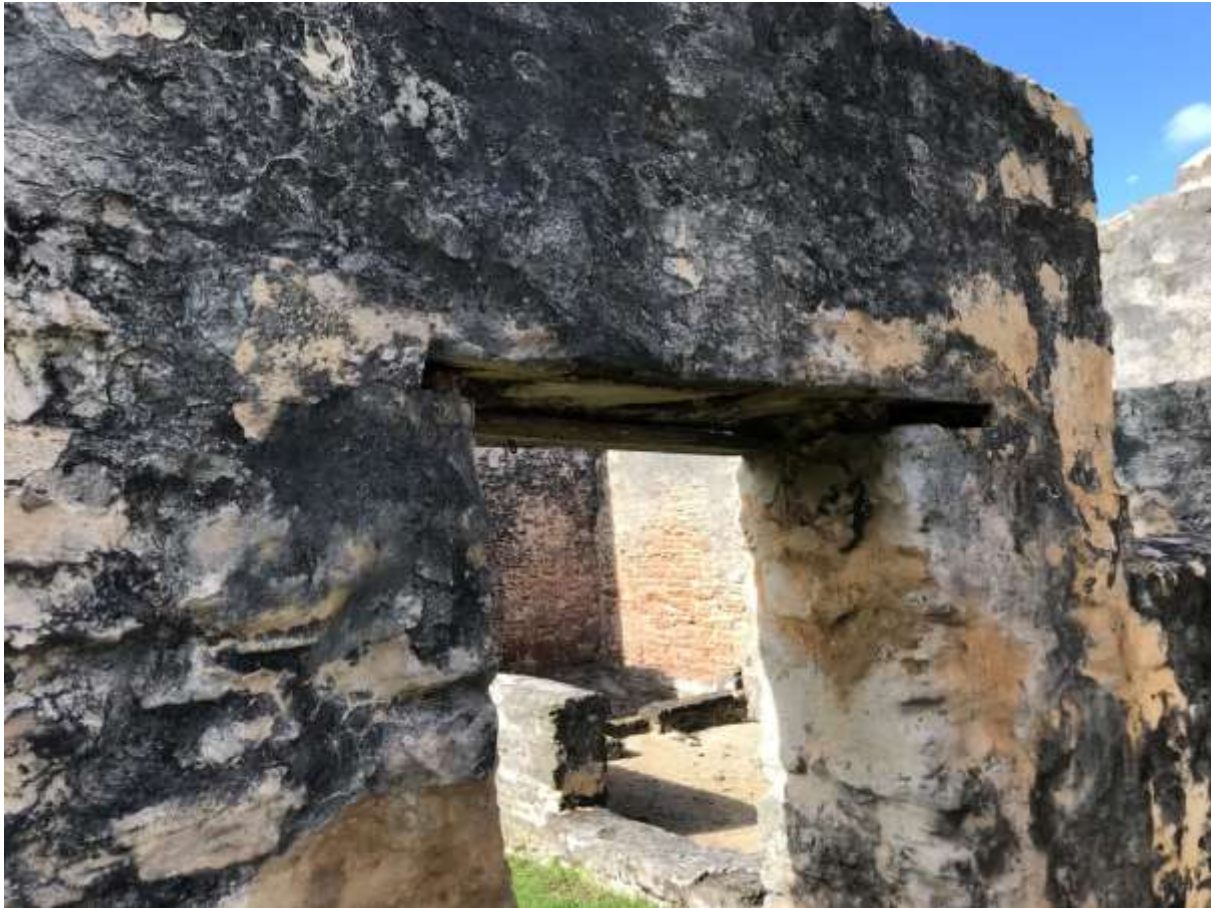
One of the doorways to the southern side of the Civil Hospital is missing a timber lintel to the southern face of the doorway. The timber lintel on the northern side was present but appeared to be in a state of decay and completely detached from the top of the doorframe. The doorframe, which is constructed of calcarenite stone, did not show any sign of vertical sagging over the opening and showed no sign of negative impact from the lack of support from the lintel. There are cracks present to the side of the doorframe, which may have propagated from the lintel notch in the wall however, they appeared to be minor with no damage to the integrity of the stonework.

**Figure 17 Missing lintel on southern face of doorframe**

Any lintel that is showing excessive signs of decay or is not bearing hard against the stone work along its upper surface or at each end should also be replaced as per above.

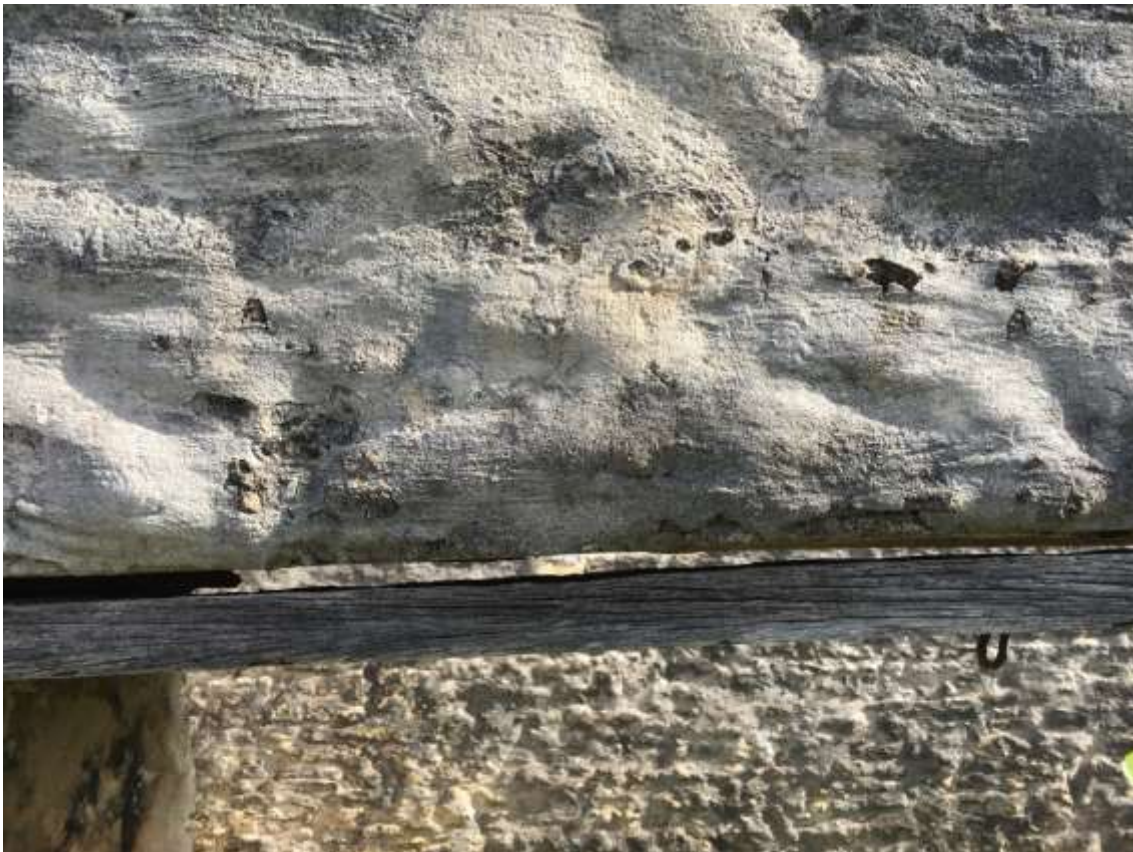
**Figure 20 Space between stone doorframe and existing timber lintel on northern face**

The timber lintel still in place on the northern side of the door was showing signs of weathering and had a 20 mm gap between the stone and the timber. Cracks are propagating from the lintel notch in the wall but based on the proportions of the stone wall above and the lack of rotation. These cracks were assessed as minor and not significant to the structural capacity of the wall.

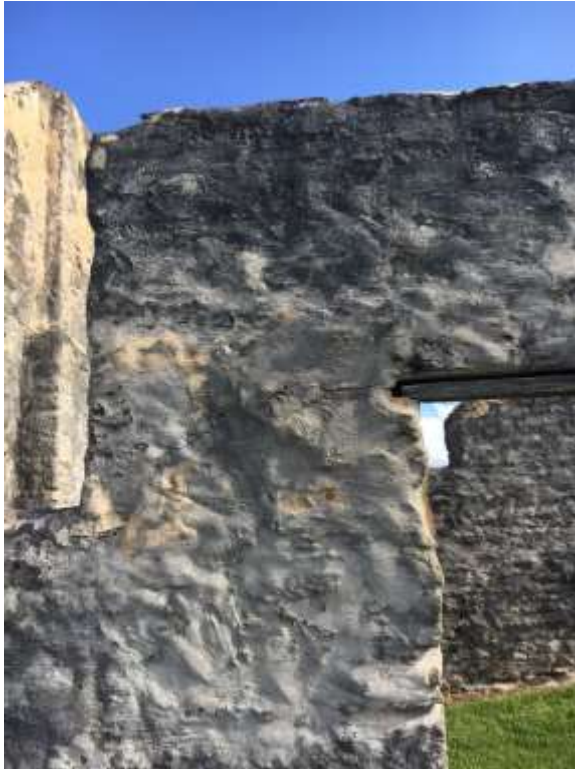
Figure 21 Crack on eastern side of northern face

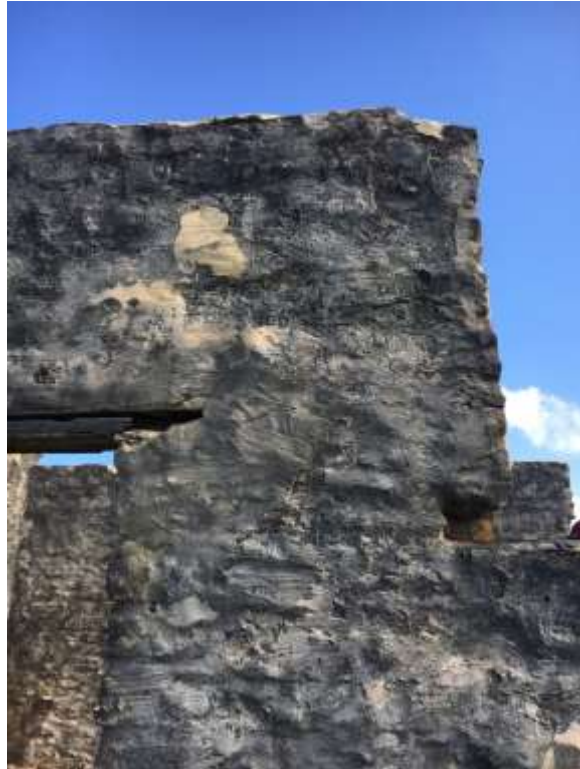
Figure 22 Crack on western side of northern face

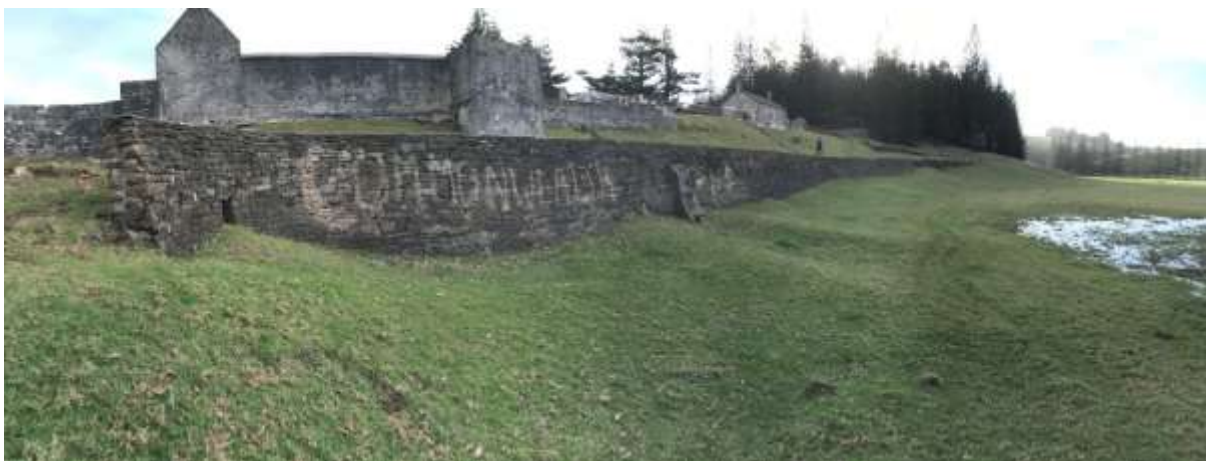
The Arthur’s Vale retaining wall, while it remained structurally intact, appeared to have some major issues with bulging of the retaining wall and erosion of parts of the retaining wall. Roughly a third of the retaining wall was showing a large bulge towards the north and the top half of the retaining wall appeared to have fallen back in on itself. There was evidence of large cracks throughout the retaining wall, gaps in the mortar between stones, no mortar in stones for portions of the retaining wall and there was evidence of significant cracking (>10 mm) and damage to the top of the retaining wall. There was evidence of three existing vertical drains within the first half of the wall however they appeared to be non-functional and possibly filled in. There was no sign of drainage in the rest of the wall, with no sign of drainage evident where the bulging in the wall was present. The landscape behind the wall was sloped to direct water into the main section of the retaining wall where there are no drains present through the retaining wall.

**Figure 27 Arthur’s Vale Retaining Wall**

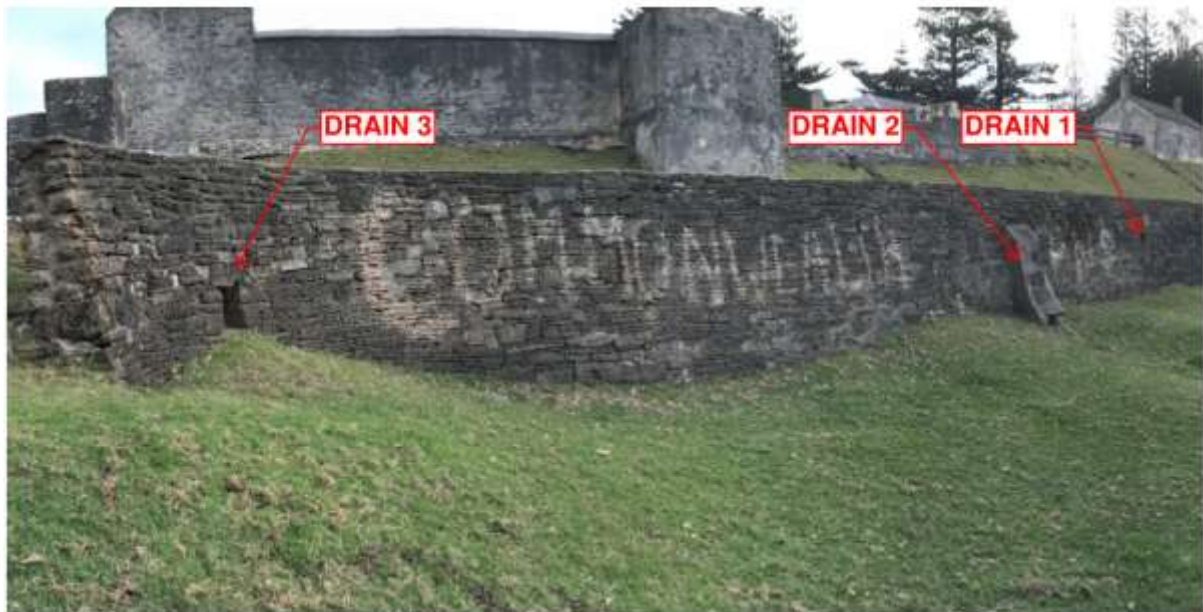
Figure 32 Arthur's Vale retaining wall drain locations

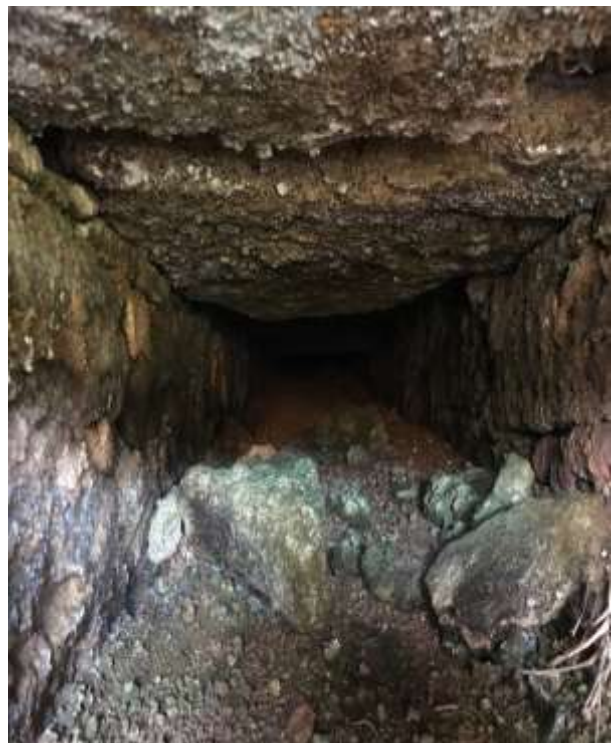
Figure 34 Drain 1 internal view

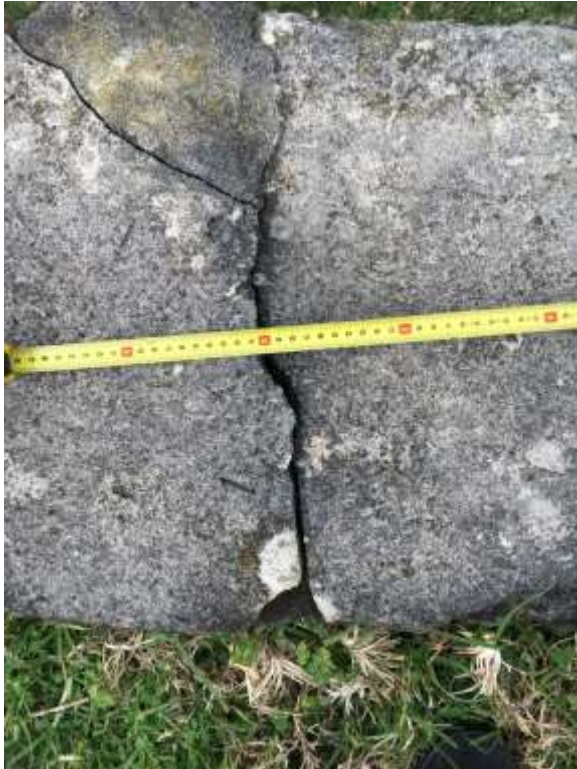
Figure 39 Cracking in top of retaining wall

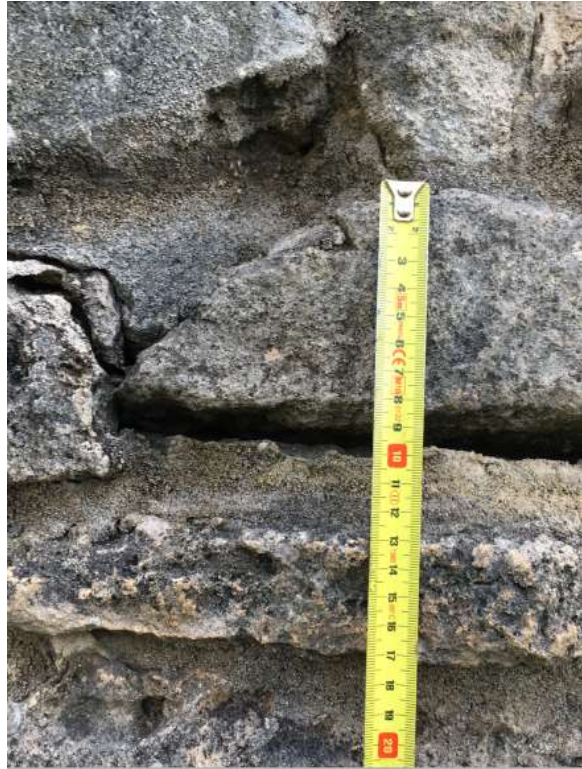
Figure 40 Cracking in the retaining wall

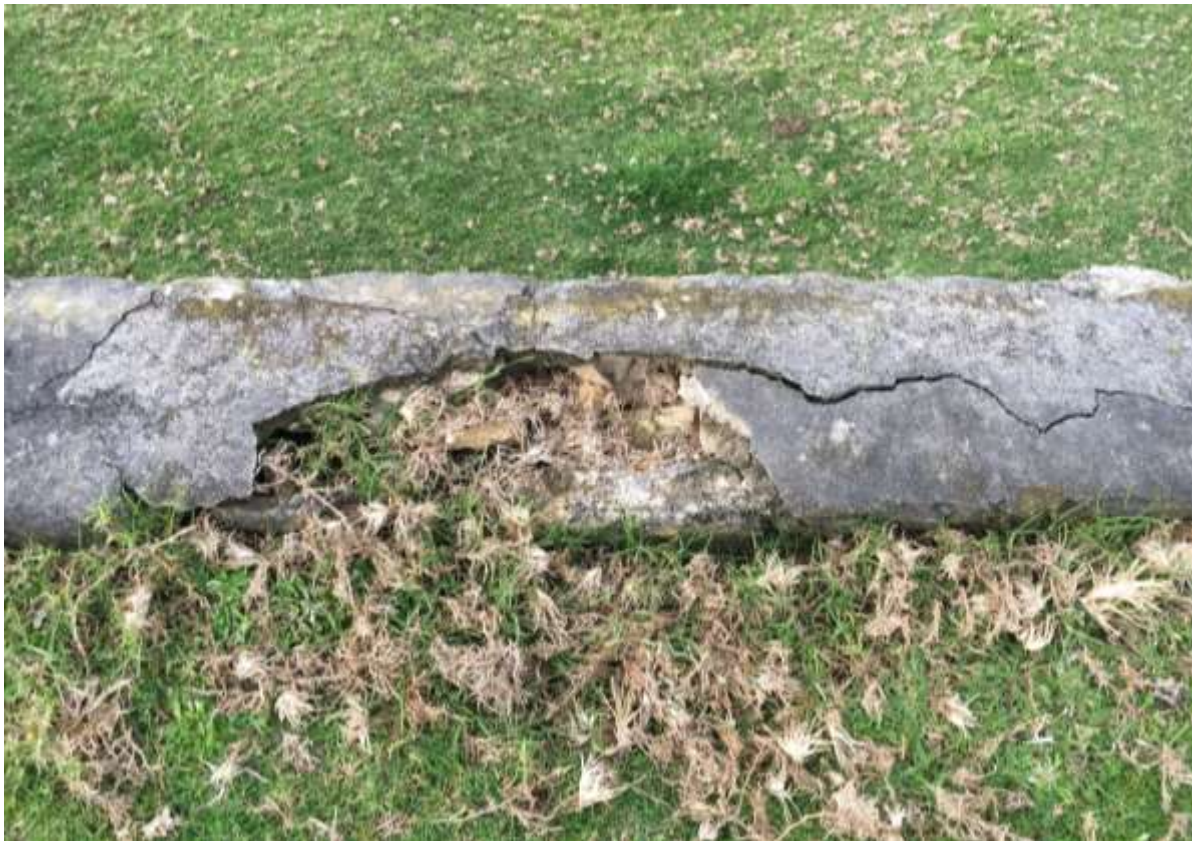
Figure 41 Damage to top of retaining wall

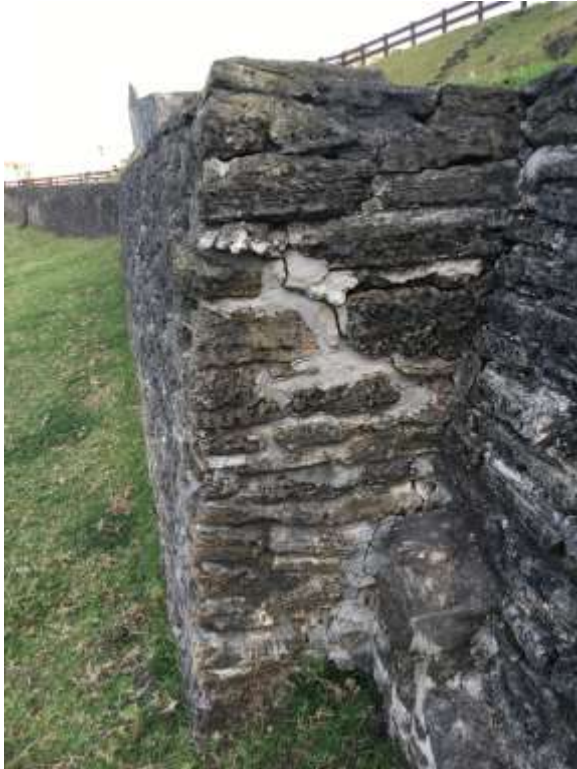
**Figure 42 Cracking and gaps in the mortar**

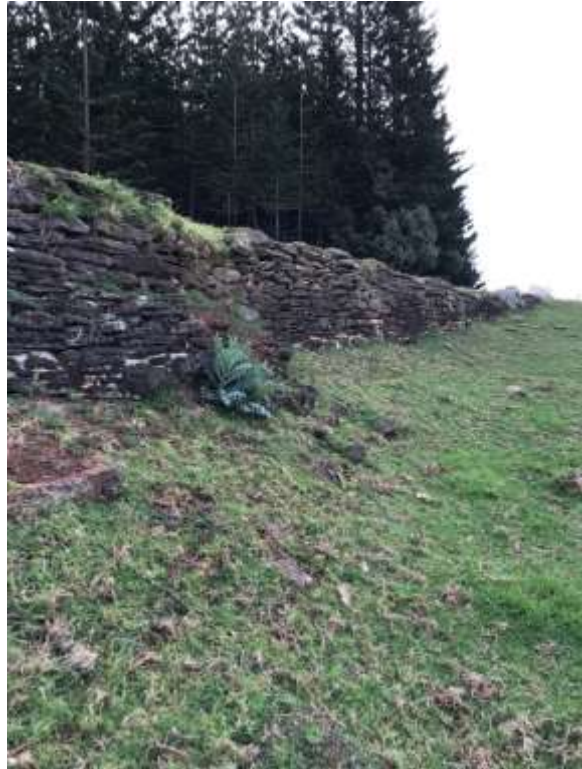
**Figure 43 Portion of retaining wall without mortar**

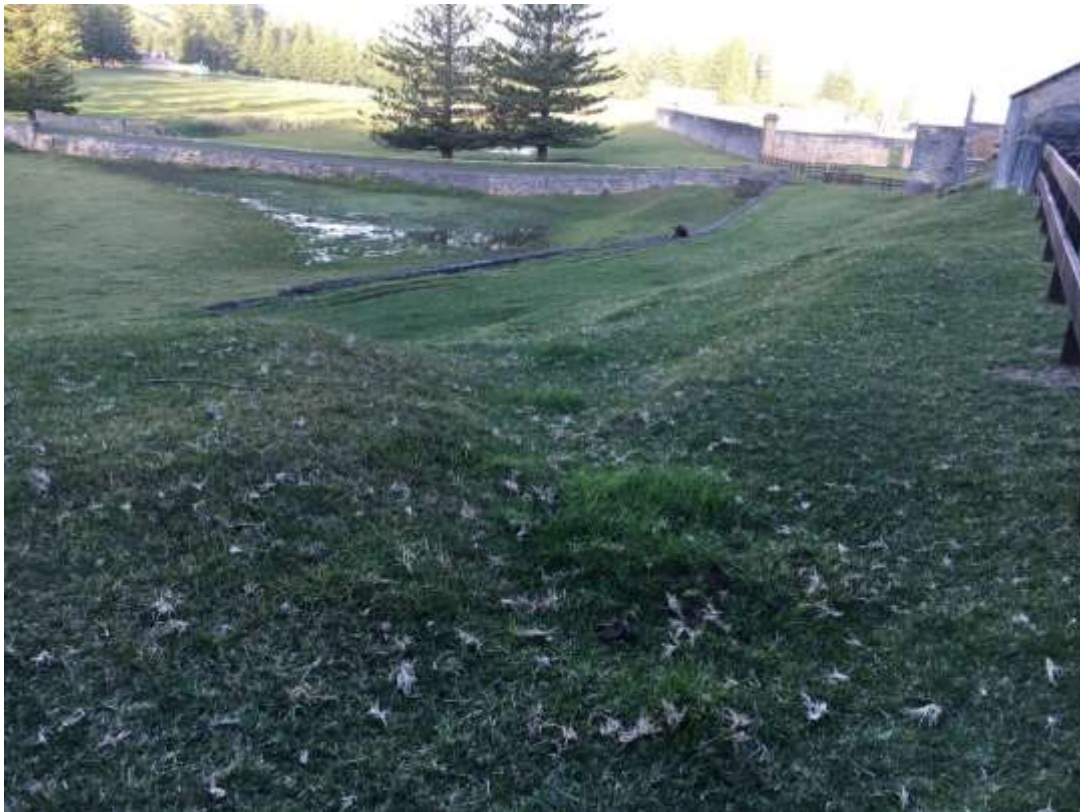
**Figure 44 Slope of land funnelling water down into retaining wall from hill behind**

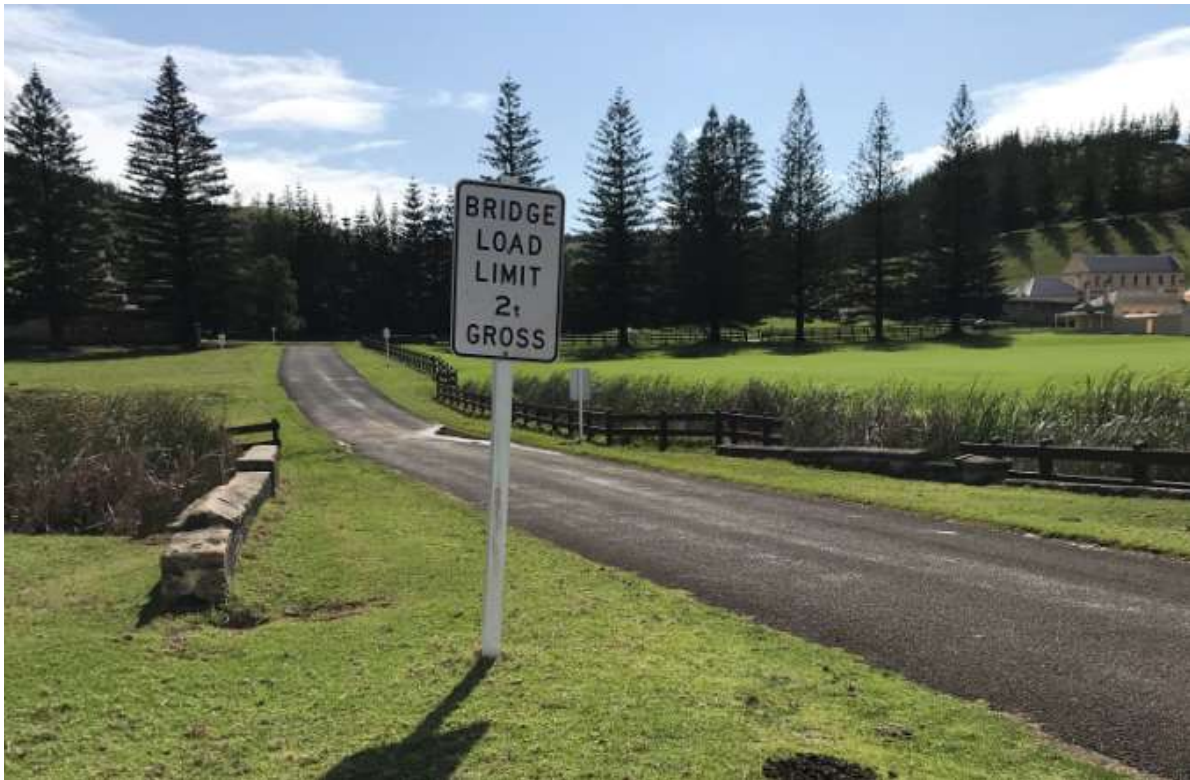
There is cracking present in the western wall of the bridge, with cracking up to 30 mm present in the top of the wall. Glass tell-tales had been attached previously to the outside of these cracks, but the glass has come loose from the epoxy in points rendering them ineffective. Measurement of the gap between the glass slide and the epoxy indicates that settlement of the northern abutment is continuing but at a slow pace.

**Figure 47 Bounty Street Bridge**

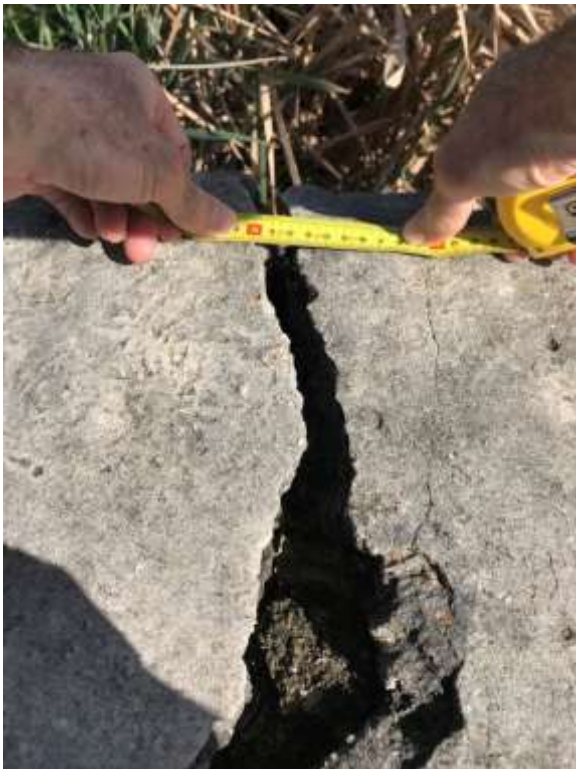
Figure 56 Crack in the western portal

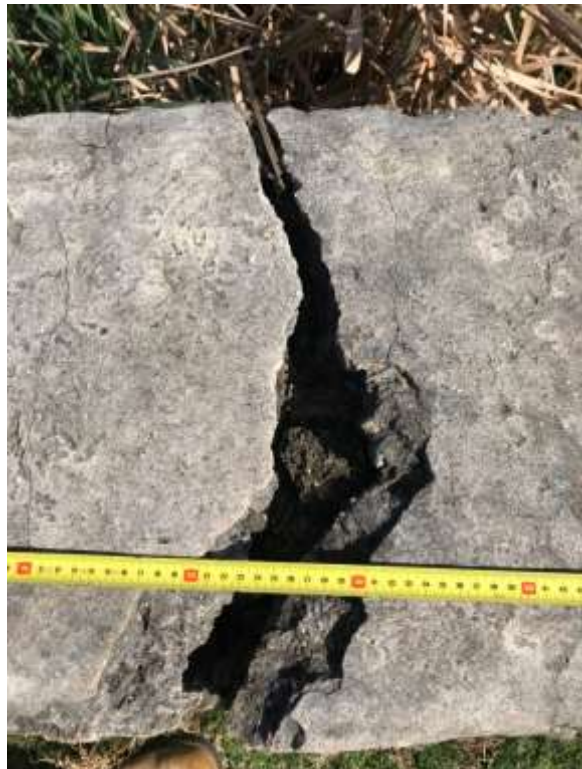
Figure 57 Crack in the western portal

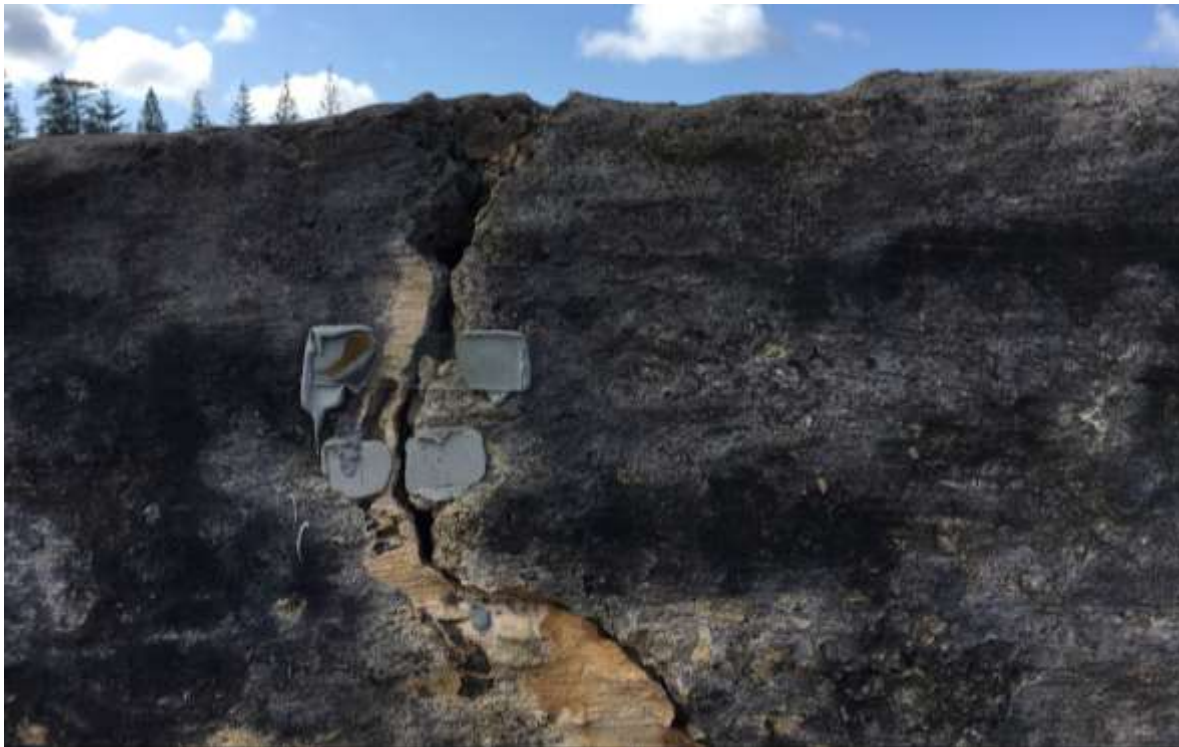
Figure 58 Glass tell-tale on side of crack in the western portal

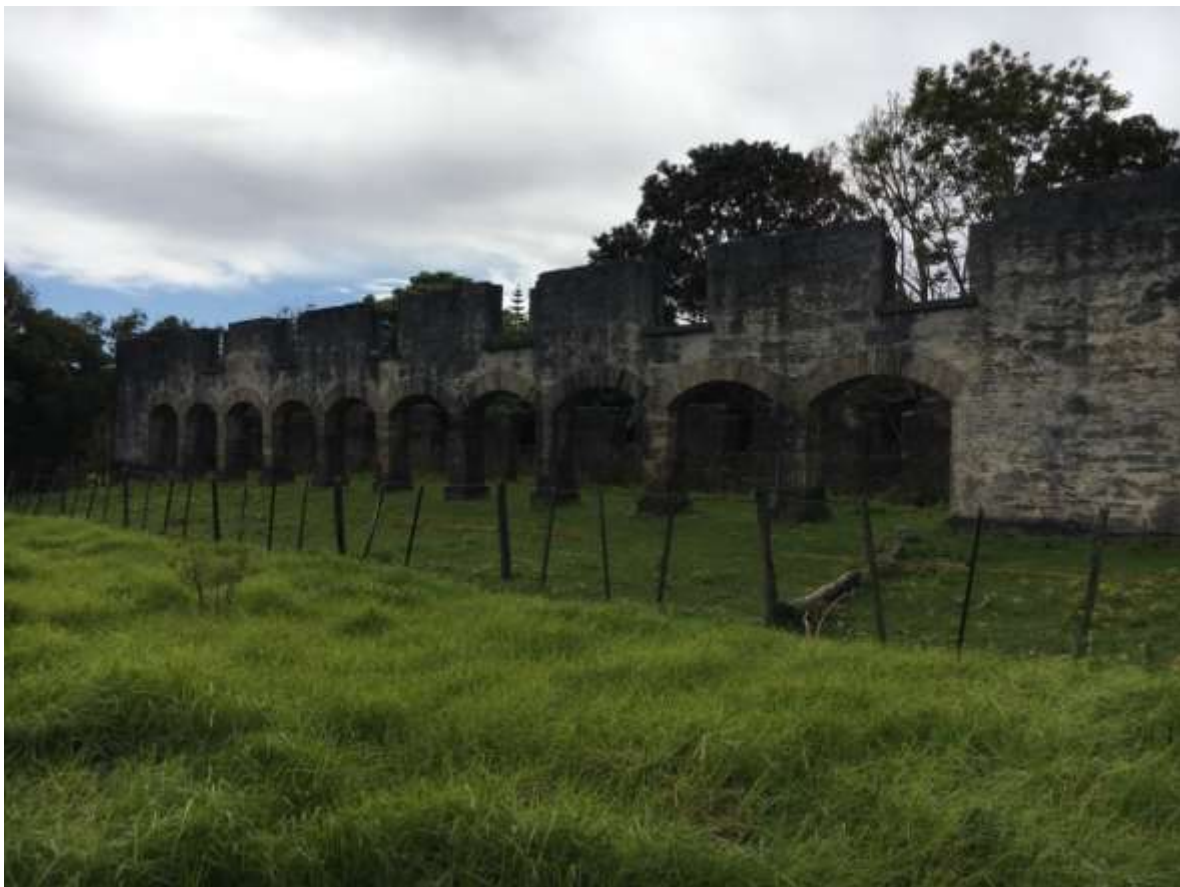
The stone of the arches appeared to be in a relatively good condition, with minor cracking to the walls and columns. There seemed to be an overall pitting of the stone on the columns, however the wall appeared to be in better condition, possibly due to being rendered or a different type of stone. The plinth at the base of the column was showing the same tilt as that of the wall. There was a lack of structure behind the wall to restrain the wall, hence leaving the wall unsupported against lateral loading.

Figure 63 Longridge Barracks Arches

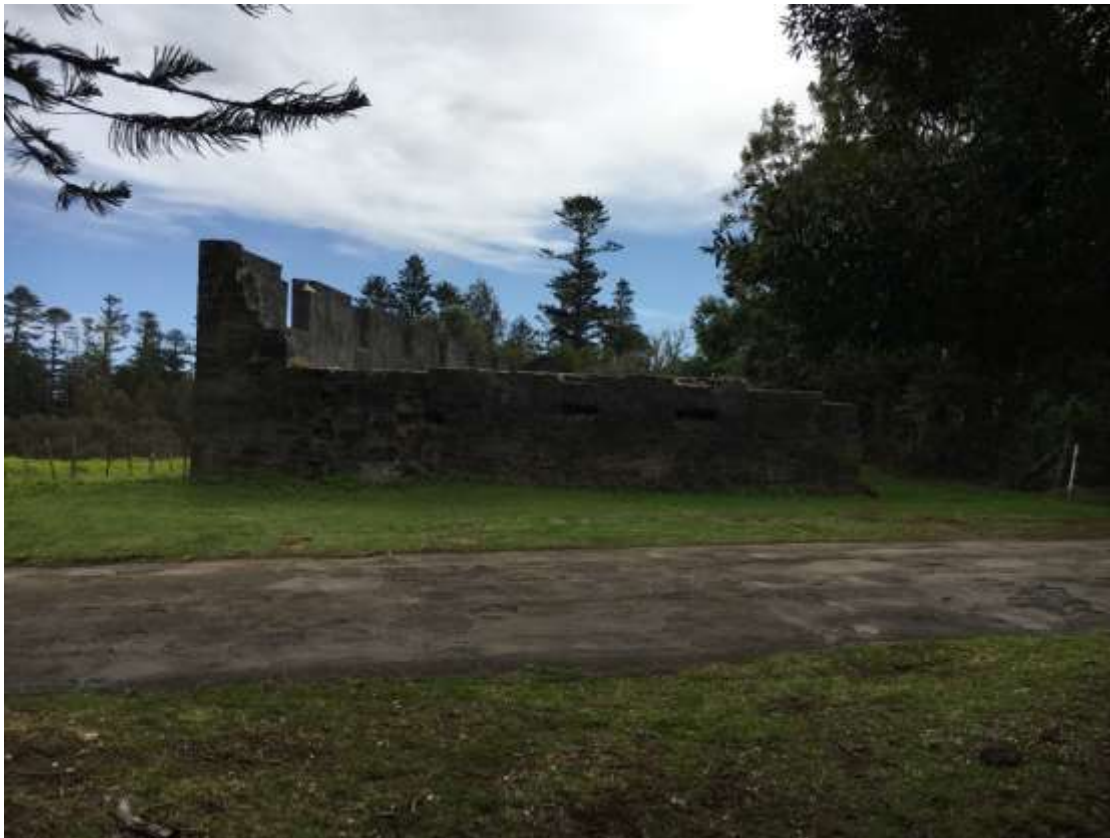
**Figure 68 Longridge Barracks lack of structure behind wall**

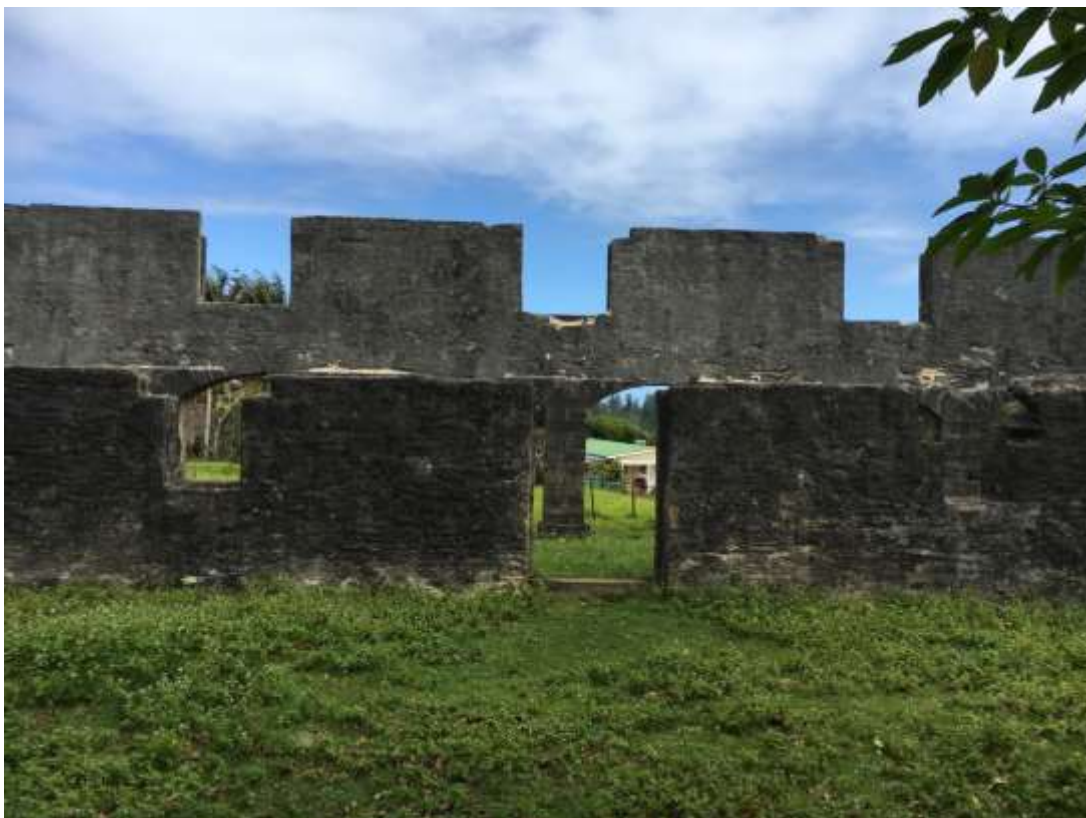
**Figure 69 Longridge Barracks lack of structure behind wall from rear of wall**

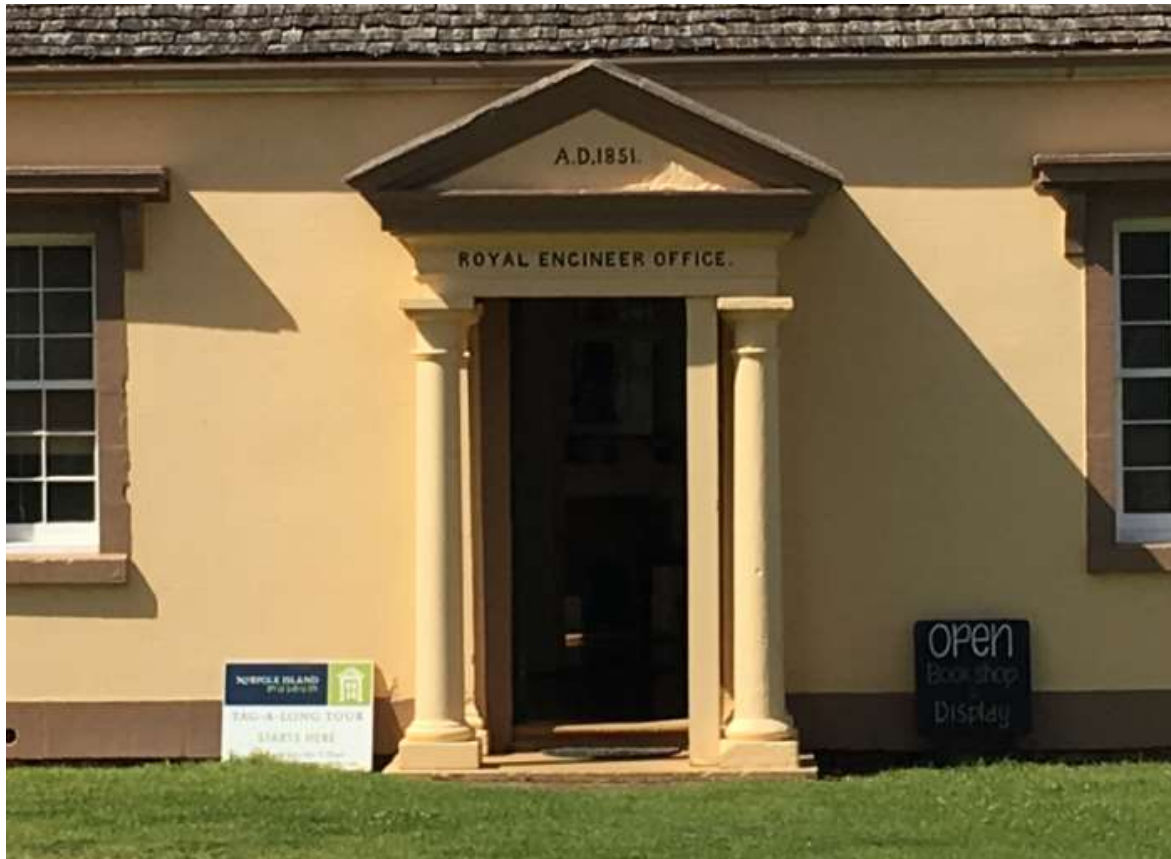
The roof of the portico appeared to be in good condition although there is a lean to the north of approximately 10 mm in the gable face. The replica column was measured to be slightly longer than that of the original column, which may have contributed to the lean in the top of the portico. There appeared to be some slight decay of the base stone of the portico, but this was minor and there was little to no evidence of settlement of the foundation below the portico.

Figure 73 Royal Engineer's Office Portico

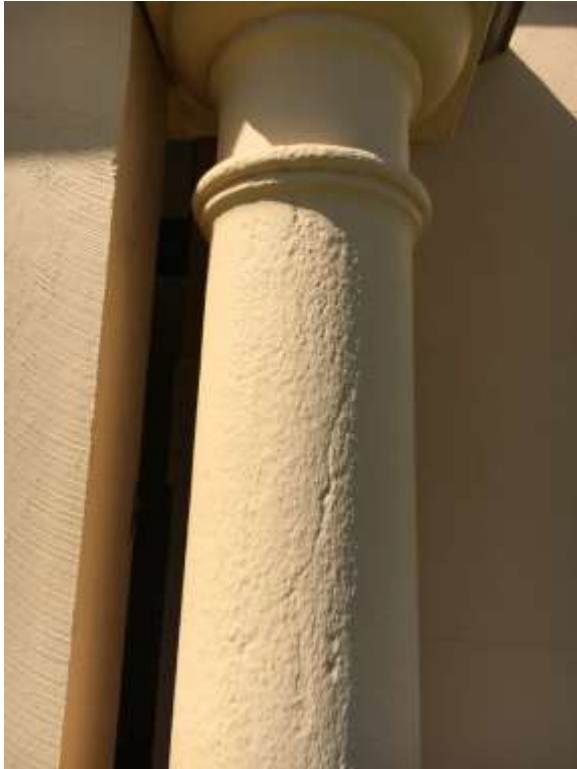
**Figure 76 Possible cracking in top of southern column**

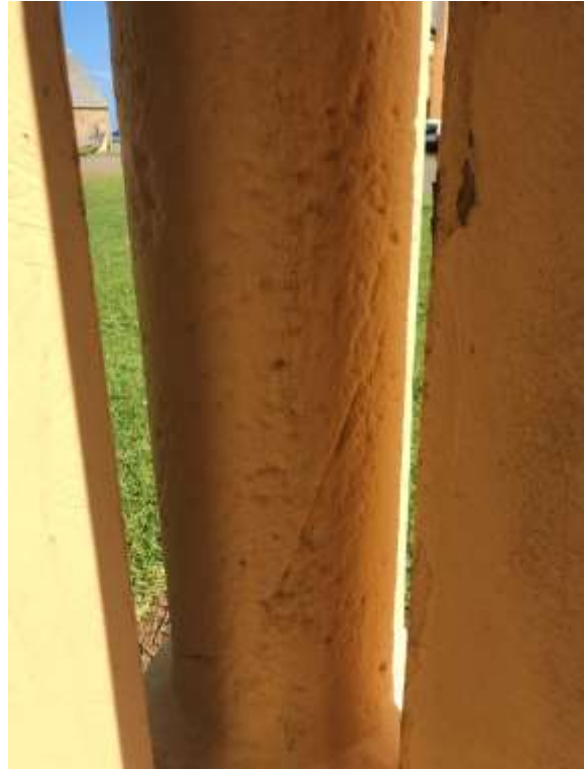
**Figure 77 Possible cracking in bottom of southern column**
