Review of KAVHA Safety Hazard Investigation

This desktop review is provided to the KAVHA Advisory Committee of the Department of Infrastructure, Regional Development and Cities (the Department) in response to their Approach to Market (Ref: TERR18/0310-01, dated 7 November 2018). It is intended as a peer review of the proposed rectification works on Norfolk Island prior to the project proceeding to a detailed design stage. This peer review considers the *KAVHA Safety Hazard Investigations Report* prepared by AECOM in October 2018 against the recommendations made in the *KAVHA Safety Hazard Scoping Study* prepared by GML Heritage in June 2018.

The review is limited to the following heritage assets:

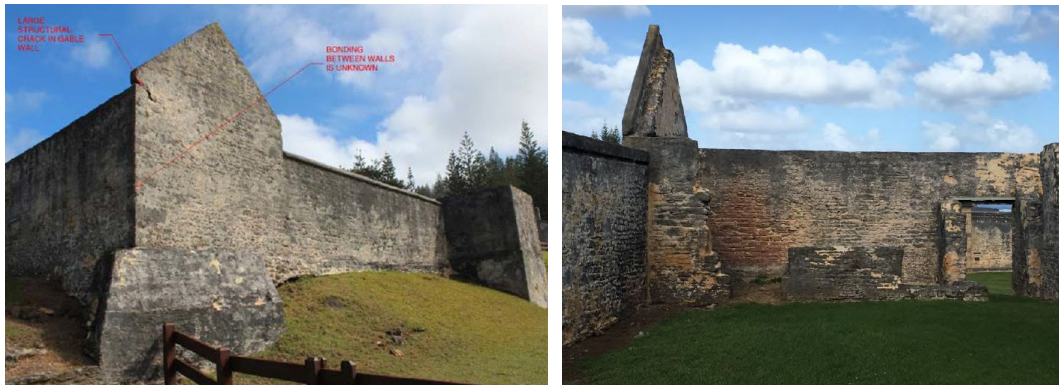
Figure 1 (left) – Northern gable of the Civil Hospital showing structural crack [Source: GML] and Figure 2 (right) – Civil Hospital ruins [Source: AECOM]

The primary concern is the unrestrained northern gable wall which has no lateral restraint and exhibits a large crack at its eastern corner. The gable is at risk of collapse, particularly during a high wind event or seismic activity. The walls of the building have been extensively pointed and skim coated with cement-based render and large voids extending 600mm into the wall have been identified. Erosion and cattle grazing have left the stone base of the wall exposed.

Both reports agree that the gable represents a significant risk and access to this area should be limited to minimise public risk in the short term. Both reports consider that the likelihood of visitors being present in the site during a high wind event is low, however Purcell would contend that given the unpredictable nature of extreme weather events on the island this is not a reasonable assumption upon which to base visitor safety. Both reports suggest a longer-term strategy of incorporating some

form of restraint or bracing into the wall to prevent overturning. The GML report proposes a form of "partial reconstruction" involving the installation of a new roof structure to emulate the original roof form to brace the walls, and the possible use of stainless steel tie rods between walls to improve the bond. The AECOM report suggests the building of a stand-alone structure behind the gable to tie the wall back.

The recommended strategy for the gable wall in the short term is an exclusion zone be established around the area and a temporary support be provided. In the long-term, a permanent additional support structure should be constructed. The report proposes that a heritage impact statement be developed to assess the proposed changes and their impact on the significance of the structure.

The act of restraining the gable wall to minimise the risk of its collapse is supported in heritage terms. Purcell agree with the recommendations of the AECOM report that a partial reconstruction (installation of some form of new roof structure as proposed in the GML report) would be visually intrusive, however in some instances such a proposal may be warranted as a long-term solution for the site. Purcell note that there are no practical methods to remove contemporary coatings without significant impact to the extant original fabric. As such these areas should be left to take their course of deterioration. Future works should be undertaken in lime-based materials. Voids in the wall should be filled to minimise the risk of further cracks developing. Such measures will help ensure the long-term preservation of the walls and will help reduce further deterioration.

- Excavate the base of the gable wall, inspect by structural engineer to confirm proposed repair works, point stonework and reinstate ground level
- Timber bracing structure to stabilise gable walls
- Timber lintels to doorway
- Detailed design, drawings, specifications
- Heritage review & approvals
- Contract documentation

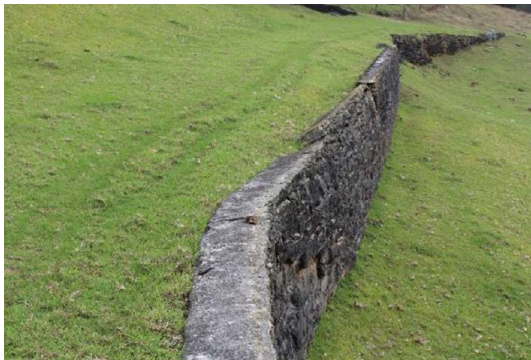
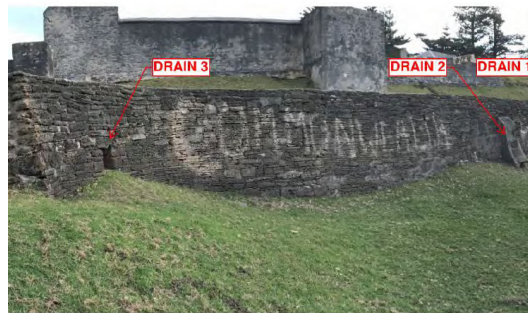
Figure 3 (left) – Bulging retaining wall below Civil Hospital [Source: GML] and Figure 4 (right) – Drain locations in the retaining wall [Source: AECOM]

The Arthur's Vale retaining wall is constructed of calcarenite stone and is of undetermined thickness. The wall was identified in both reports as being at risk of structural failure from the loads imposed by vehicular traffic on the upper level, particularly following a period of prolonged rainfall. Both reports recommend permanent exclusion of vehicles from a zone 2m to the rear of the wall. Drains within the wall appeared to be non-functional and the current landscape behind the wall is directing rainwater towards the centre of the wall rather than dispelling it away from the wall.

The central portion of the wall constitutes the most damaged portion. It appears to be a dry stone facing laid over an earth surface, with some sections having had mortar repair pointing in 1996. A distinct "bulging" could indicate both inadequate wall thickness and excessive water pressure behind the wall. The GML report recommends that the wall should be rebuilt using original materials following careful documentation prior to disassembly. This solution is at odds with the current heritage management policies for the place, and is not supported by the AECOM report which recommends that the damaged section of wall can be left as is (once stabilised with the recommended drainage works) and re-pointed with lime mortar if necessary.

The report recommends directing water away from the wall through the construction of an earth bund and the addition of an agricultural drain behind the wall, along with ensuring the existing drainage system within the wall is operational. If such works are observed to stabilise the wall, then the wall can be left as is. If strengthening is required, the application of appropriate lime mortar is recommended.

Purcell agree with the AECOM report that the dismantling and rebuilding of the wall would be expensive, time consuming, and not in keeping with conservation policy for the place. The potential impact of drainage works upon the ground conditions and the archaeological remains around the wall will require a heritage impact statement be prepared.

In principle Purcell support the above project staging and feasibility. We would not support the dismantling of the wall prior to the landscaping/drainage works listed above which are aimed at halting the displacement of the wall. Once the proposed drainage works are undertaken, the wall should be inspected by a structural engineer to monitor its condition and the effectiveness of the works. Actual replacement of stones or mortar should only come about following the above works.

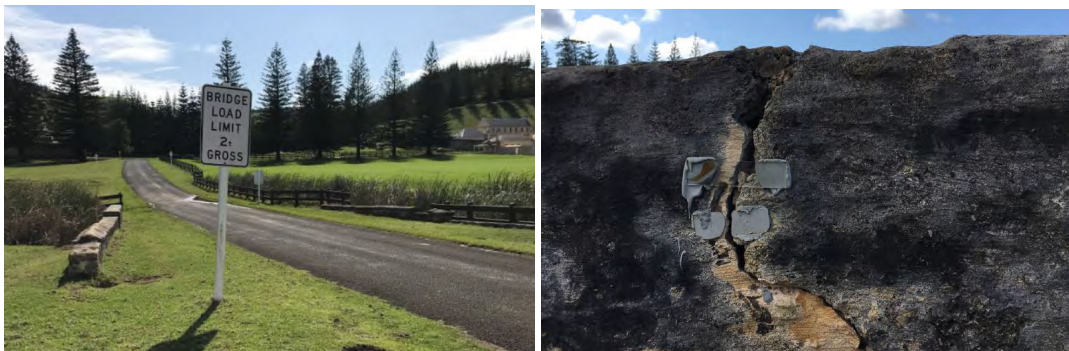
Figure 5 (left) – Bounty Street Bridge and Figure 6 (right) – crack in the western portal [Source: AECOM]

The bridge is suffering from well documented structural issues, including extensive cracking and settlement. The western portal of the bridge has a particularly large crack, indicating settlement of the northern abutment, likely to be caused by inadequate bearing material as the bridge foundations settle into the mud. The fact that the bridge is submerged will lead to continued erosion of the stonework.

Both reports recommend the closure of the bridge to vehicular traffic, followed by significant measures to achieve de-watering of the site to allow an appropriate investigation of the bridge and its foundations. The Watermill Creek Dam has been identified in the GML report as a potential safety (drowning) risk and that warning signage or other appropriate protective measures be implemented.

The AECOM report recommends the bridge be immediately closed to all but pedestrian traffic. A geotechnical investigation is required to assess the foundation conditions. Before any works to the actual bridge can be undertaken, a number of other works will be required to address site issues. Works to address the issue of sewage contamination are required before any other works commence, as these represent not only human health risks but also a risk to the ecology of Emily Bay. Later works include the lowering of the water level of Watermill Creek to historical levels by removal of water and weeds, the construction of a coffer dam and diversion channel, emptying and repairing the existing dam, removing the concrete blockwork weir immediately downstream of the tunnel,

Only by first undertaking extensive works to address sewer contamination and then remove the significant build-up of alluvium will it be possible to undertake a meaningful structural and condition assessment of the bridge. There is little doubt that the submersion of the structure will in the long-term lead to significant degradation of the stonework. Purcell agree with the AECOM report that excavation works for desilting or other purposes may undermine bridge structure and/or result in damage to original material and archaeological deposits. A suitably qualified engineer should direct the excavation works, with appropriate archaeological monitoring.

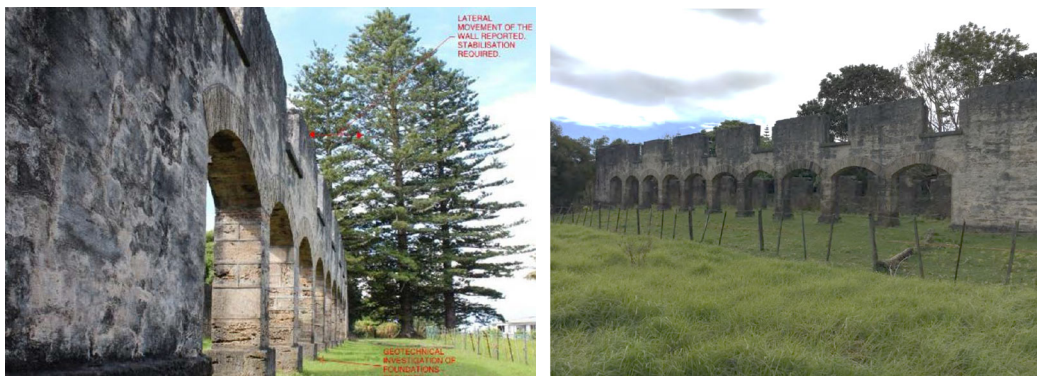
The Longridge Barracks Arches are currently in a state of ruin with the face of the arches leaning to the south by up to 200mm. The barracks structure has significantly decayed and has left the arches wall unrestrained.

Figure 7 (left) – Longridge Barracks Arches showing thickness of wall [Source: GML] and Figure 8 (right) – Colonnade wall of Longridge Barracks Arches [Source: AECOM]

The centre portion of the wall has a significant lean, and this is likely to result from undersized footings. The lean in the wall is exacerbating this effect, meaning the lean is likely to increase over time leading to the potential loss of this exceptionally significant structure and possible injury or death from structural collapse.

Both reports identify the significant lean of the structure and the potential for collapse. The reports are unanimous in their short-term recommendation that the area immediately to the south of the arches be closed off to both pedestrian and vehicular traffic to mitigate the risk to public safety from potential wall collapse. The GML report suggests that following a geotechnical investigation the structural design of a new “heritage interpretation” of the roof/floor structure could brace the walls, while the first part of a two-stage solution proposed by the AECOM report focusses on underpinning the arches to prevent further rotation.

A “do nothing” approach is not considered a viable option in this case. The AECOM report proposes a two-stage solution. Firstly, works would be undertaken to underpin the footings to the arches to prevent further rotation. The wall will need to be temporarily braced on both sides to prevent collapse

The second phase would involve the top of the wall above the arches being braced to resist wind and seismic forces. This may be achieved in a fashion similar to that proposed for the retaining of the Civil Hospital Gable.

Purcell agree from our desktop review that the initial focus of any proposed works should be to reduce the pressure on the foundations from the eccentricity of the wall by way of underpinning the footings. The introduction of extensive bracing structures alone would ultimately not address the issue. We agree with AECOM that the "less intrusive option for the stabilisation of the Arches will be most in keeping with the conservation aims of the EPBC Act and the Burra Charter." The exact method of inserting underpinning needs to be investigated further, and Purcell question whether the proposed temporary propping of the wall (below) during this process is anticipated to actually remove the lean in the wall at the same time. The exact form, material and detail of the necessary propping should be predicated on minimising the visual intrusion of any new structure on the existing wall while at the same time offering the best long-term structural stability. We do not consider the rebuilding of roof or floor elements in some form of "interpretation" to be best heritage practice in this instance.

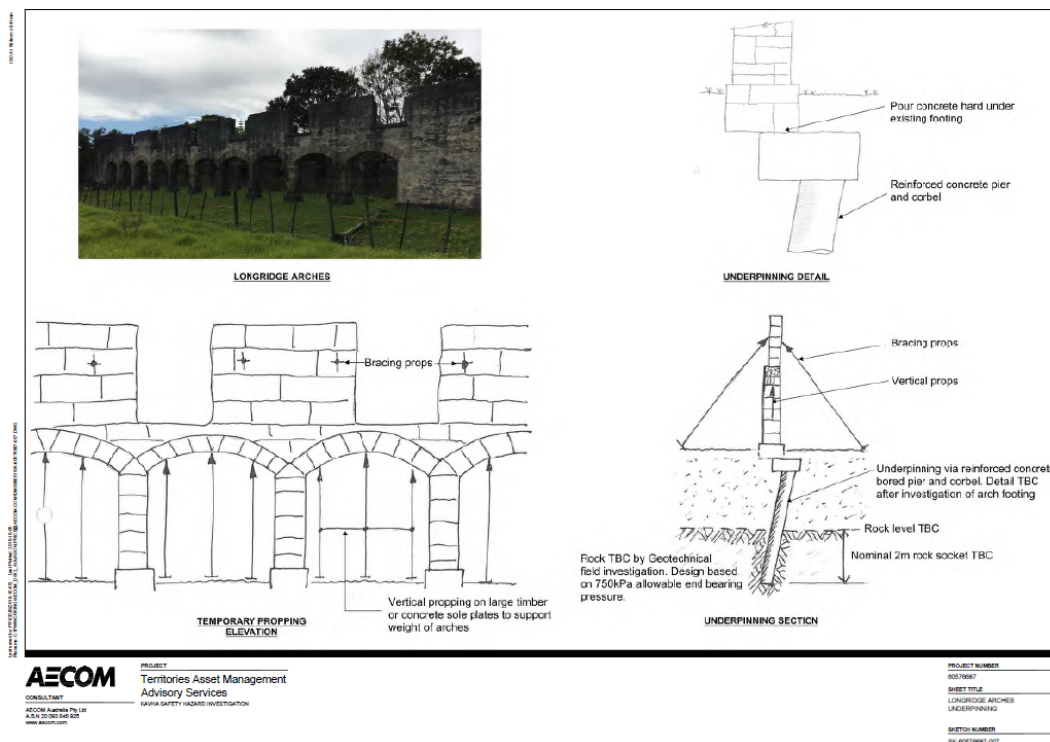
Figure 9 – Proposed works for underpinning of arches [Source: AECOM]

- Undertake supervised excavation around arch footings to determine footing extent, depth and type. This to facilitate underpinning and steel brace column footing design.
- Undertake supervised geotechnical field investigation to determine depth to rock and rock quality to enable completion of underpinning design and steel brace column footings.

- Temporary propping of arches
- Underpinning design
- Steel bracing columns to the rear of the arches. This will require architectural, heritage and structural input
- Footings for the steel bracing columns
- Detailed design, drawings, specifications
- Heritage review & approvals
- Contract documentation.

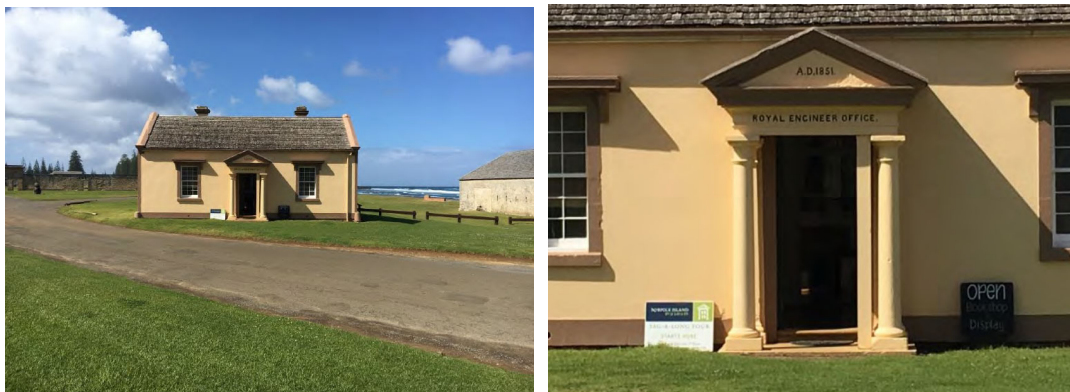
Figure 9 (left) and Figure 10 (right) – Royal Engineer's Office (REO) with detail of portico [Source: AECOM]

The Royal Engineer's Office is in generally good condition, with the focus of both reports being the structural integrity of the front portico, in particular the southern column. The portico is said to have suffered damage some years ago as the result of a car accident, following which the northern column was replaced entirely and the southern column was flanked by two timber posts for additional support. Currently, the northern replacement column has a damaged capital and base, and the current Sydney sandstone column itself is "not servicing the exposure conditions adequately" and eventually these matters will affect its structural integrity. There is also a concern that the gable face itself is not adequately tied back to the roof of the portico, and a lean has developed in this structure.

There is some inconsistency between the two reports in terms of both cause and effect for the current condition of the portico, and also a difference of opinion in terms of risk. The GML report maintains that the portico rotation is caused by footing settlement, and that underpinning may be required. GML suggest that this has led to cracking of the stones which are now potentially unstable and at risk of collapse. Given the daily pedestrian activity through the portico, GML consider this to be a high-risk situation. They recommended that following a "forensic investigation" stainless steel rods are inserted "to tie the entry portico structure back to the main building walls". Following insertion of these rods, if the southern column is found to be in good condition, the report recommends removing the timber posts to the southern column and replacing the northern column with a more durable stone. Purcell question whether the removal of the timber posts would present an undue level of risk.

The AECOM report states that "the ground conditions and base stone (of the southern column) appeared to be stable and showed little sign decay... (with) little to no evidence of settlement of the foundation below the portico." The report suggests that rather than the settlement noted in the GML report, the apparent rotation of the portico can instead be attributed to the fact that the replacement northern column is in fact slightly larger than the original column, and this "may have contributed to the lean in the top of the portico".

To determine the structural condition of the southern column and if any repairs are necessary or the timber props can be removed, the report recommends the paint on the column be stripped in order to determine the extent of cracking.

Purcell support the recommendation to strip the paint to the southern column to determine the extent of cracking and agree with the AECOM recommendation that a heritage specialist and archaeologist be present for such work. Given that the column capital and stone base of the northern column show signs of decay, with the capital being eroded by wind and salt action, and the incorrect height of the column itself causing the lean in the portico, the replacement of this element with a column of more appropriate dimension and material is supported by Purcell.

Given that the apparent damage to the portico was initially caused by a car accident, the AECOM report recommends that vehicular access to the grassed area in front of the building be restricted through the installation of a visually discreet barrier or kerb. Purcell view this as a sensible suggestion.
