# **HMS** Sirius

## Site Inspection Report 2020

Norfolk Island Australian External Territory

March 2021

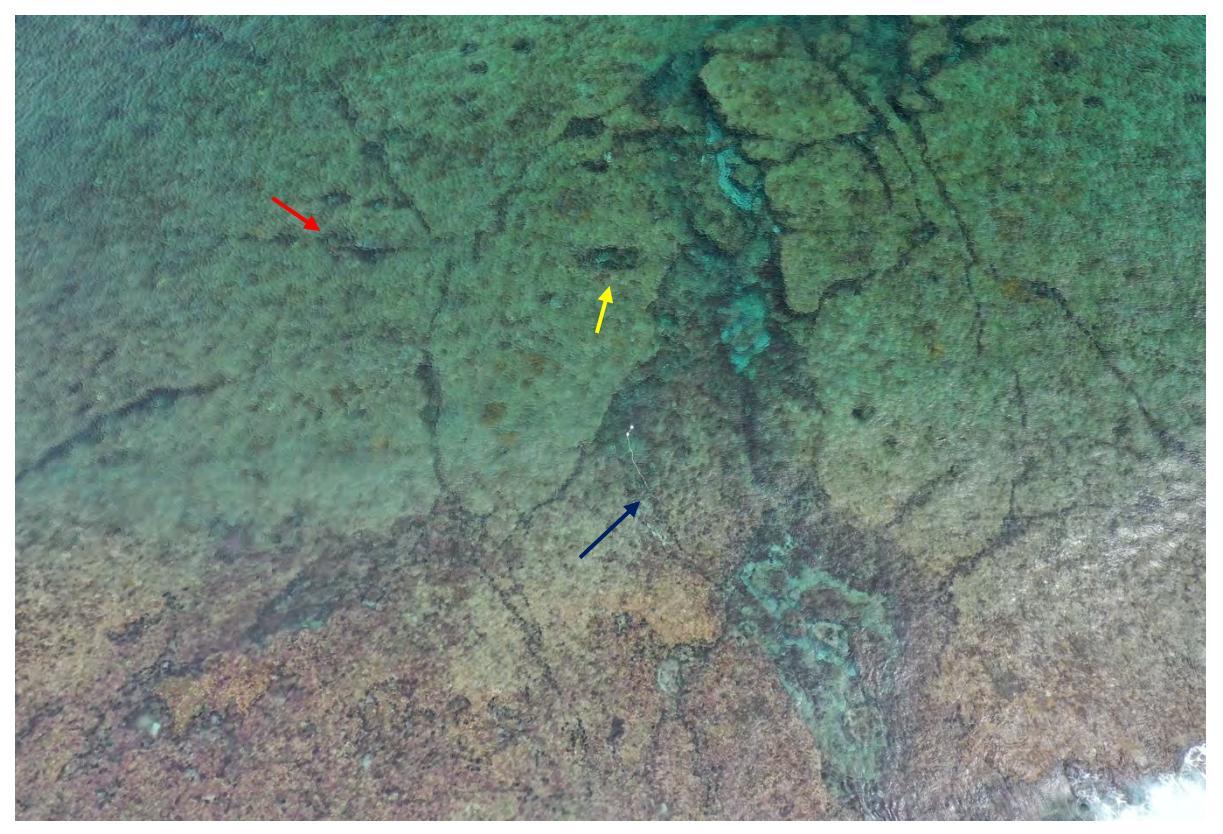
The drone footage helped to identify the main gully as well as new micro gullies in the reef, which could then be placed onto the site plan. The conditions over the site were so calm, wreck features could be seen through the water column which also assisted in spatially mapping the site (Figure 29).

*Figure 29: Still image from drone footage, highlighting the main gully through the reef and micro gullies through the reef top.* Yellow arrow indicated corranade hole, red arrow indicates Anchor SI 624, dark blue arrow indicates Anchor SI 625. (Image taken 15<sup>th</sup> November 2020, shore is to the base of the image).

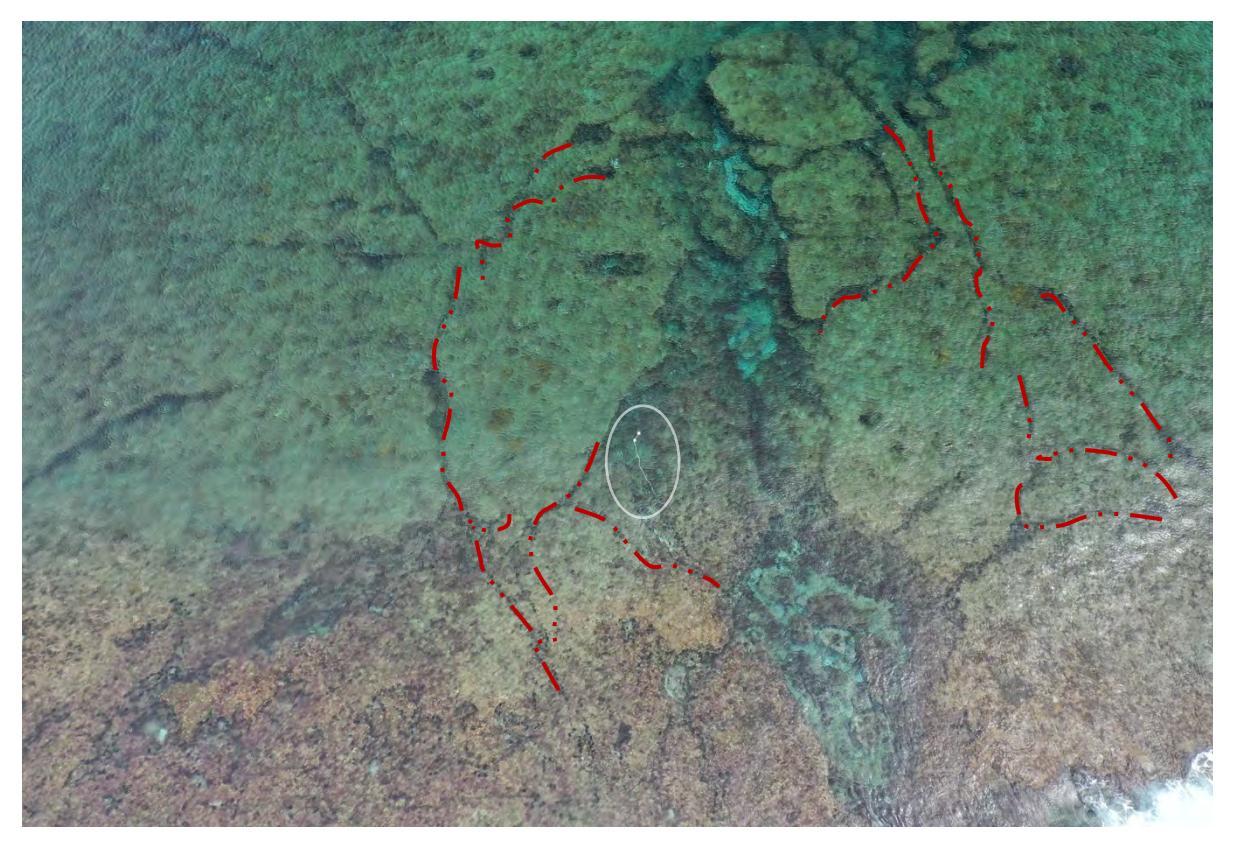
Sea urchins are prevalent over the entire site. They are creating micro gullies that are eating into the reef top. These micro gullies can be seen from drone footage on a clear, calm day (Figure 37). The urchin activity relevant to key features of the wreck will be discussed in the sections below.

*Figure 37: Drone footage showing sea urchin micro gullies, looking south west.* Red lines drawn on examples of sea urchin micro gullies. White circle highlights the buoy marking anchor SI 625 (Image taken 15<sup>th</sup> November 2020, Nathan Weaver).

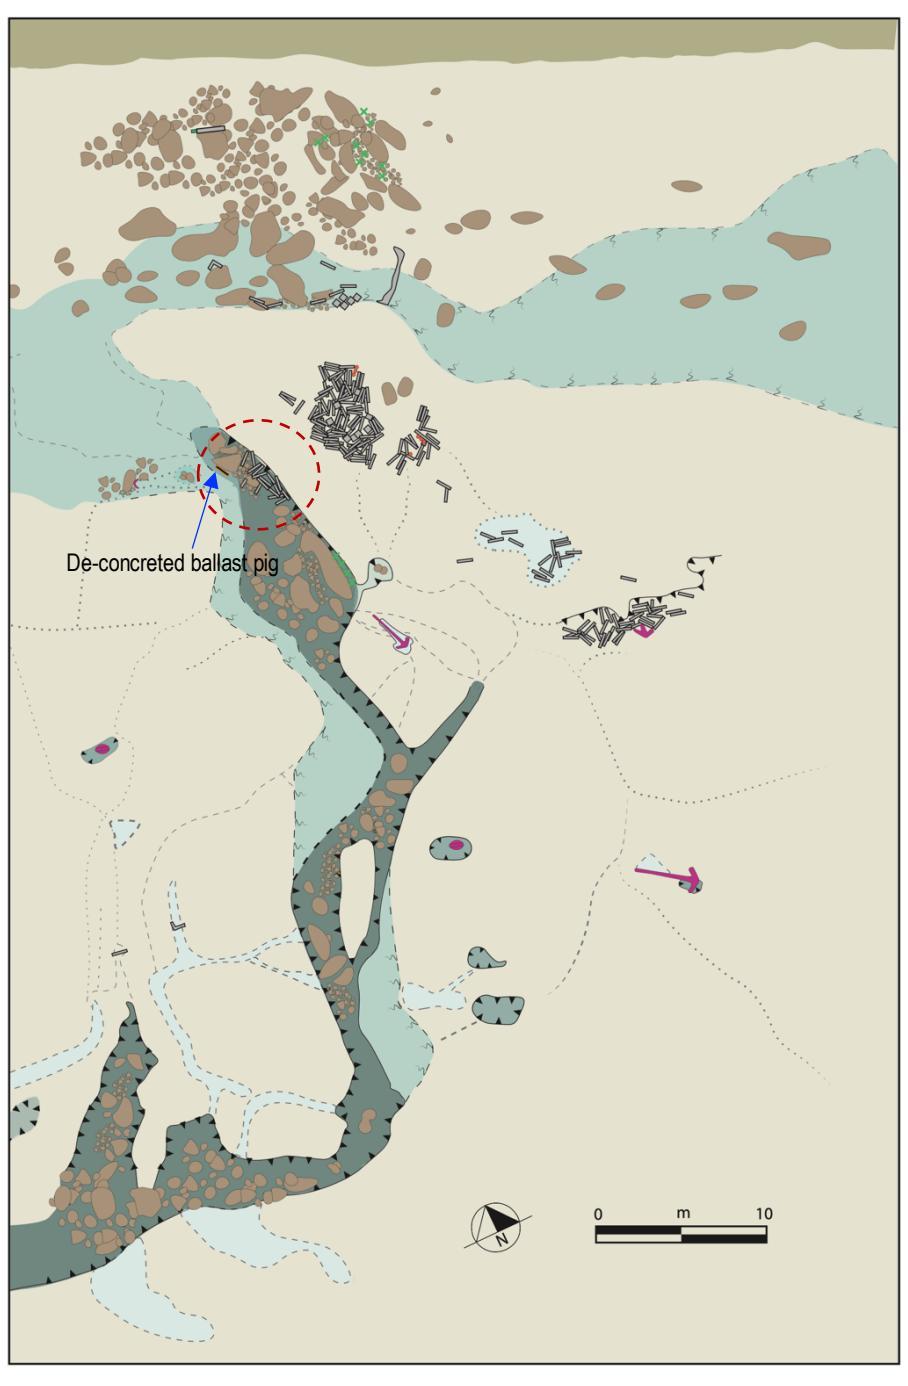
One ballast pig is rolling loose in the gutter and no longer has any growth or concretion protecting it (Figure 52 and Figure 53). It is unclear where this ballast iron has come from but likely from the gully ballast pigs. The pig is now cylindrical rather than rectangular. Heavy storm action may see this ballast pig move entirely away from the site.

*Figure 49: Location of gully ballast pigs (red circle).* De-concreted ballast pig indicated with blue arrow.

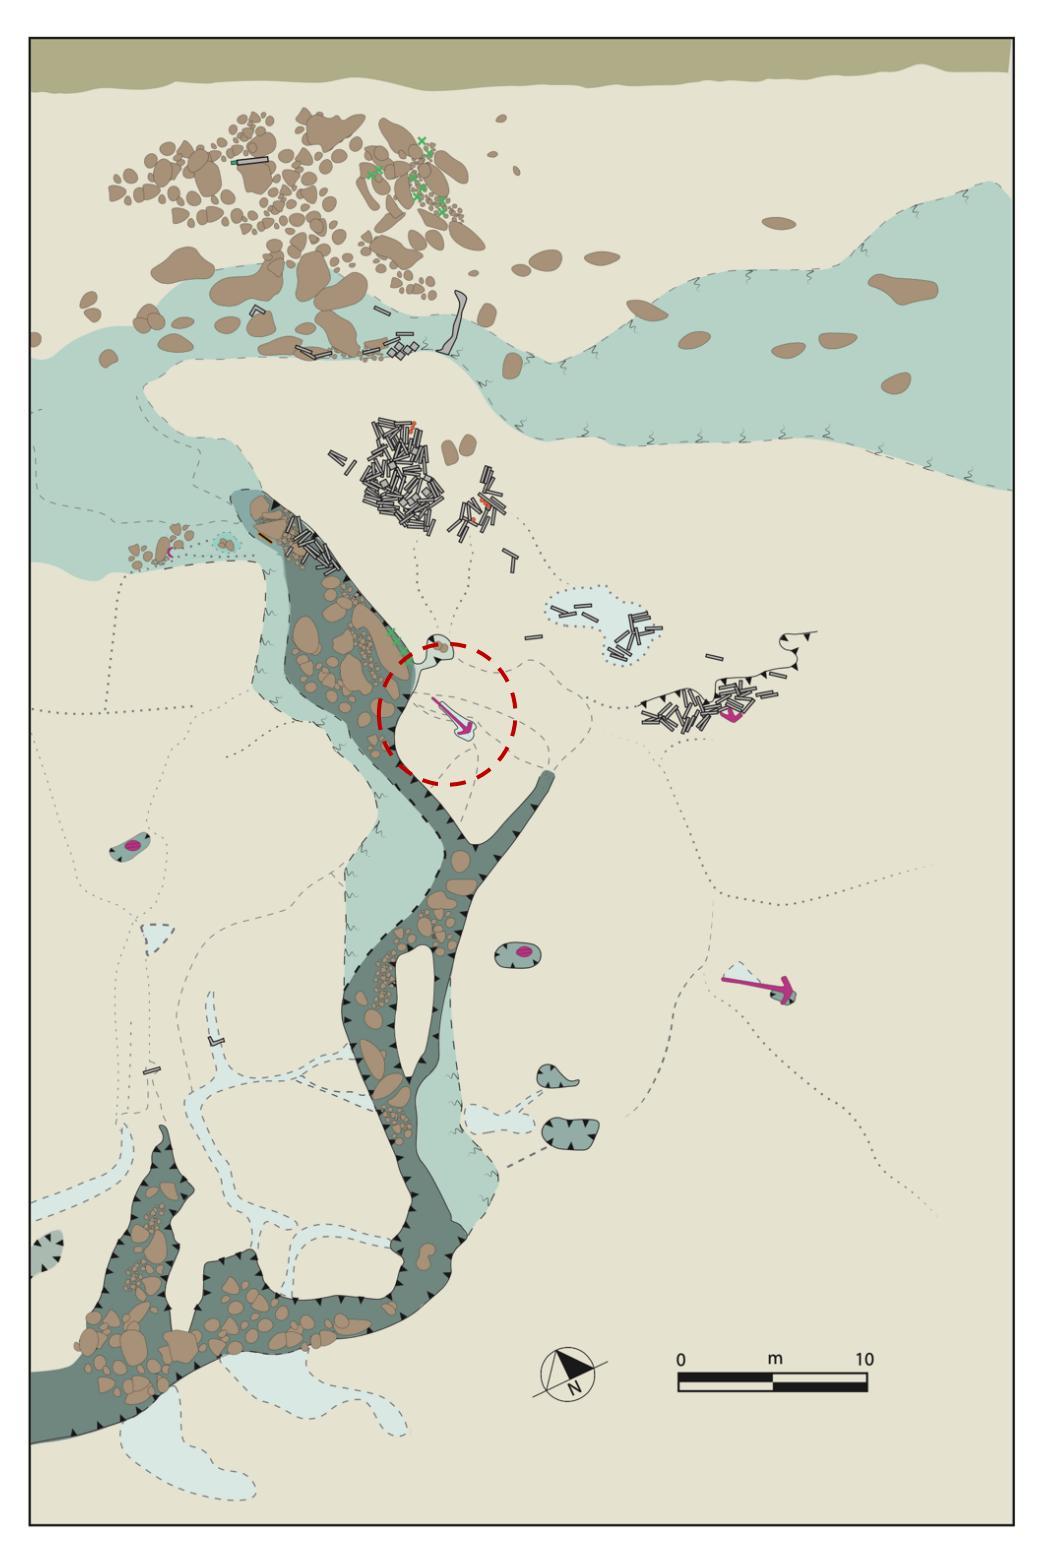
Figure 70: Location of Anchor SI 625.

This anchor rests in a thin gully, south of the main ballast mound (Figure 70 and Figure 71). It is a smaller anchor than SI 624, and lies flat along the seabed. The left arm still has its fluke, and its shape is still evident despite concretion and algae growth. The right arm is broken and the tip lies just under the gully edge (Figure 72). The anchor measures 2.90 m long from the crown to the end of the shank. The left arm is 1.1 m from the crown to the tip of the fluke, while the right arm is 0.5 m.

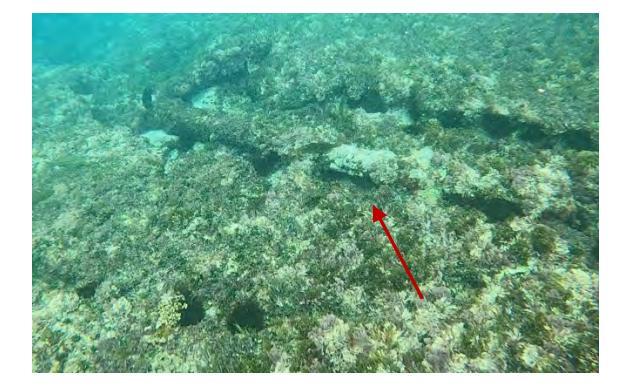
*Figure 75: Anchor SI 625 in February 2020. Note concretion covering entire shank.* (Image taken 27<sup>th</sup> February 2020).

although the concretion that has broken off appears not to have had seaweed growth on it previously (Figure 75).

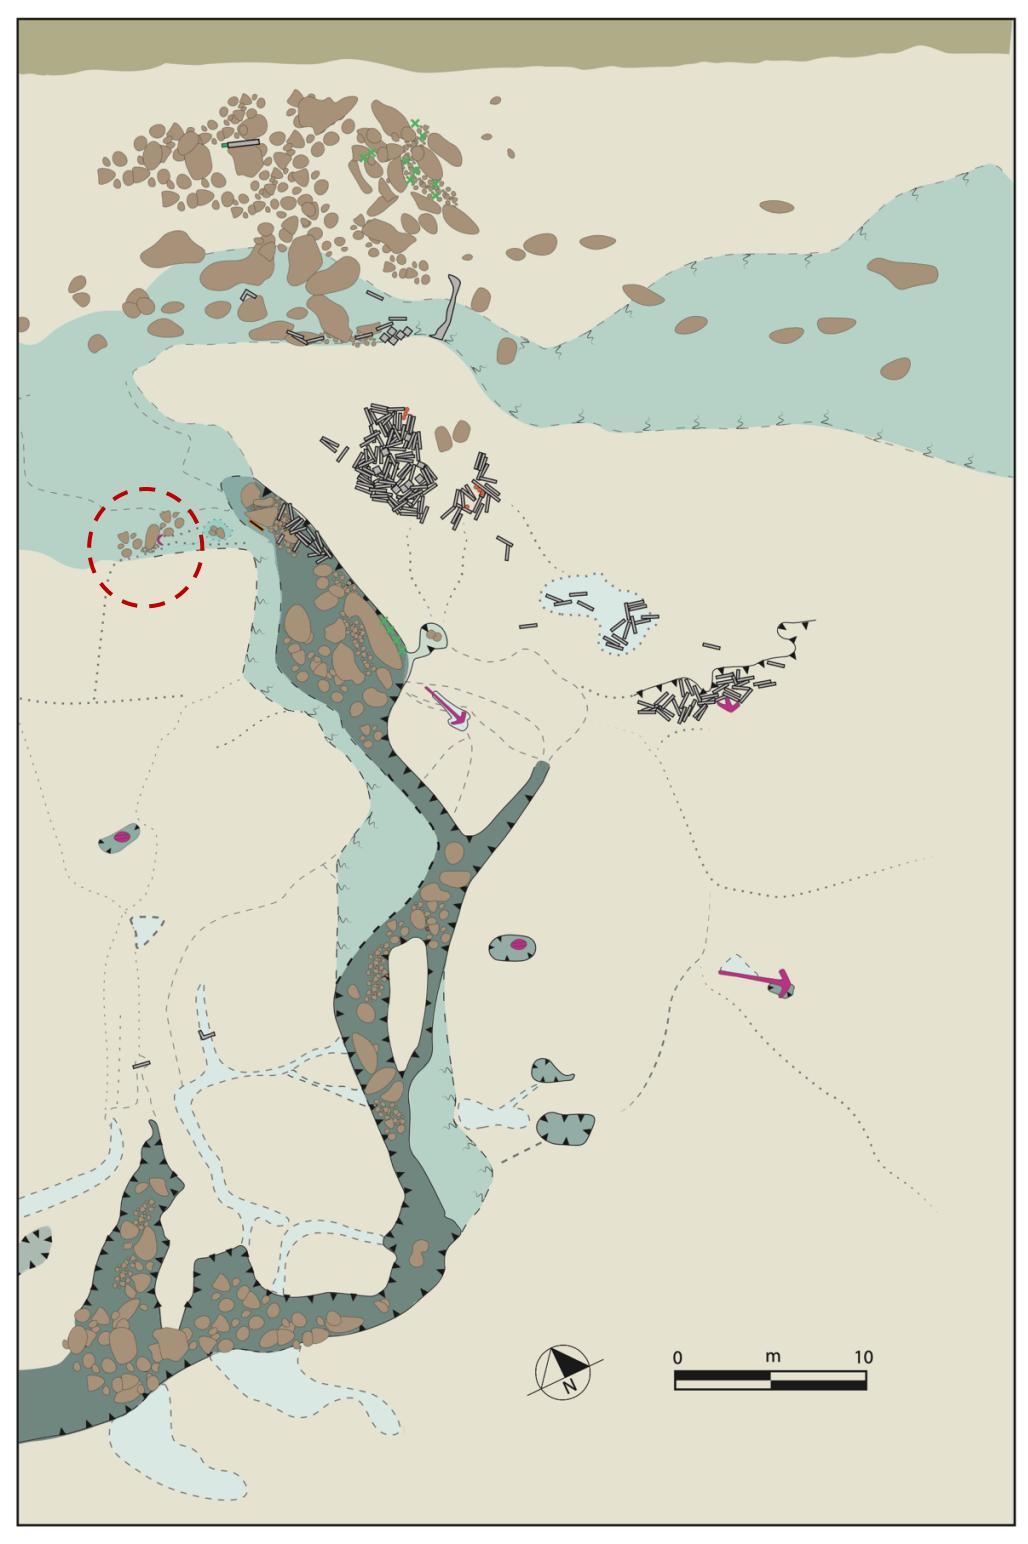
Figure 87: Location of anchor ring.

The anchor ring is located lying loose in a depression to the west of the site (Figure 87). Approximately just under half appears to remain .The ring has a thickness of 100 mm and the distance between each broken tip is 600 mm (Figure 88 and Figure 89). It is currently unknown which anchor this ring belonged to, although it has been speculated that it is from the 1905 anchor that was blasted from the reef.

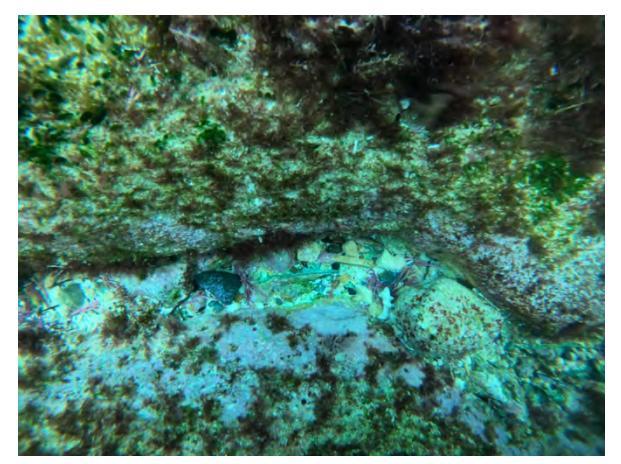
*Figure 96: Small copper artefacts concreted into gully crevice, including weathered ceramics.* (Image taken 15<sup>th</sup> November 2020).

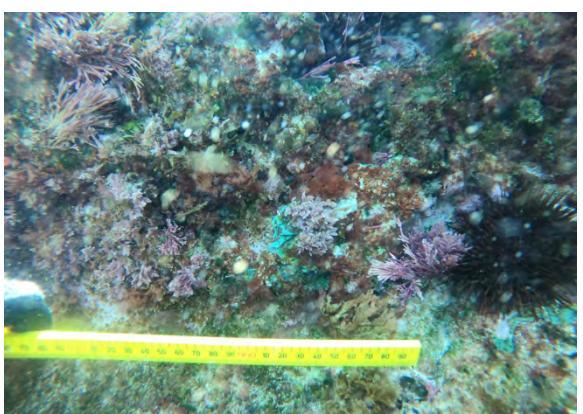
**Figure 99: Another example of copper sheathing in gully wall near anchor SI 625.** (Image taken 17<sup>th</sup> November).

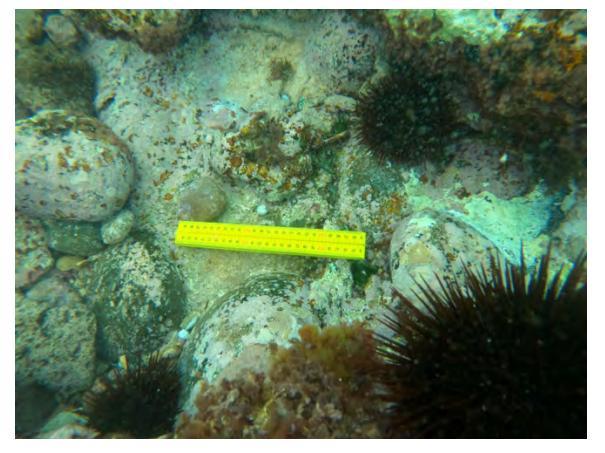
*Figure 102: Loose ammunition and copper concreted into crevices in shallow area of Site 1.* (Image taken 17<sup>th</sup> November 2020).

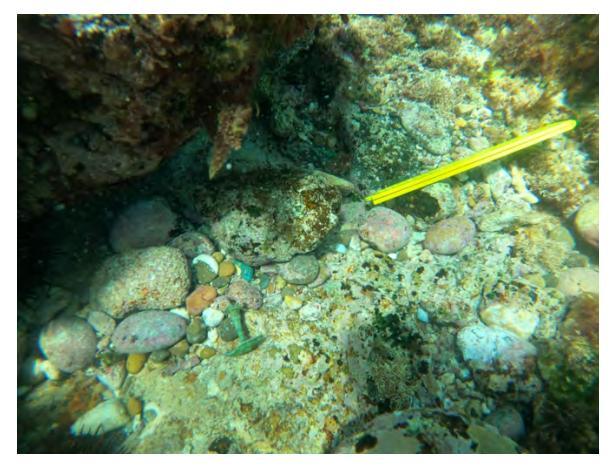
*Figure 104: Possible copper alloy wall fitting in shallow area site 1.* (Image taken 17<sup>th</sup> November 2020).

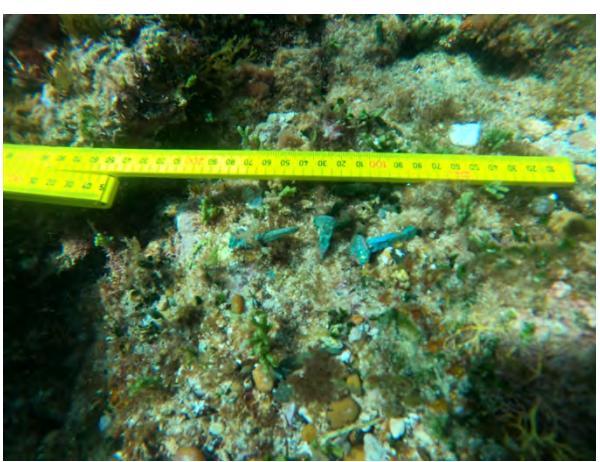
Figure 101: Loose copper tacks in shallow area of site 1. (Image taken 17<sup>th</sup> November 2020).

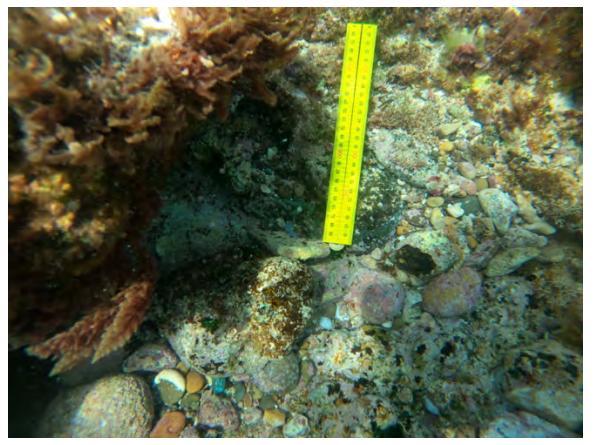
Figure 103: Loose ammunition and copper concreted into crevices in shallow area of Site 1. (Image taken 17<sup>th</sup> November 2020).

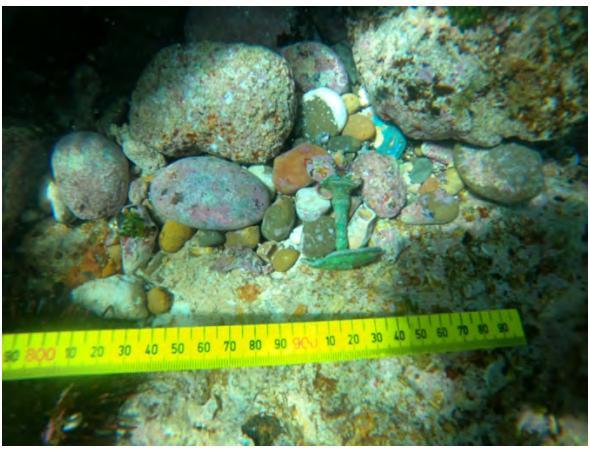
*Figure 105: Detail of possible copper alloy wall fitting shallows site 1.* (Image taken 17<sup>th</sup> November 2020).

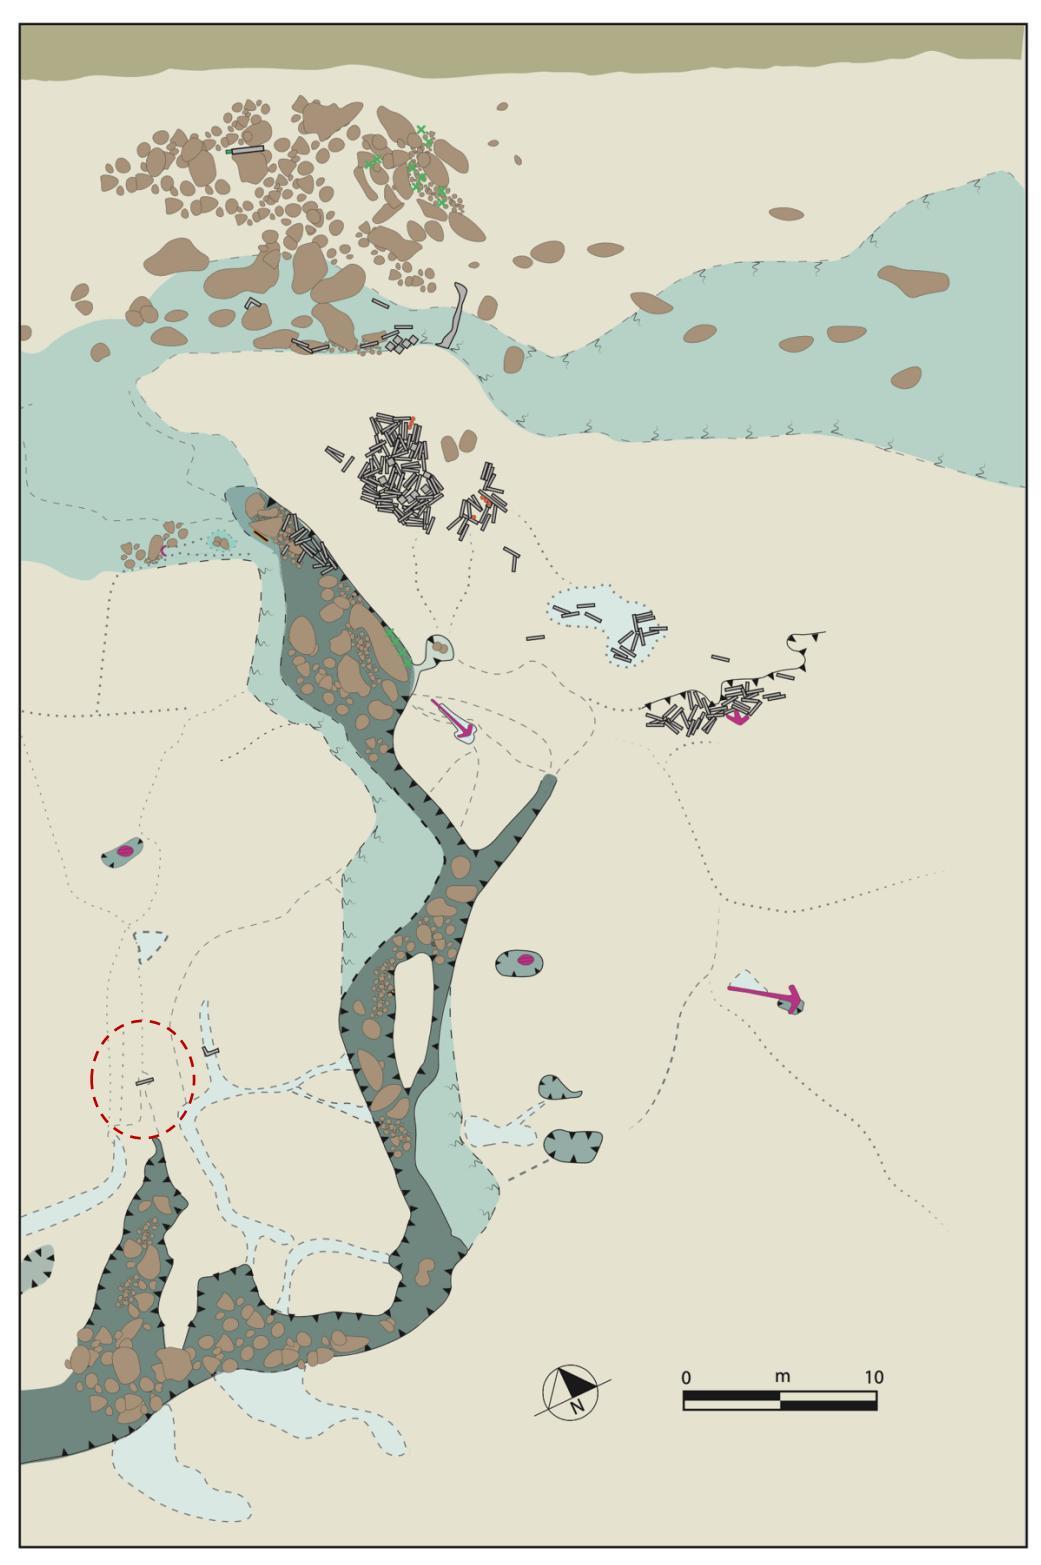
Figure 111: Location of single ballast iron in south west.

This single ballast is an isolated find in the south west of Site 1 (Figure 111). It is resting over a steep gutter and appears to be affected by sea urchin activity, with one animal in particular making a deep crater in the southern face of the ballast iron (Figure 112 and Figure 113).

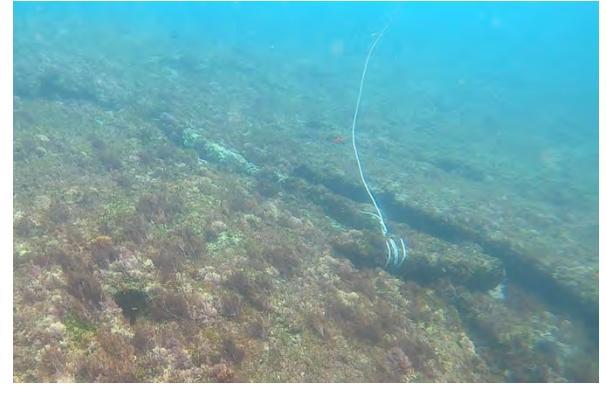
*Figure 153: Anchor SI 625 in 2020.* (Image taken from video Sirius20\_201114\_15\_JM\_Anchor 10 heading north to gully; 01:21).

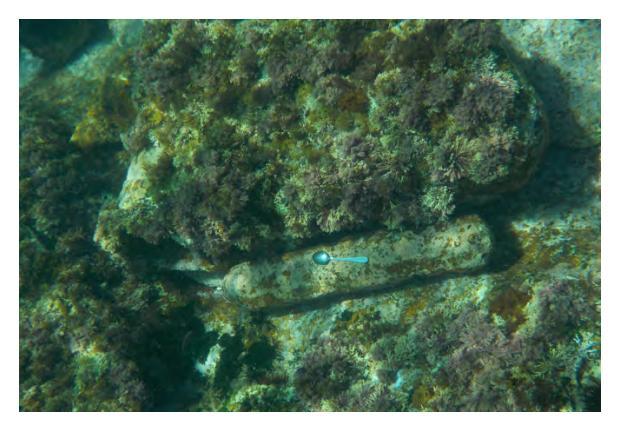
*Figure 156: De-concreted pig in gully in October 2017.* (Image courtesy of Christian Patteson 21<sup>st</sup> October 2017).

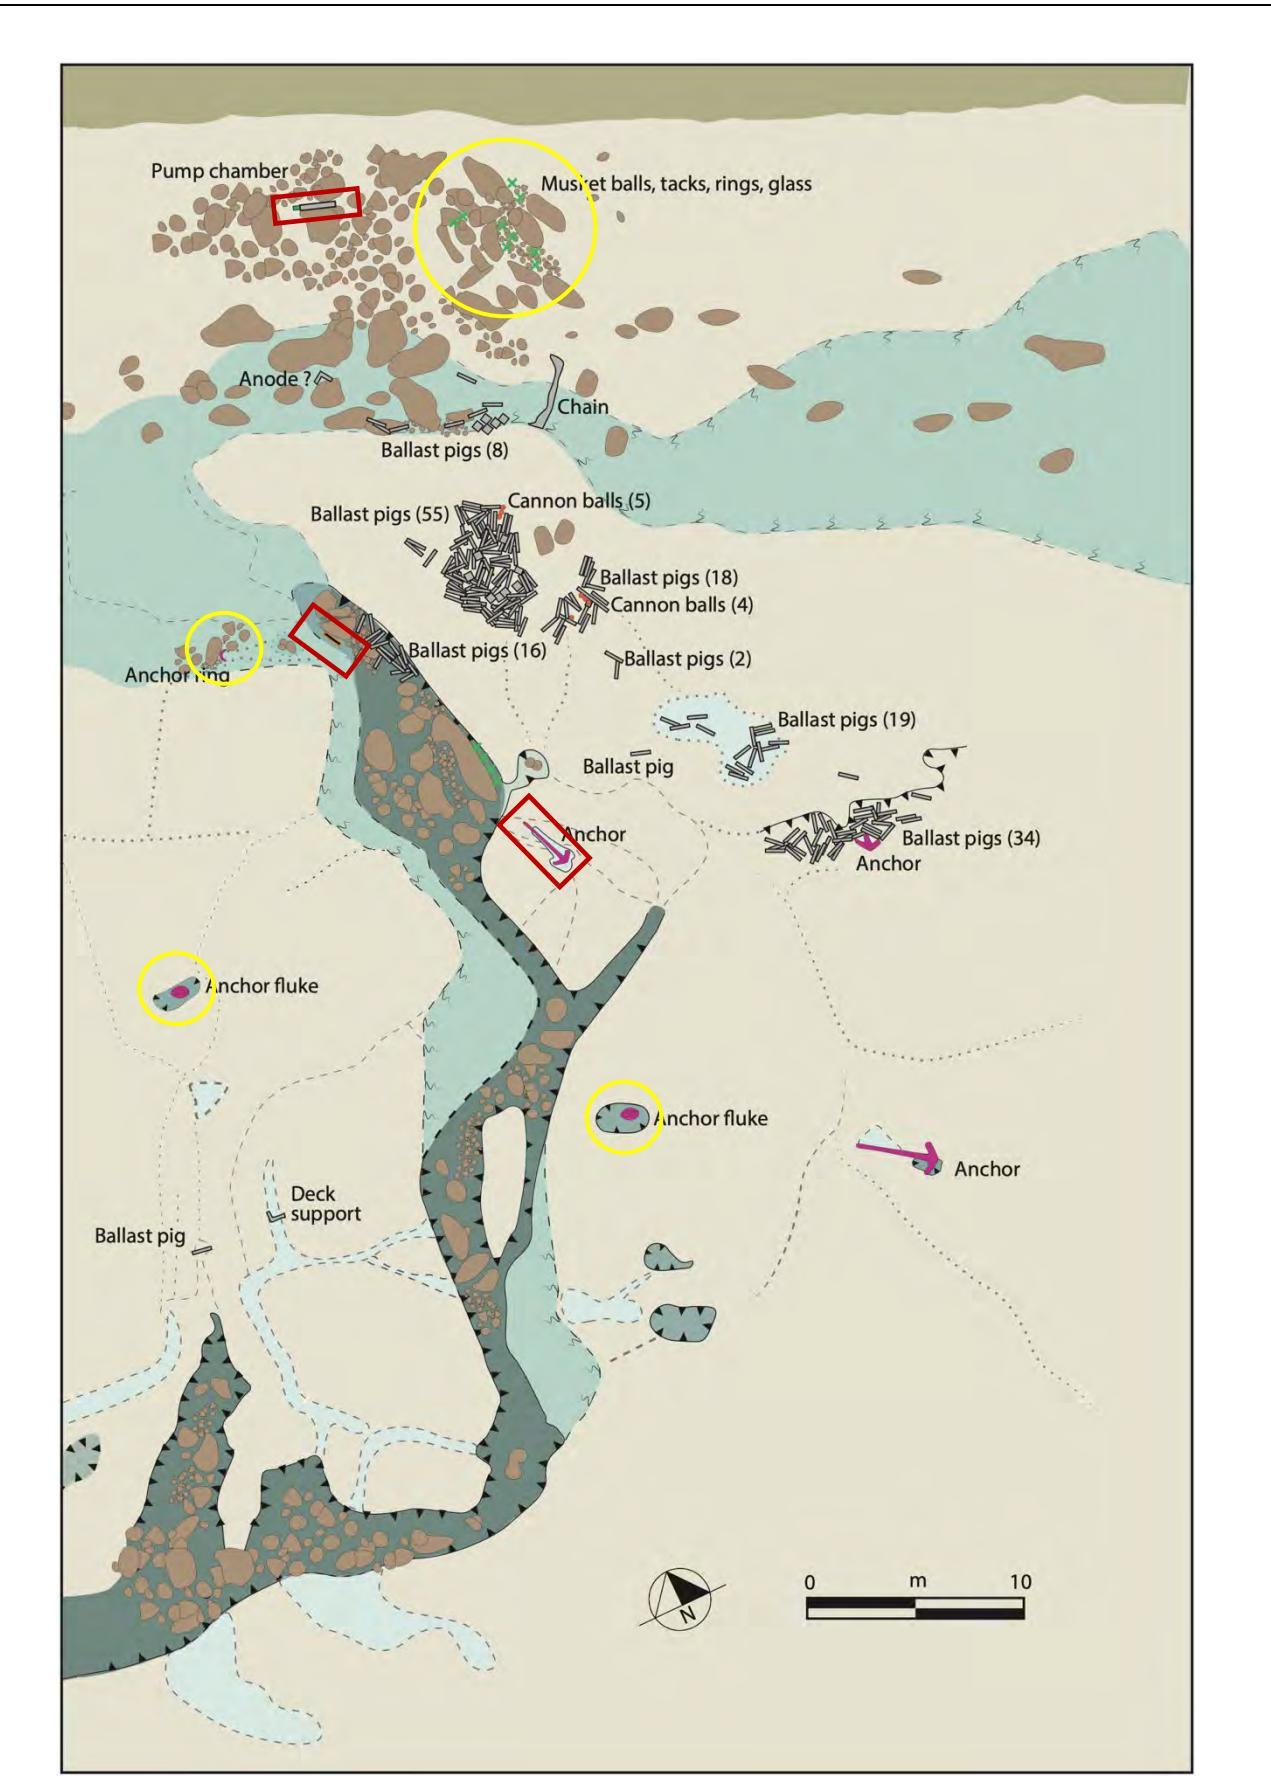
*Figure 166: Areas of the site requiring particular monitoring.* Red squares indicate areas of de-concretion, yellow circles indicate loose artefacts.
