## Review of the 1993 Plan of Management for HMS *Sirius* Shipwreck

Consultant: Graeme Henderson AM, CitWA

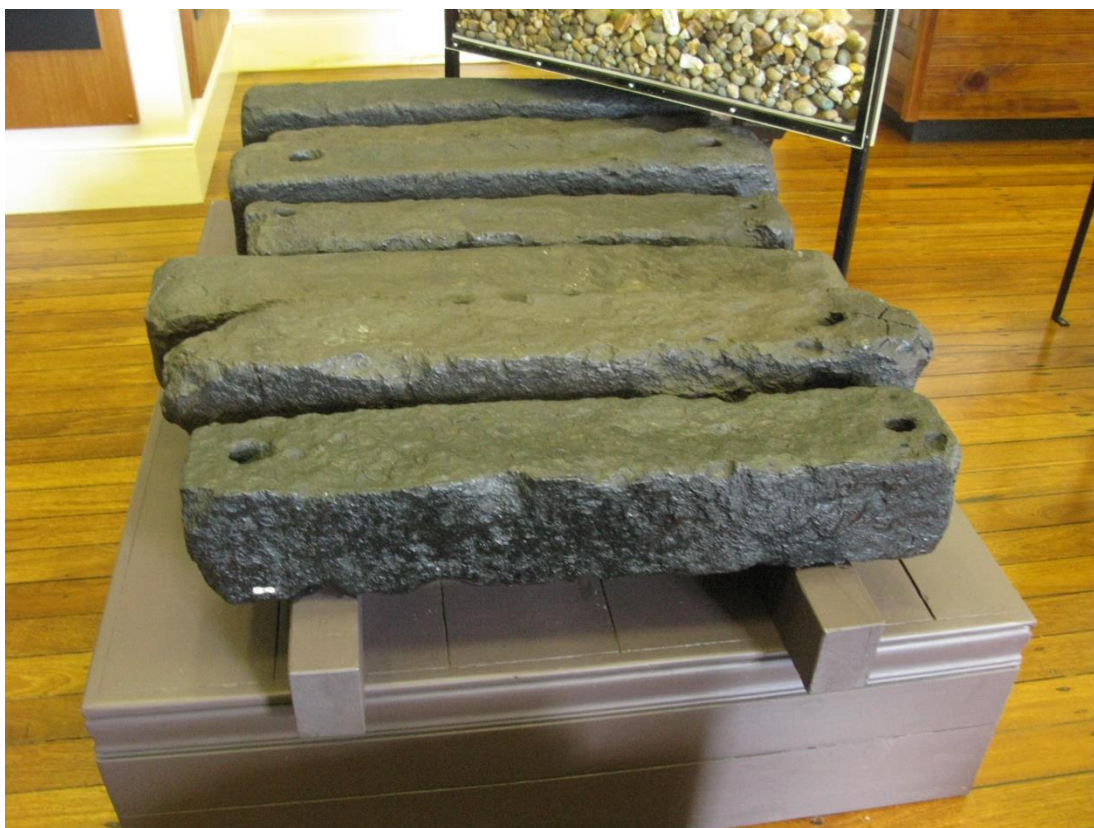
The project also recorded more than 200 of the cast iron ballast pigs originally located at the lowest point of the ship's hull to aid stability. Also known as 'Kentledge', iron ballast came in a number of standard sizes and weights. The individual ballast pigs were laid fore and aft along each side of the keel and overlaid with rock shingle ballast, which provided a more suitable surface for stowing the timber casks in which provisions were kept. A few tons of ballast iron were usually kept spare for shifting about to alter the vessel's trim, and this was made easier by the location of holes at each end of the pigs to attach ropes or lifting tackle. Eleven ballast pigs were recovered from the wreck site, and these appear to represent three different sized types; the largest weighing approximately 155 kilograms.

**Fig. 5. Kentledge ballast in the Sirius Museum. Image G. Henderson, Wreck Check, 2017**

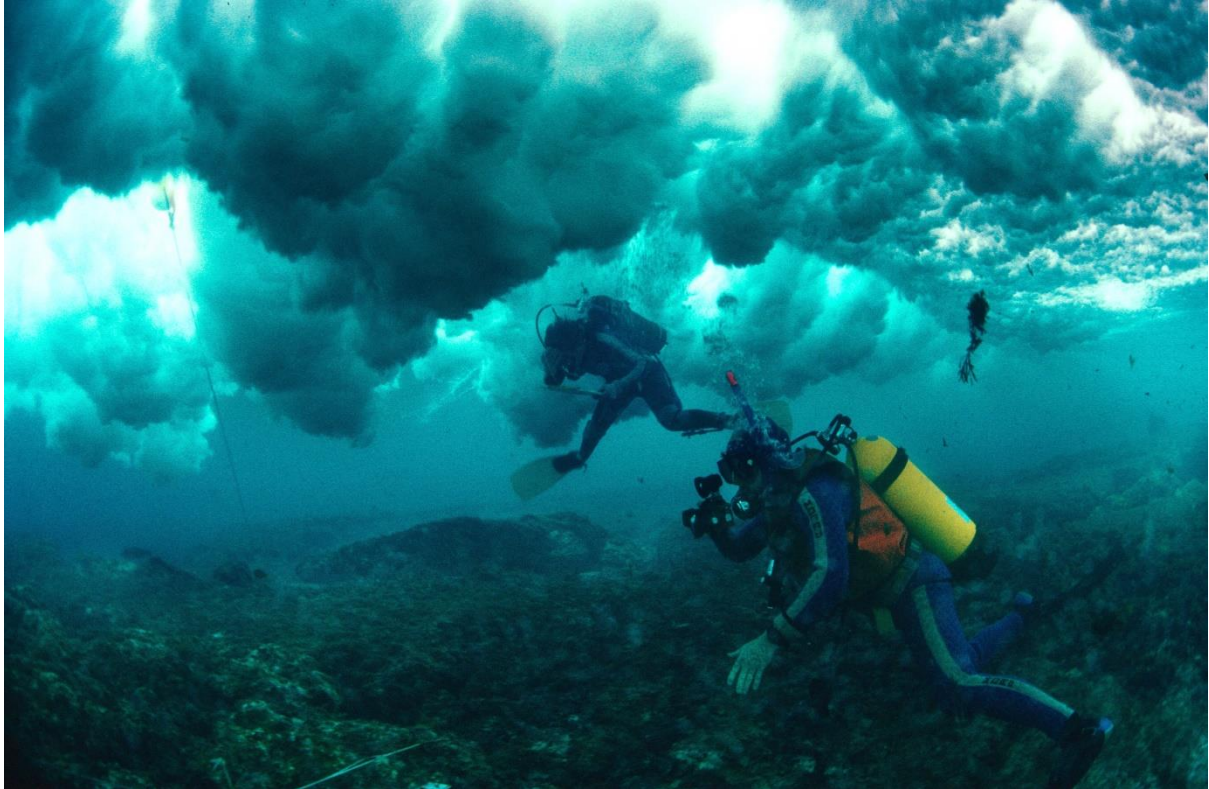
British archaeologist Keith Muckelroy examined a number of environmental factors and correlated these with the condition and intactness of archaeological remains: these being exposure to varying physical forces, exposure to specific physical forces, water depth, and seabed topography, and he graded twenty wreck sites into five classes (Muckelroy, 1977). The *Sirius* fits into Muckelroy's Class 5, the worst category, for which he predicts no structural remains, no organic remains, and only a few scattered objects.

**Fig.9. HMS *Sirius* lies in a shallow high energy environment. Image P. Baker, WAM, 1988**

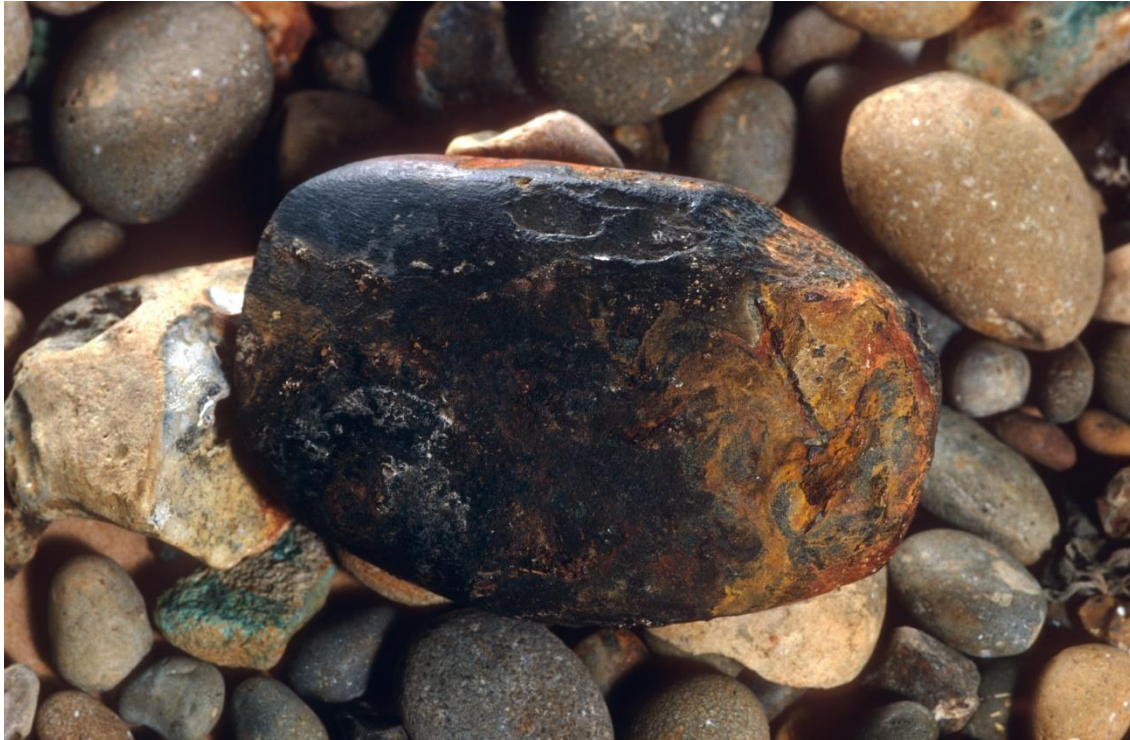
The archaeological remains of HMS *Sirius* are important in terms of Indigenous heritage values. A ground stone hatchet head of Indigenous Australian origin was found among shingle ballast recovered from the site.

**Fig. 10. The hatchet head found in the shingle ballast. Image P. Baker, WAM, 1988**

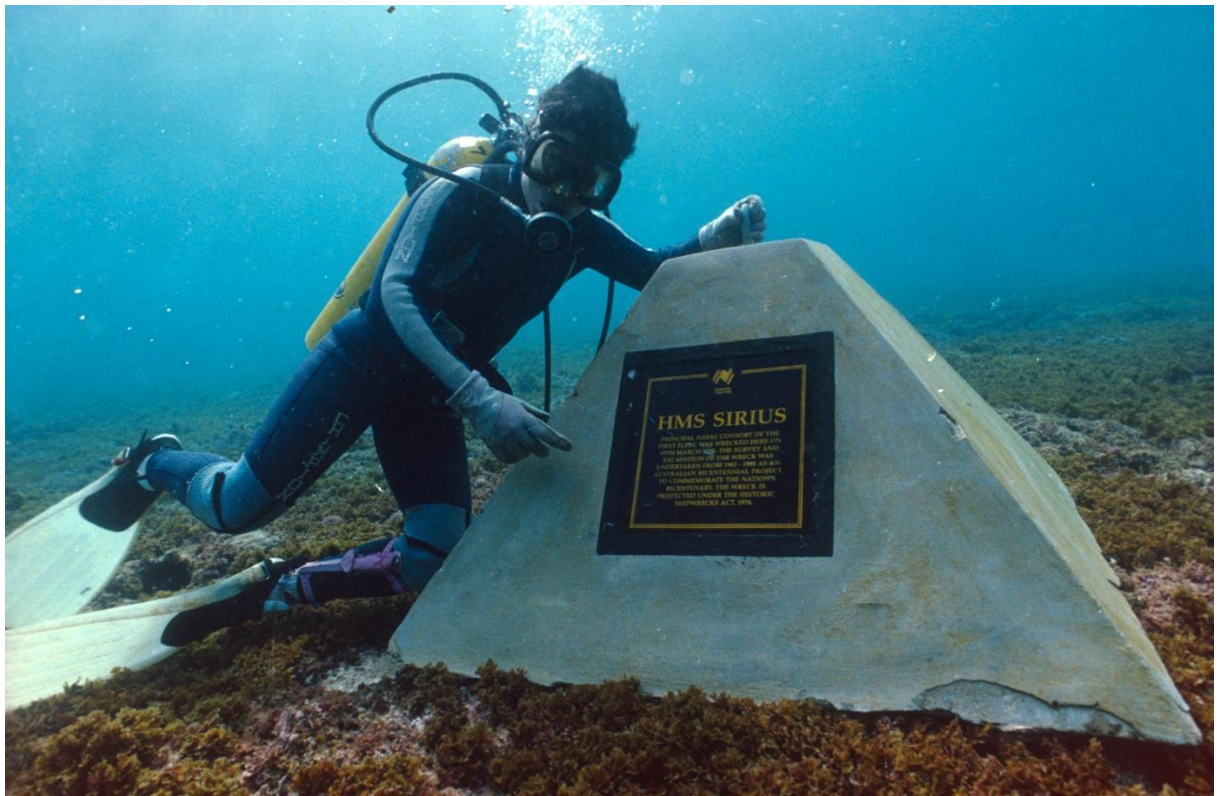
**Fig. 13. The missing *Sirius* underwater plaque. Image P. Baker, WAM, 1988**

Comment: Appropriate signage above and below water is necessary to maintain the condition of values 1 and 2 in criterion (a). The pyramid's present whereabouts are unknown and it is likely to have moved out to sea. The information plaque on the seawall in front of the prison compound is in the form of a clock face with the hands indicating midday and pointing seaward. The clock face is prone to interpretation as a pointer to the wreck site, but it points to a different location.

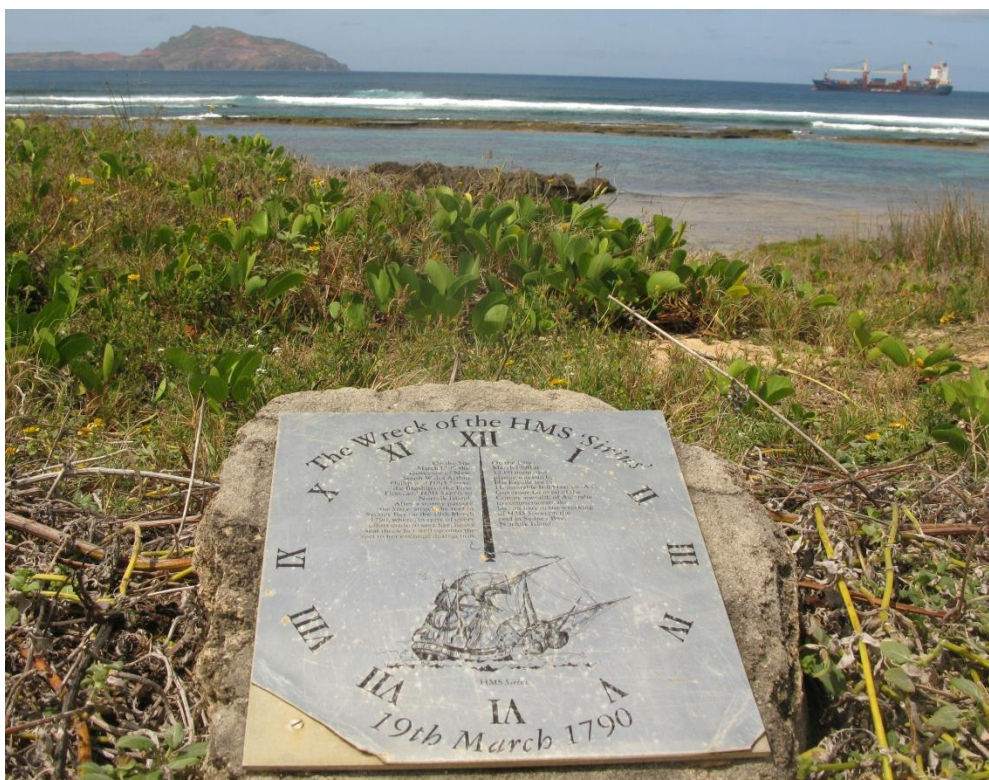
**Fig. 14. The clock-face sign. Image G. Henderson, Wreck Check, 2017**

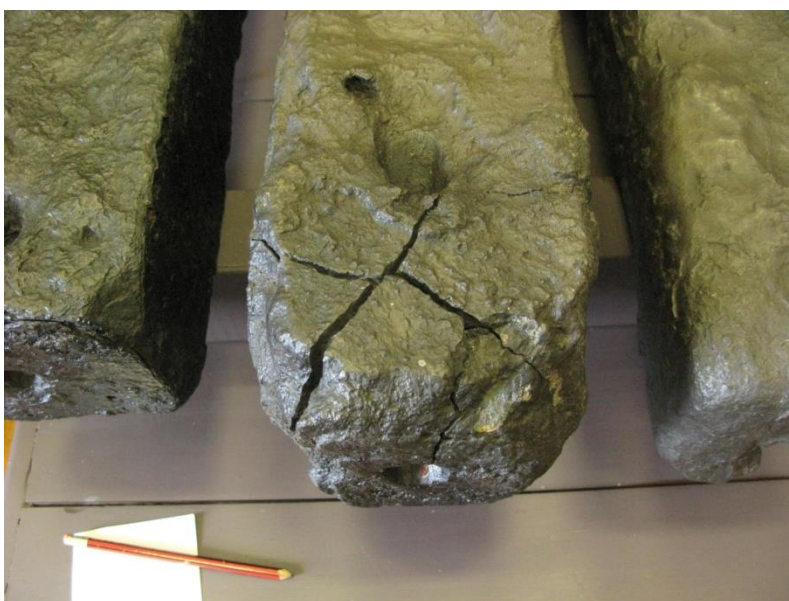
In 2017 the consultant noted deep cracks in the surface of one of the Kentledge ballast blocks, and several 'exploded' cannon balls.

**Fig. 15. Kentledge showing damage. Image G. Henderson, Wreck Check, 2017**

If analysis provides sufficient grounds, scope the installation of airconditioning into the *Sirius* Museum or other facility intended to display and store the *Sirius* collection. Fund and install (Dalwitz).

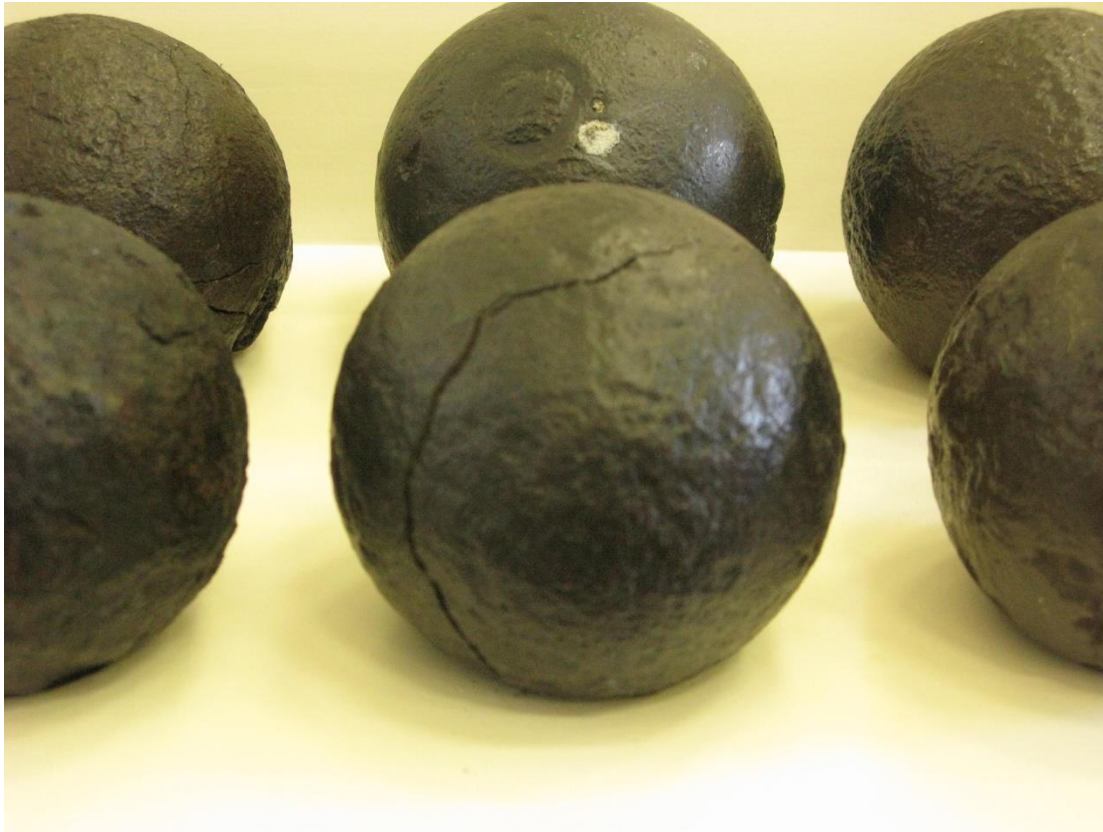
**Fig. 16. Cannonball showing damage. Image G. Henderson, Wreck Check, 2017**

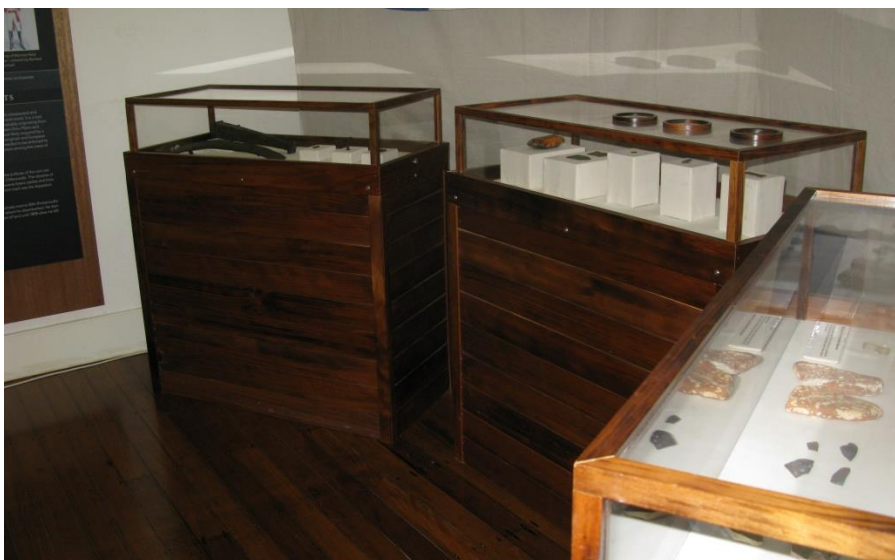
The question arising is whether passive environmental controls (the cheapest option) could provide a satisfactory environment for the exhibits. The second option, air conditioning, may be much more expensive, and may intrude on the authenticity of the building. A third option, moving the collection to a purpose-built 'green' building, would involve major cost (Henry 2007). To date the passive option (including museum quality display cabinets) has not been fully implemented.

**Fig. 17. Sirius Museum display cabinets. Image G. Henderson, Wreck Check, 2017**

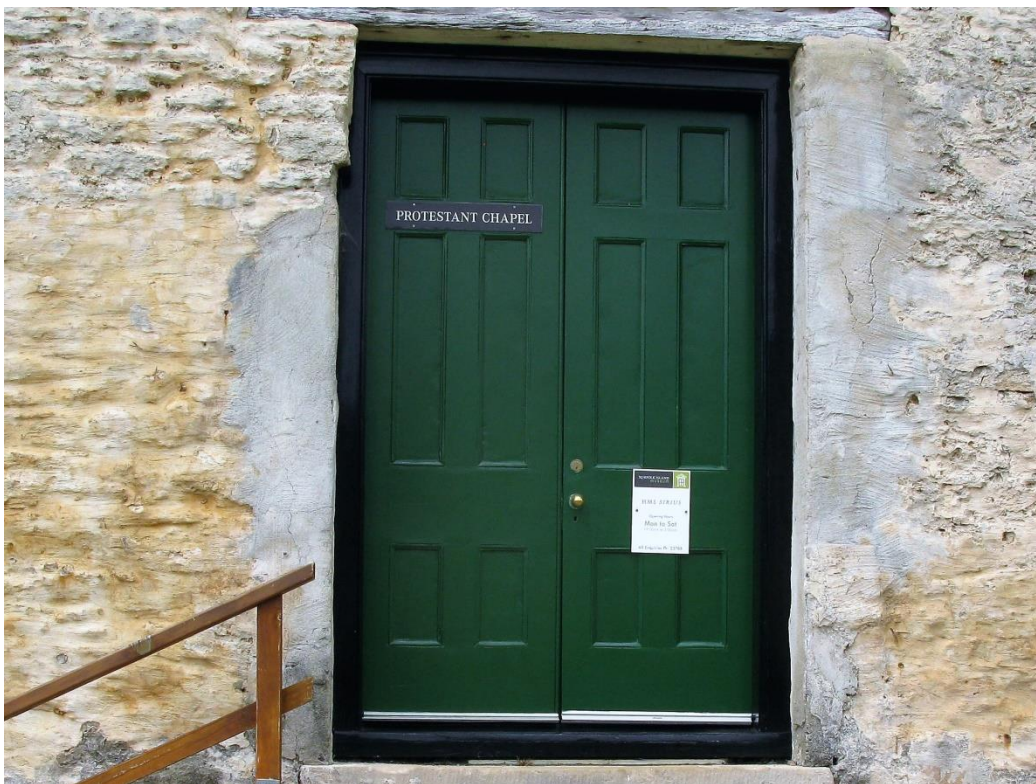
**Fig. 19. Sirius Museum signage. Image G. Henderson, Wreck Check, 2017**

Despite being in the proximity of the waterfront the building is isolated and separated from the tourist traffic visiting the Kingston Pier. Directional signage for the Sirius Museum is inadequate – the ‘Protestant Chapel’ sign on the entrance door is in larger font than the ‘*Sirius*’ sign. The consultant was unable to read the A4 ‘*Sirius*’ sign from the road. On the sandwich board sign erected during opening hours the font for ‘*Sirius*’ is smaller than the font for ‘Norfolk Island Museum’, and much smaller than the adjacent road grid warning and other road traffic signage. The KAVHA HMP (p.115) states that ‘Compatible uses within the KAVHA site...do not require overt...advertising’. However, overt – meaning ‘open and observable, plainly apparent’, is a necessary condition for informing the public of the exhibition. Many of the tourists from the visiting cruise ships take the opportunity to wander, but unless they pass close by during opening hours they will not be aware of the *Sirius* exhibition.

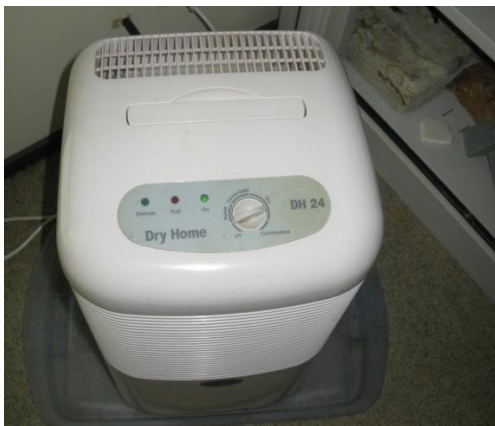
Comment. Artefacts not on exhibition are now housed in the former ANZCAN manager's house built in the 1960s at Anson Bay, repurposed as NIM's collection storage. It is not air conditioned and routinely experiences high humidity (Dalwitz 2016), but the facility appears sound and relatively secure.

**Fig. 21. Dehumidifier in Anson Bay storage. Image G. Henderson, Wreck Check, 2017**

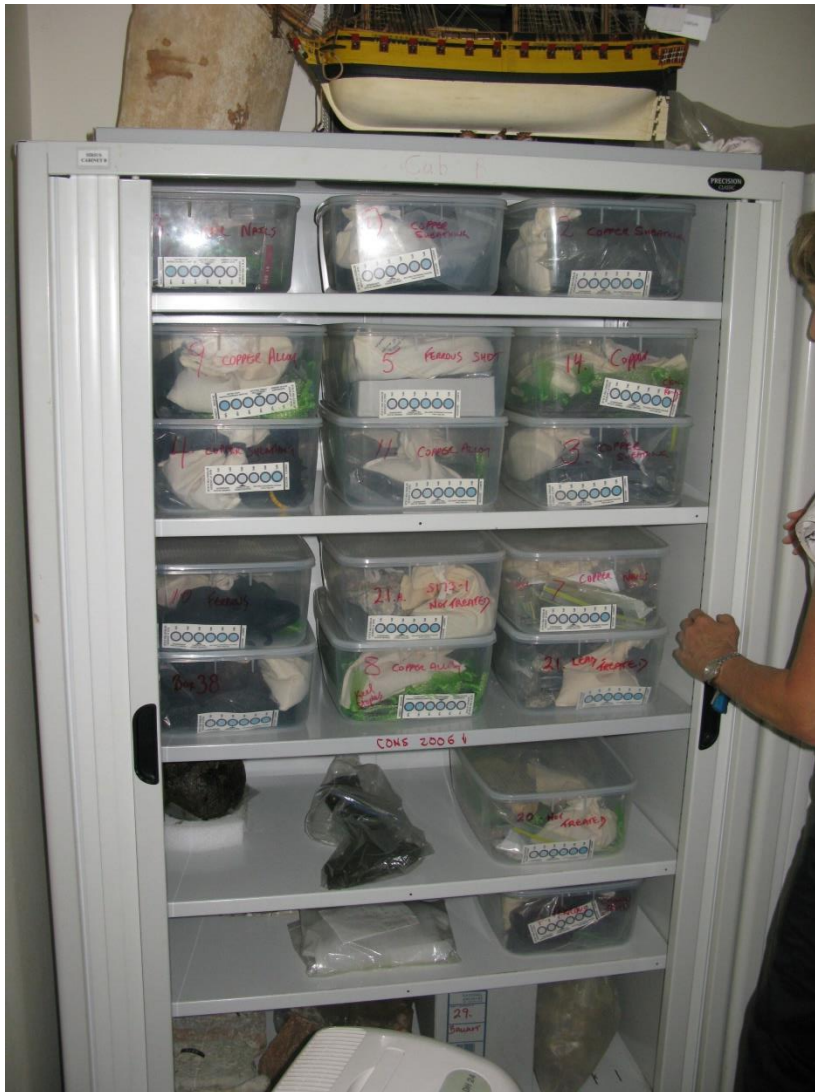
**Fig. 22. Storage cabinet at Anson Bay. Image G. Henderson, Wreck Check, 2017**

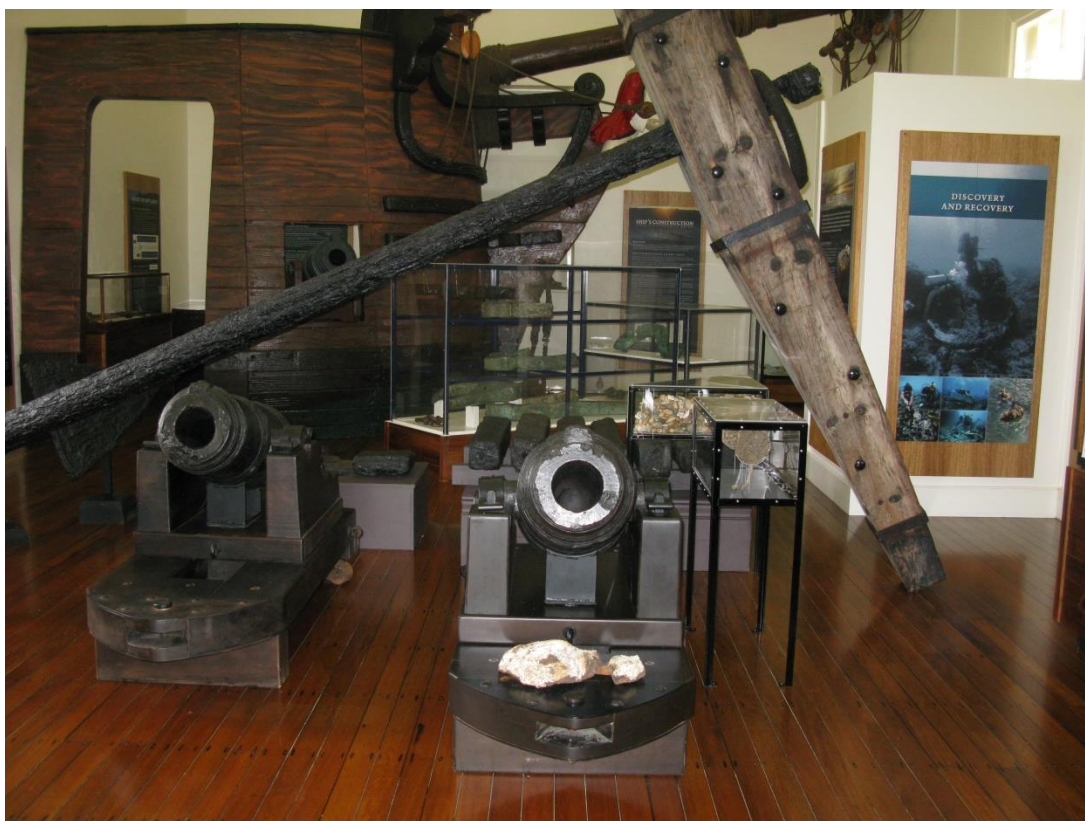
Comment. The Sirius Museum has a variety of showcases, showcase materials and object supports, none of which appear to be 'museum standard'. The building exhibits salt efflorescence on internal walls, is not air conditioned, and routinely experiences high humidity, although the portable dehumidification unit operates constantly. Passive environmental controls (appropriate cabinets) have not been acquired since the 1993 Plan recommendations.

**Fig. 23. Sirius Museum interior. Image G. Henderson, Wreck Check, 2017**

11. All but large iron artefacts will be housed in temperature-and-humidity-controlled storage and display cabinets. Such control can be achieved through passive environmental management strategies associated with the construction of 'sealed' display cases. The storage cabinets will be 'Perth Cabinets' (manufactured by Joyce Australia, 8 Forsyth St O'Connor WA 6163) or a similar product.
