# **HMS** Sirius

## Site Inspection Report 2020

Norfolk Island Australian External Territory

March 2021

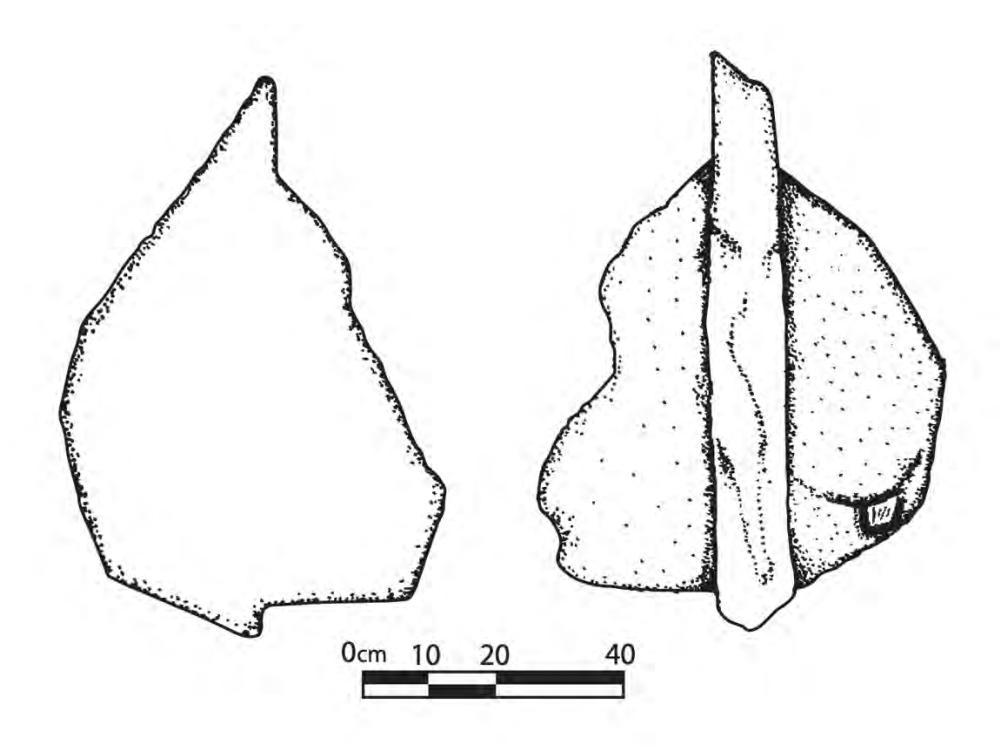
Figure 27: Anchor fluke SI 590 after M. Stanbury 1994.<sup>26</sup>

Several updates have been made to the 1989 site plan. Several items still appeared on the plan, despite having been raised. The anchor fluke in area 1 (SI 590) was raised at the end of the 1998 season (Figure 27).<sup>24</sup> The pump housing fittings (SI 482, SI 618) and pump housing (SI 236) in the northern area of the site were raised during the 1987 season (Figure 28).<sup>25</sup>

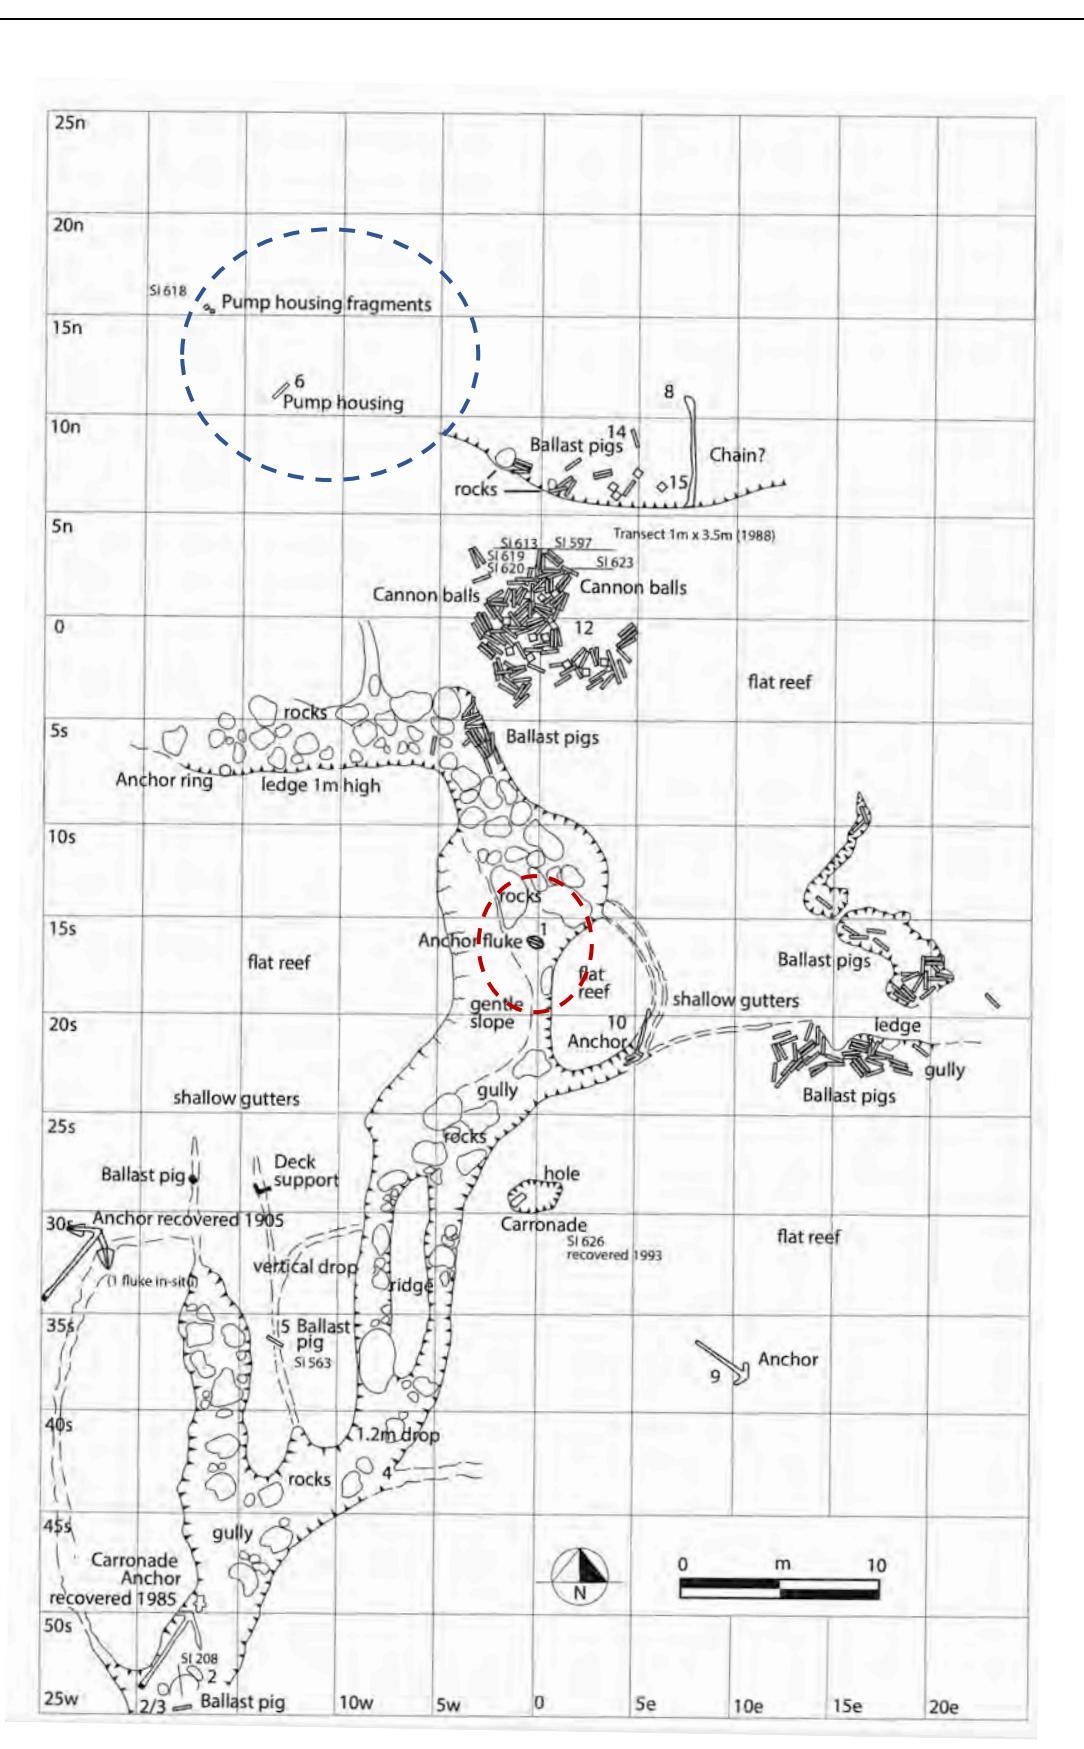
*Figure 28: 1989 site plan showing anchor fluke (red) and pump housing fittings (blue) that were raised during the 1980s.*

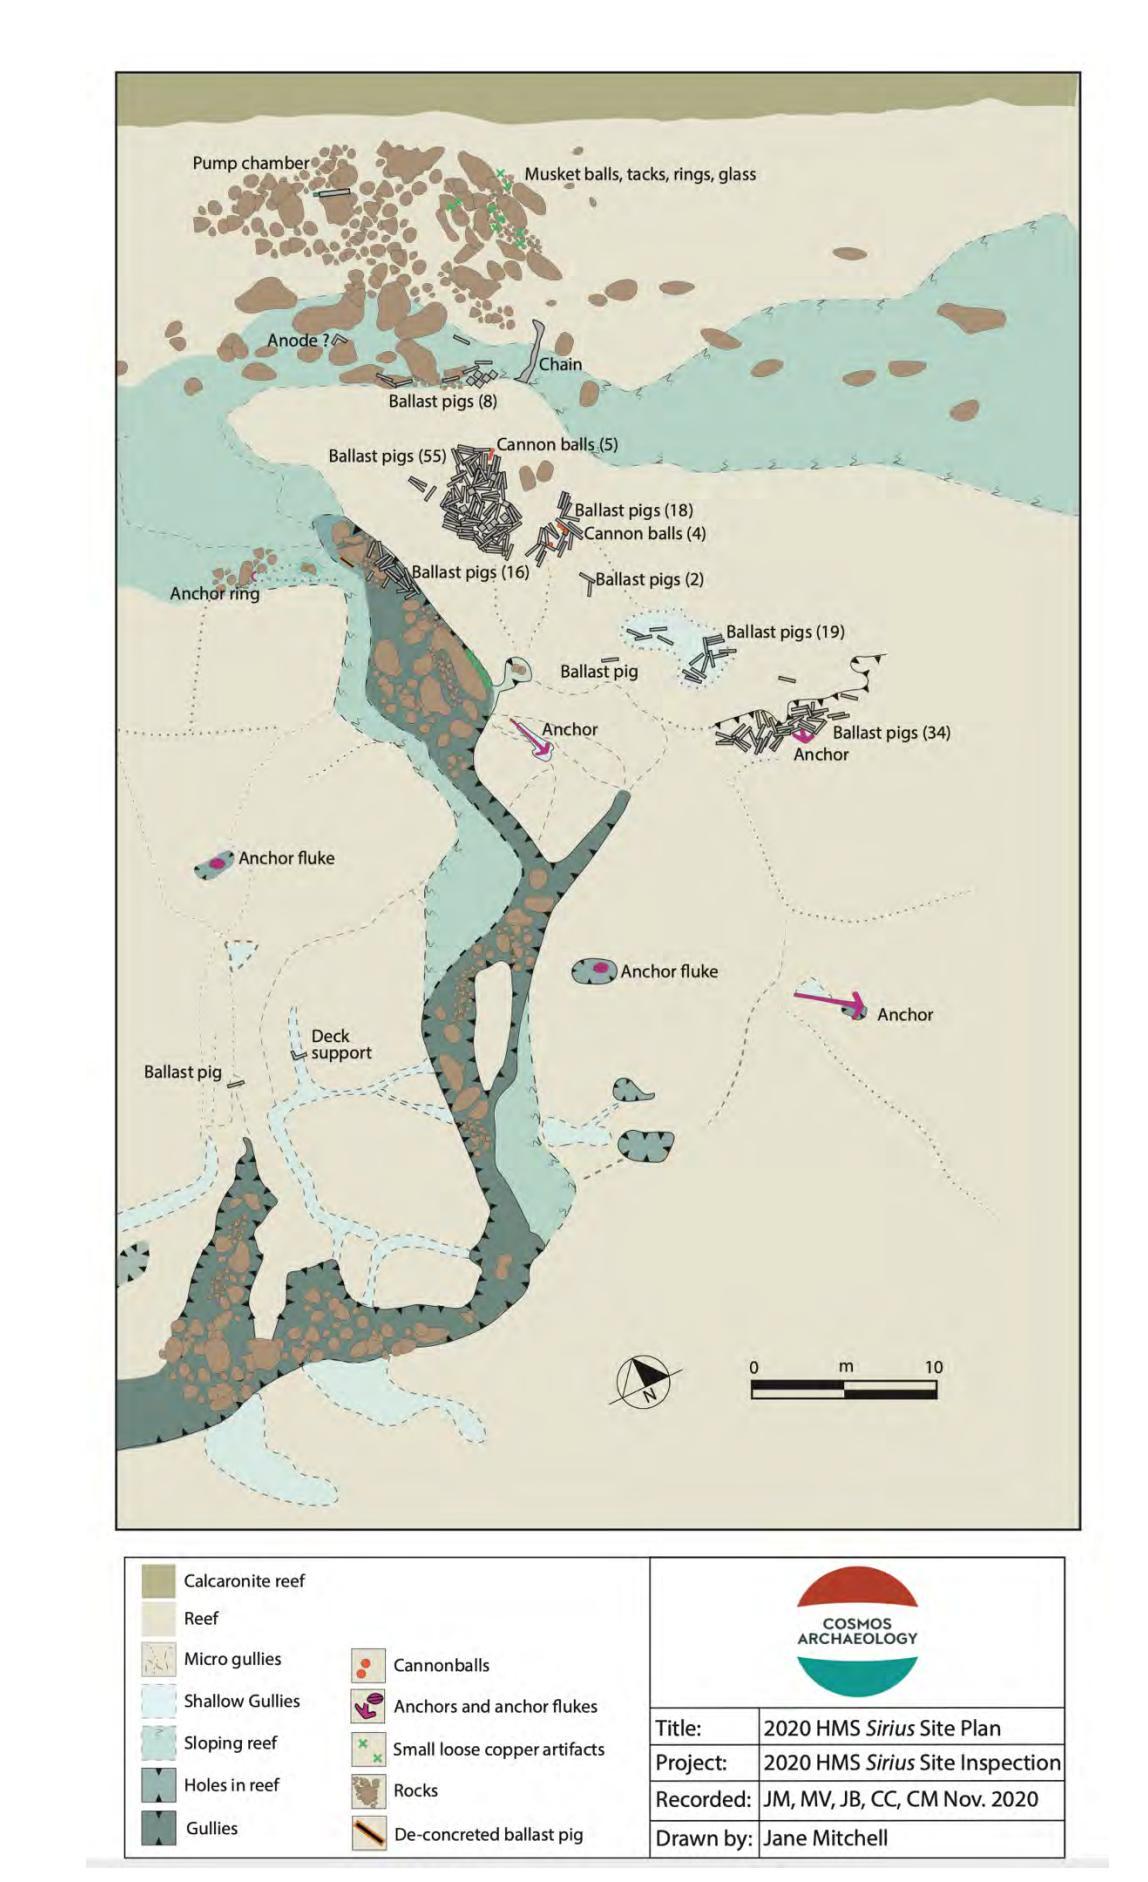
Figure 30: Updated HMS Sirius Site Plan

The updated site plan can be seen at Figure 30. Additions to the updated site plan include a loose anchor fluke in the carronade hole, a loose anchor fluke to the west of the site, a section of pump chamber in the north of the site and a new anchor to the east. The approximate location of loose artefacts in the shallow areas of Site 1 has also been noted. All items that have been raised have also been removed for clarity. There was not time during the site inspection to accurately survey the ballast pigs in position so their positions are the same as the 1989 site plan.

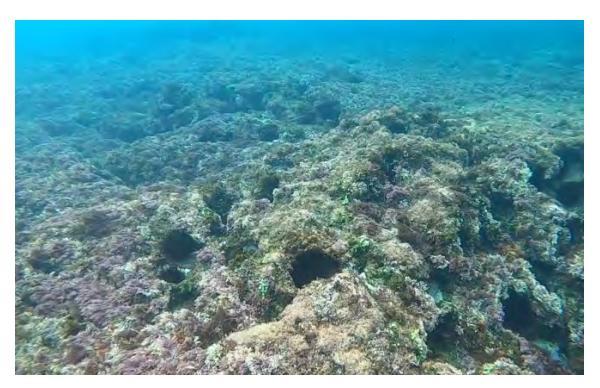
In general, there was a covering of seaweed over the entire site, and all wreck elements had some growth on them (Figure 32). The base of the main gully running through site 1 was either clear or only had short algae growth, creating a clear view of the bottom (Figure 33). There is very little shingle ballast remaining in the gully. The shallow area of site one had less algae growth and consisted of a rocky rubble seabed with larger calcarenite boulders. Some shingle ballast remains in the shallow areas (Figure 34). The consistent growth across the reef platform meant divers had to look closely to locate some wreck features such as the eastern ballast mound (Figure 35). Figure 36 depicts the direction and location of the images showing coverage across the seabed.

*Figure 32: Example of algae growth over site 1 facing south.* (Image taken 15<sup>th</sup> November 2020).

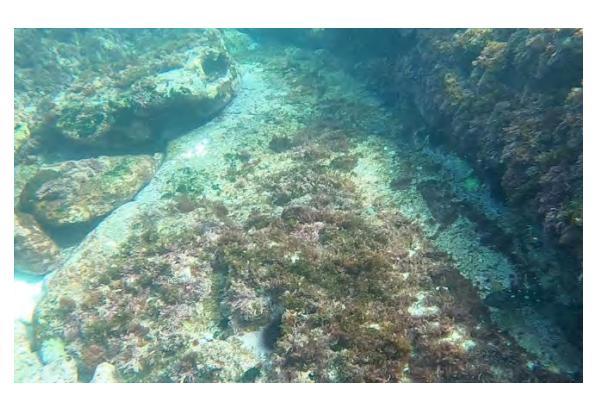
*Figure 33: Example of base of gully.* (Image taken 15<sup>th</sup> November 2020).

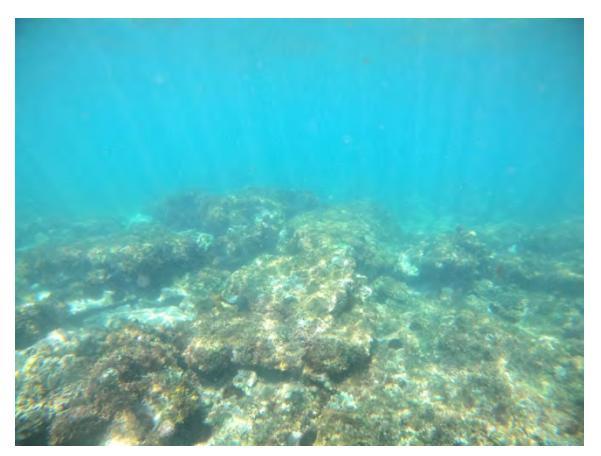
*Figure 34: View over shallow area of site 1 looking west.* (Image taken 17<sup>th</sup> November 2020).

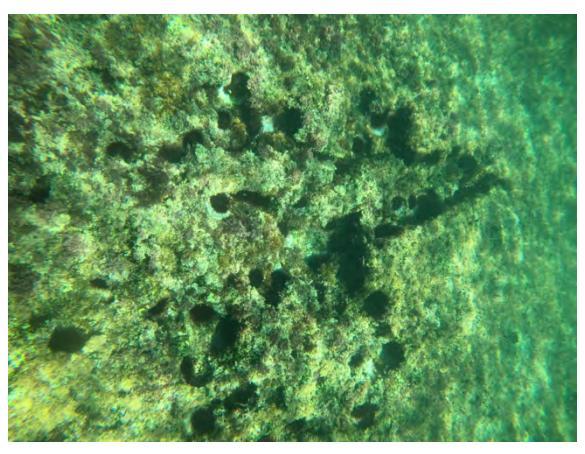
*Figure 35: View of eastern ballast pigs.* (Image taken 17<sup>th</sup> November 2020).

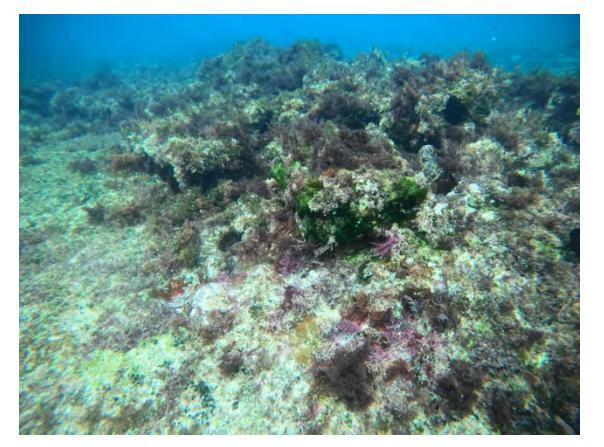
The location of the main ballast mound is shown in Figure 38. The main ballast mound was extensively covered in seaweed growth, making identification of individual ballast pigs difficult (Figure 39 and Figure 40). Various attempts at counting the iron ballast were attempted with an average count of 55 for the main mound and 18 for the ballast scattering to the east of the mound. The northern tip is 3 m away from the ledge that leads into the shallow section of the site. The main section of ballast at its widest point measures 6.4 m north to south and 4.3 m east to west. During low tide, it appeared that the ballast mound was almost exposed and it is likely that it would occasionally be exposed during King tides (Figure 42).

*Figure 39: Main ballast mound looking south west.* (Image taken 15<sup>th</sup> November 2020).

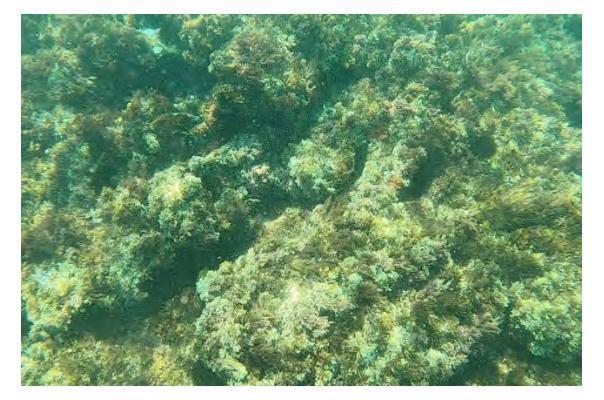
*Figure 41: Detail of ballast pigs from main ballast mound.* (Image taken from video Sirius20\_201117\_01\_CC\_ballmound; 00:37).

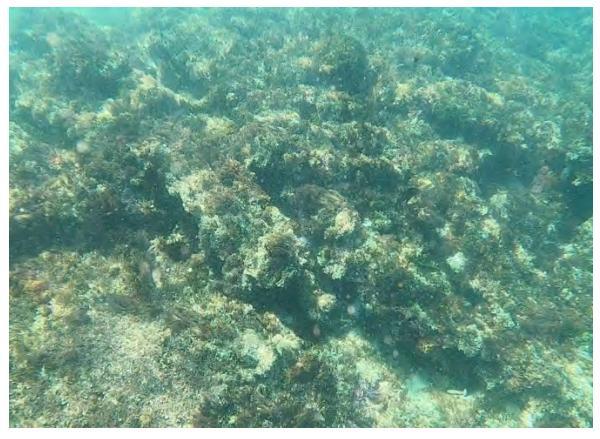
*Figure 40: Main ballast mound looking down from the western edge.* (Image taken 15<sup>th</sup> November 2020).

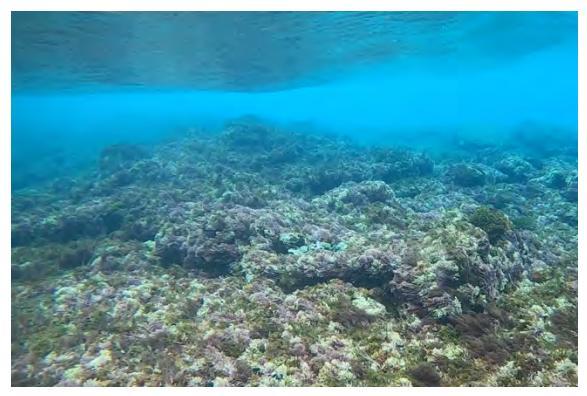
*Figure 42: The main ballast mound is almost exposed at low tide.* (Image taken from video Sirius20\_201115\_16\_CC\_ballast mound (12);00:09).

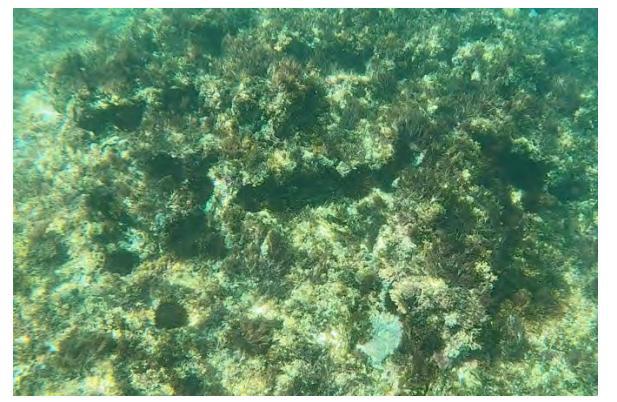
Sea urchins are creating micro gullies around the mound and appear to be creating holes in the reef top underneath the outer edge of the ballast (Figure 43).

*Figure 43: Sea urchin activity on the main ballast mound.* (Image taken from video Sirius20\_201117\_01\_CC\_ballmound; 00:23).

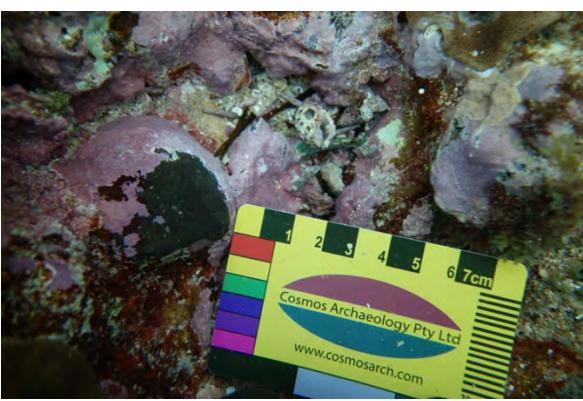
At the north-east tip of the ballast, concreted into the calcarenite reef, there is a concretion of approximately 5 cannon balls, with the concretion obscuring the dimensions (Figure 44 and Figure 45). A sea urchin was removed next to the cannon balls and underneath was a shined copper alloy fragment, concreted into the seabed (Figure 46 and Figure 47). Figure 48 shows the location of the sea urchin images on the site plan.

Figure 44: Cannon ball to left of image with small copper artefacts concreted into calcarenite. (Image taken 15<sup>th</sup> November 2020).

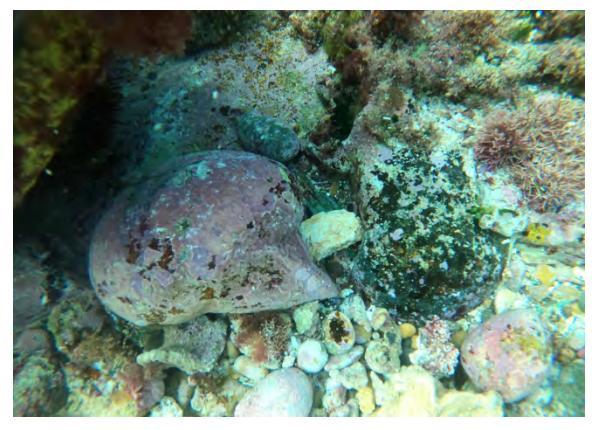
*Figure 45: Grouping of cannon balls main ballast mound.* (Image taken 15<sup>th</sup> November 2020).

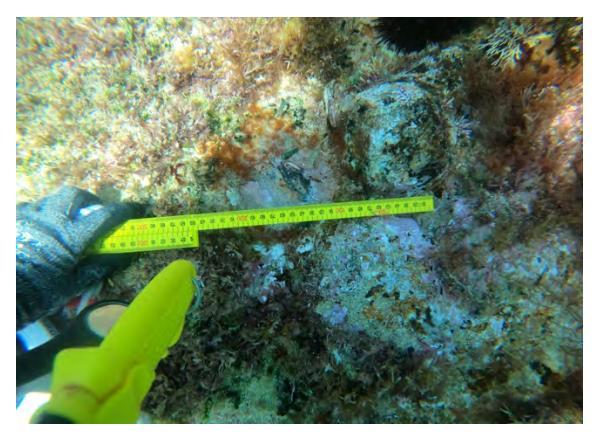
*Figure 46: Reef area where a sea urchin was removed next to the cannon balls.* (Image taken 17th November 2020).

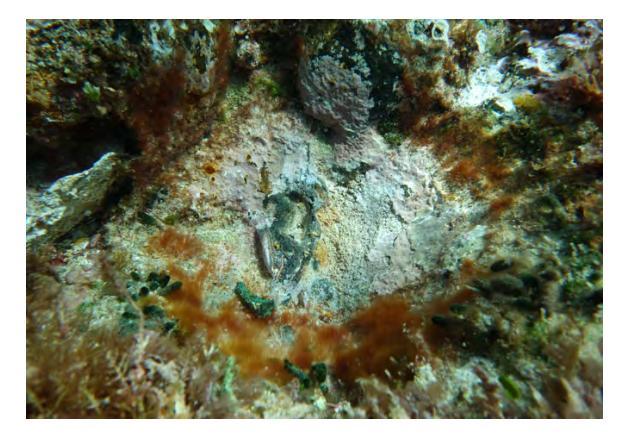
*Figure 47: Detail of shined copper alloy fragment after removal of sea urchin.* (Image taken 17<sup>th</sup> November 2020).

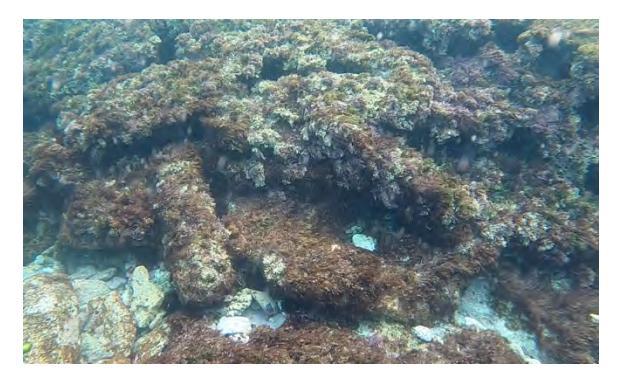
Figure 49 shows the location of the gully ballast pigs. While the gully was relatively clear of growth, the small mound of approximately 16 ballast pigs along the eastern wall was heavily covered with algae growth (Figure 50 and Figure 51). Sea urchin activity appeared to be concentrated around the ballast, eating into the gully wall.

*Figure 50: Pile of ballast pigs in gully to the west of main ballast mound.* (Image taken from video Sirius20\_201115\_2\_MV\_Ballast video run PM; 02:23).

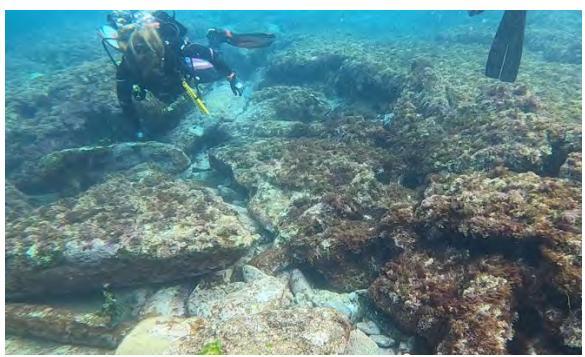
Figure 51: Relationship between single ballast pig (bottom right) and northern edge of pile of pigs in the gully (bottom left). Image taken from video Sirius20\_201115\_2\_MV\_Ballast video run PM; 02:15).

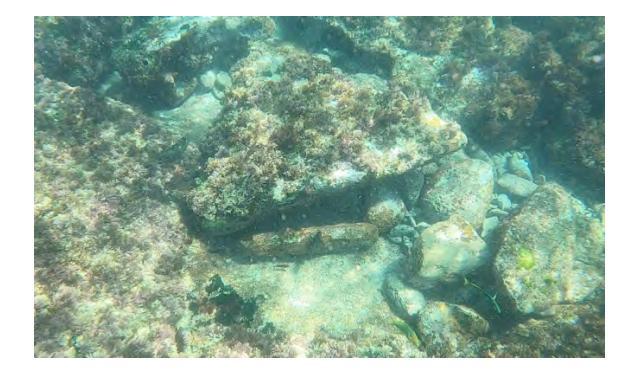
One ballast pig is rolling loose in the gutter and no longer has any growth or concretion protecting it (Figure 52 and Figure 53). It is unclear where this ballast iron has come from but likely from the gully ballast pigs. The pig is now cylindrical rather than rectangular. Heavy storm action may see this ballast pig move entirely away from the site.

*Figure 52: Single ballast pig.* (Image taken from video Sirius20\_201117\_09\_CC\_Anch10 to single pig; 01:23).

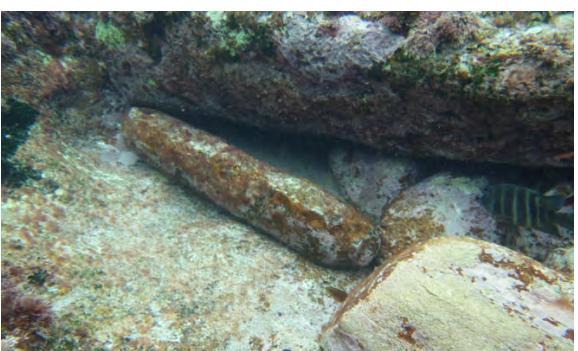
*Figure 53: Single ballast pig in gully with no protective concretion.* (Image taken 15<sup>th</sup> November 2020).

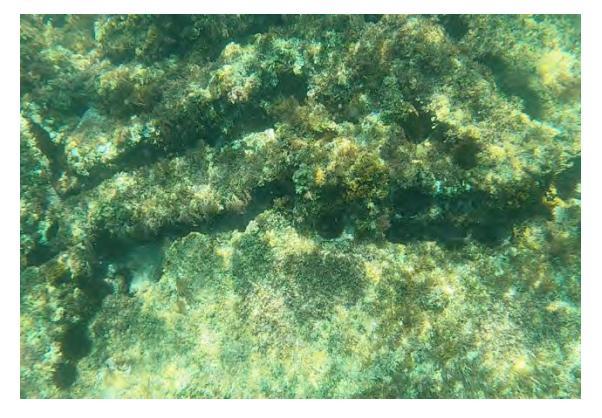
Figure 54 shows the location of the eastern ballast pile. The eastern ballast mound consists of two main areas. Nineteen ballast pigs are scattered within a shallow gully along the reef platform (Figure 55). A further 34 ballast pigs are scattered at the base of a ledge further to the east of the site (Figure 56). The ballast pigs are generally well covered in algae growth and in some locations blend in so well with the reef platform that they can be difficult to see. There is much sea urchin activity in and around the ballast pigs (Figure 57 and Figure 58).

*Figure 57: Sea urchin activity around eastern ballast pigs.* (Image taken from Sirius20\_201117\_08\_CC\_Anchor 10 to ballast east; 00:37).

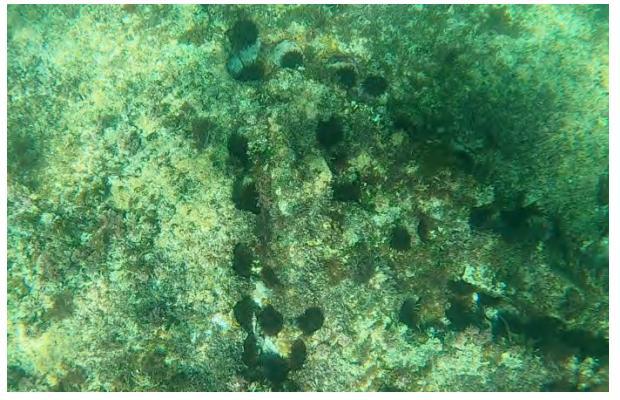
*Figure 58: Sea urchin activity scraping into reef platform and in and around ballast pigs.* (Image taken from Sirius20\_201117\_08\_CC\_Anchor 10 to ballast east; 01:37).

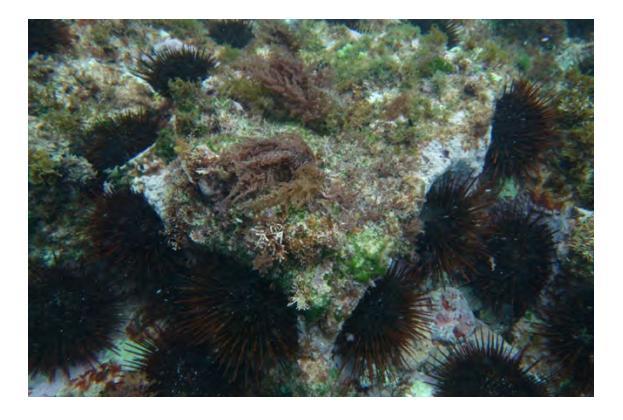
Sea urchin activity in this area is particularly aggressive. Sea urchins are making obvious craters in the ferrous material (Figure 62). One sea urchin was removed to reveal a crater 40 mm deep with a diameter of 150 mm (Figure 63).

*Figure 62: Example of sea urchins scraping into the ballast iron.* (Image taken 15t<sup>h</sup> November 2020).

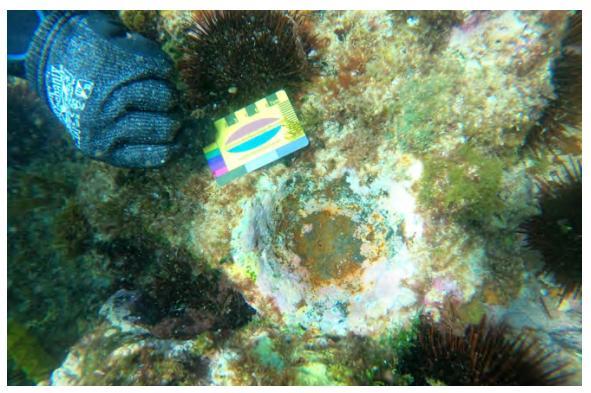
*Figure 63: The sea urchin had scraped 40 mm into the ballast iron.* (Image taken 17<sup>th</sup> November, 2020).

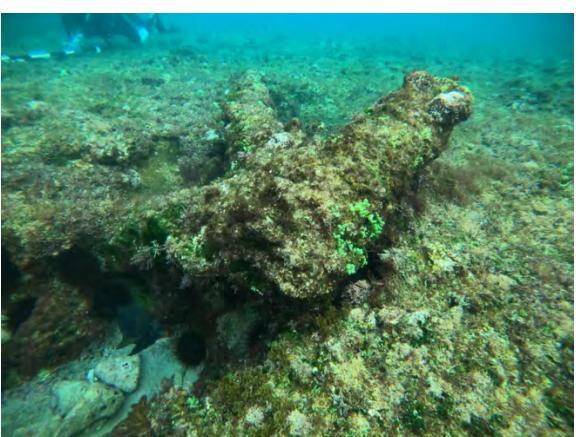
This broken anchor rests on the top of the reef, south of the main wreck site (Figure 64 and Figure 65). The tip of the left arm is concreted into the reef top, with the arm crossing a hole in the reef (Figure 66). The crown is resting on the reef and the anchor rests at an angle such that the right arm is slightly elevated. Both flukes are missing. The anchor is fully concreted with an indent at the tip of the shank which possibly indicates the position of the notch for the stock or where the shank has eroded away (Figure 67 and Figure 68). The anchor measures 3.35 m long from the crown to the end of the shank. The left arm is 0.8 m from the crown to the tip, while the right arm is 1.15 m.

*Figure 66: Anchor SI 624. Note right arm unsupported and left arm leaning into hole in reef.* (Image taken 15<sup>th</sup> November 2020).

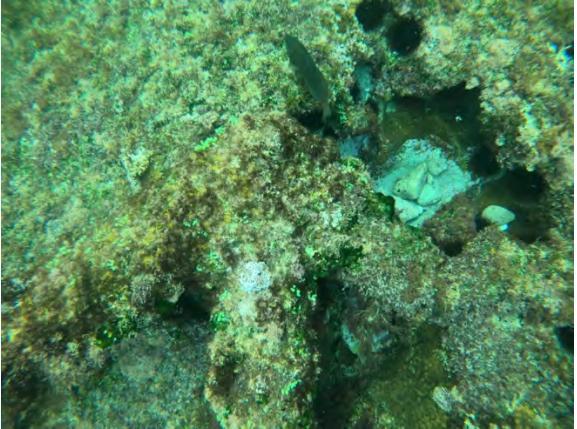
*Figure 68: Arms of Anchor SI 624 with hole in reef top right.* (Image taken 15<sup>th</sup> November 2020).

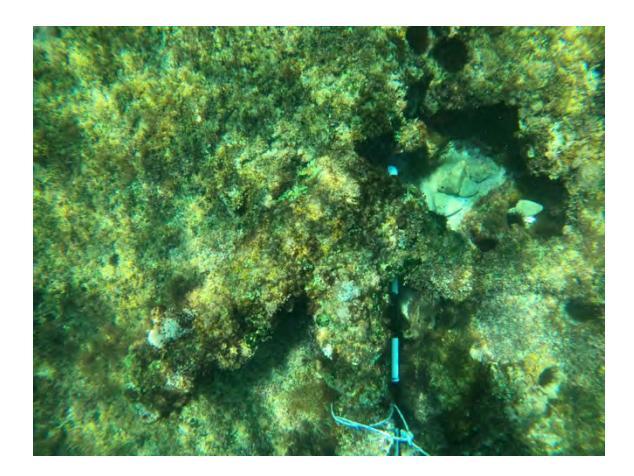
The sea urchin activity in and around this area appears relatively minor. There appears to be some urchins in the walls of the hole under the right arm and these should be monitored to determine if they are making the hole larger in diameter or deeper (Figure 69).

*Figure 69: Sea urchins in hole under Anchor SI 624.* (Image taken 15<sup>th</sup> November 2020).

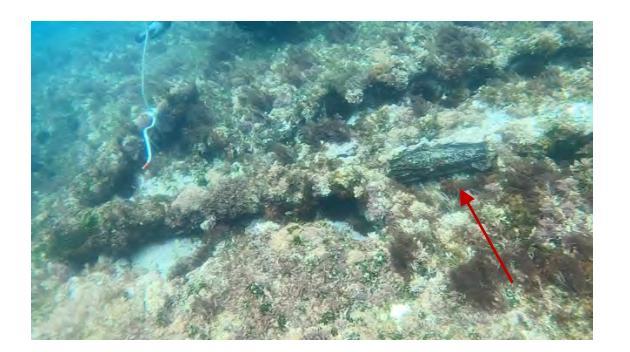
*Figure 73: Shank of Anchor SI 625; note a section of concretion has been removed.* (Image taken from video Sirius20\_201114\_03\_JM\_anchor 10: 003).

A section of the shank was noted to have been deconcreted since February 2020 (Figure 73 and Figure 74). The deconcreted area measures 280 mm in length, 110 mm wide and was approximately 420 mm from the top of the shank. It is unknown what caused the damage,

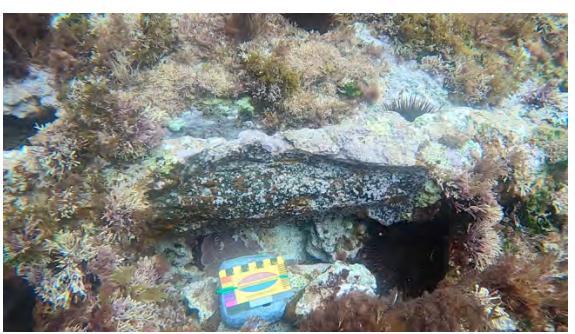
*Figure 74: Detail of exposed shank on Anchor SI 625 where concretion has been removed.* (Image taken from video Sirius20\_201115\_5\_Anchor 10 concretion, 00:01).

although the concretion that has broken off appears not to have had seaweed growth on it previously (Figure 75).

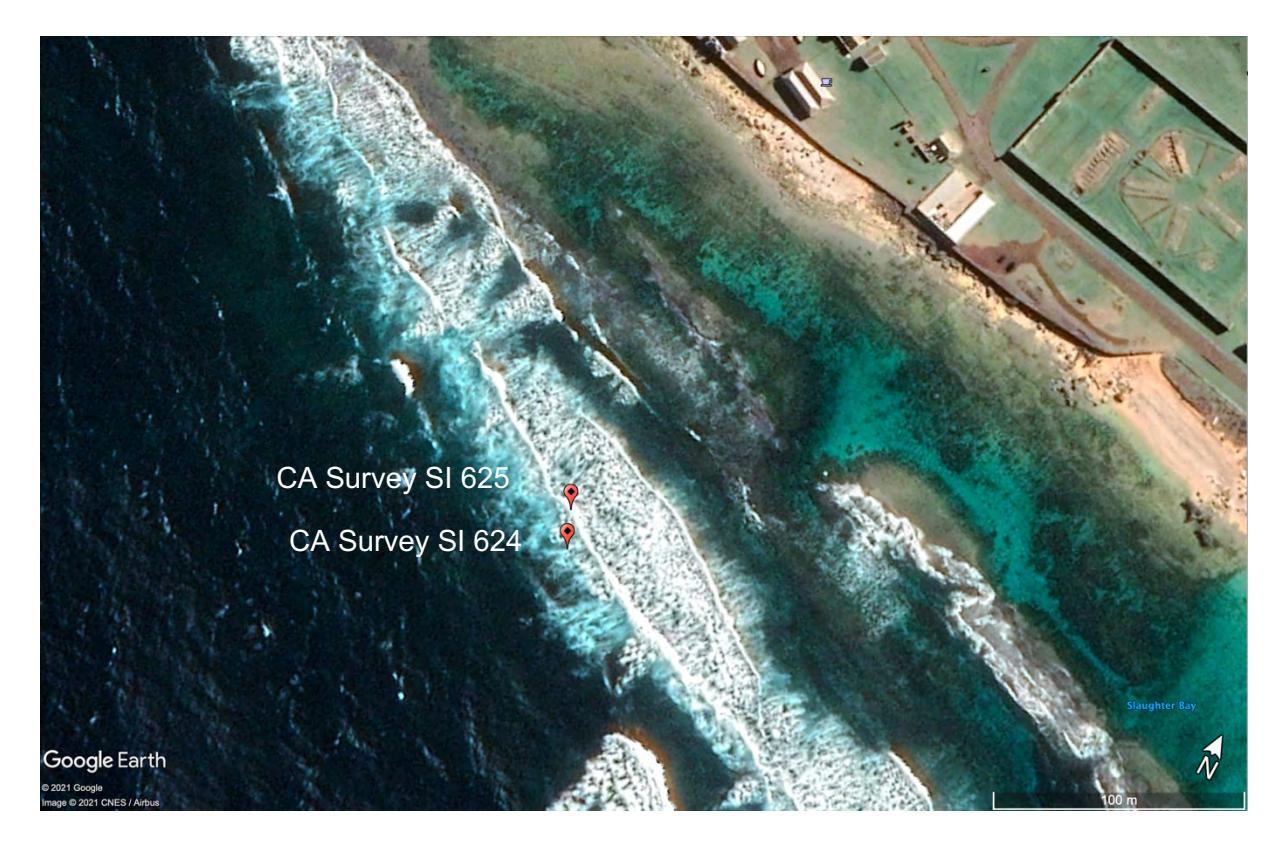
Figure 76: Positions of anchors SI 624 and SI 625 overlaid onto Google Earth.

Both anchors were recorded on the dive vessel's GPS in degrees, decimal minutes during this inspection (Figure 76).

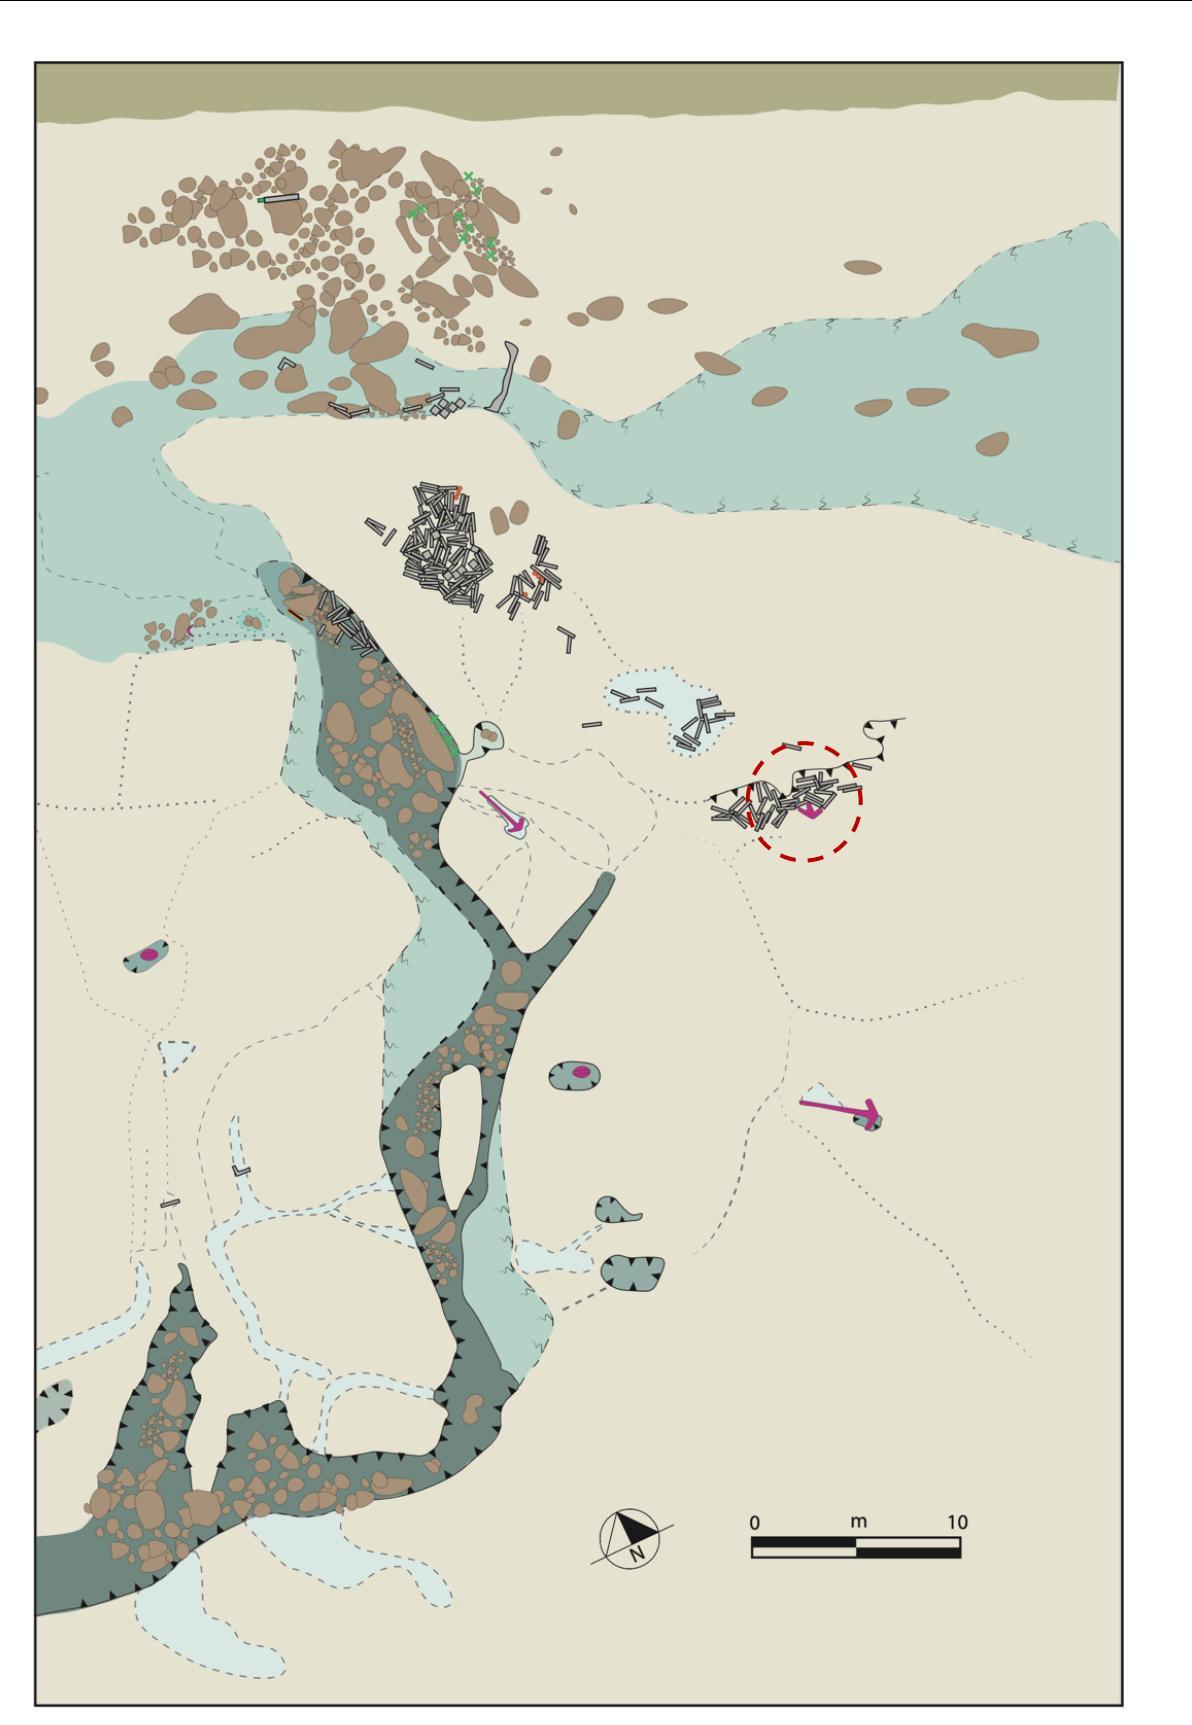
Figure 77: Location of anchor 2020.

On 17<sup>th</sup> November, an inspection of the ballast mound at the eastern edge of the site revealed a broken anchor, previously unrecorded (Figure 77). The anchor rests on top of a ballast pig at the southern edge of the ballast pile (Figure 78 to Figure 81).

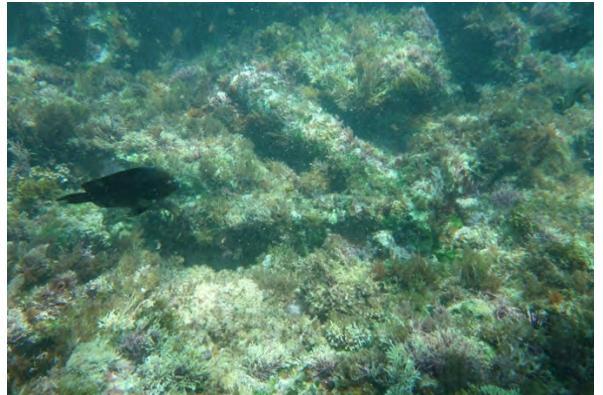
The anchor measures 740 mm long from the crown to the broken end of the shank. The shank has a circumference of 430 mm. The left arm is 860 mm from the crown to the end of the arm, while the right arm is 300 mm. The longer arm appears to have some of the fluke remaining but it is heavily corroded and covered in concretion. The shape of the arms to the shank indicate a crown angle anchor or old plan long-shanked anchor, the same as the two remaining on site and three already raised from the wreck.

*Figure 78: Anchor 2020 resting on the eastern ballast mound.* (Image taken 17<sup>th</sup> November 2020).

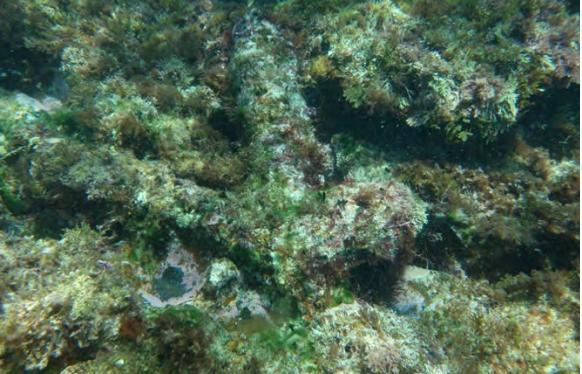
*Figure 80: Anchor 2020.* (Image taken 17<sup>th</sup> November 2020).

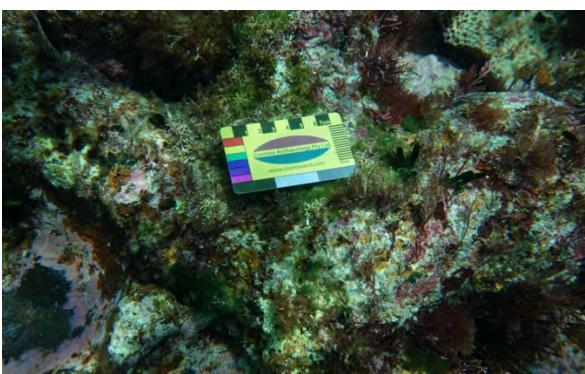
*Figure 81: Crown of anchor 2020.* (Image taken 17<sup>th</sup> November).

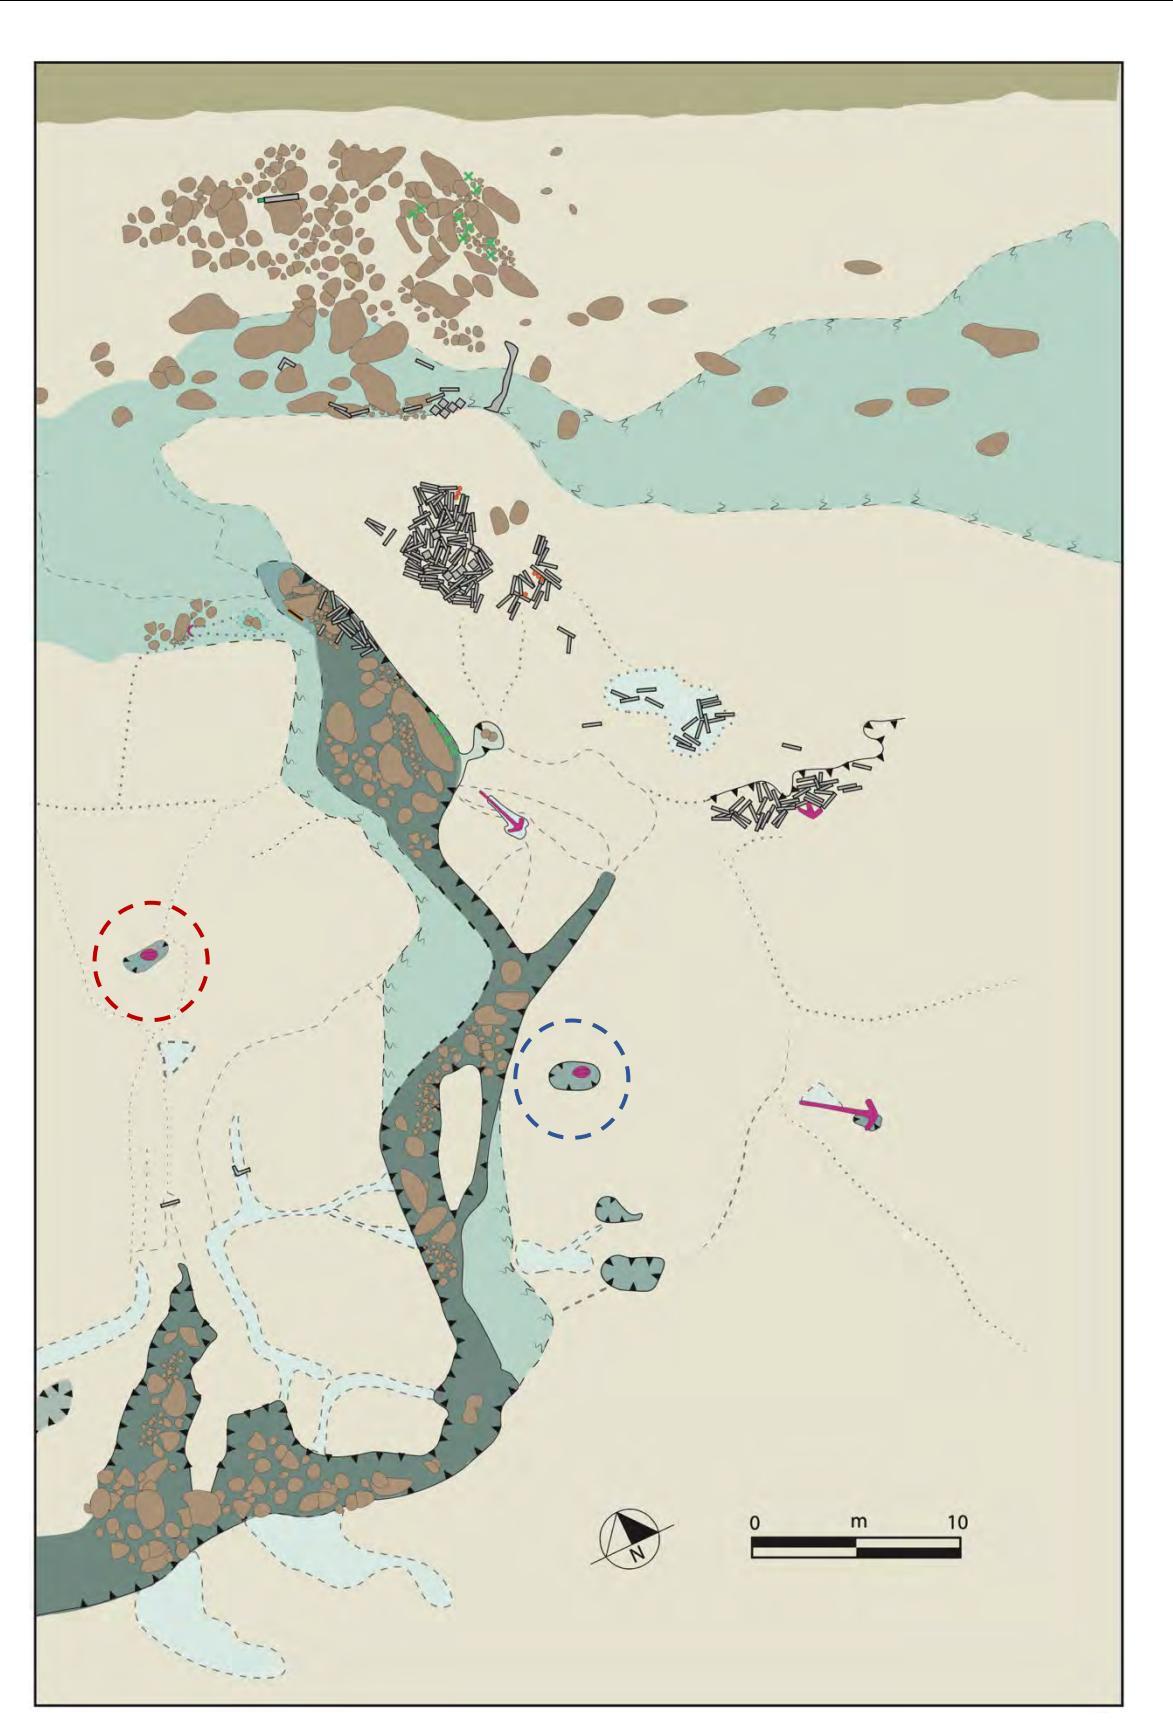
Figure 82: Location of western fluke (red) and eastern fluke (blue).

There are currently two anchor flukes on site. The 1989 site plan lists one anchor fluke concreted into the reef in the south west where the 1905 anchor was raised and another is featured in the gully near Anchor SI 625. The latter (SI 590) was raised at the end of the 1988 season.<sup>27</sup> The two anchor flukes presently on the site are both loose and sit in holes worn into the reef (Figure 82).

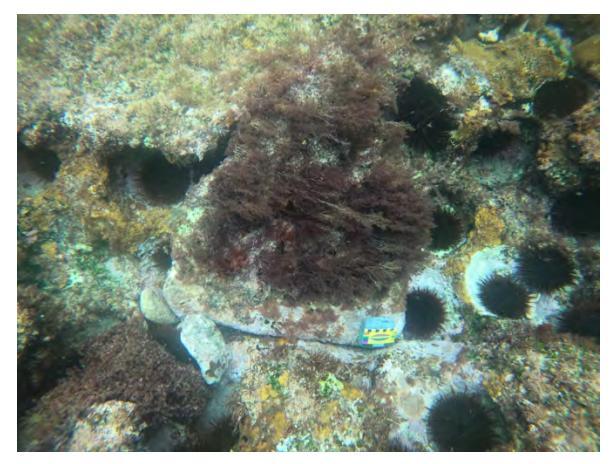
The south west fluke appears heavily concreted and covered with a purple sea weed (Figure 83 and Figure 84). The base measures 670 mm, the diagonal sides are 780 mm with the vertical distance from top to base 700 mm. The width was 50 mm. It is uncertain at this stage if this fluke is the one from the 1905 anchor that has broken free of the reef.

*Figure 83: Western anchor fluke, very heavily concreted.* (Image taken on 15<sup>th</sup> November 2020).

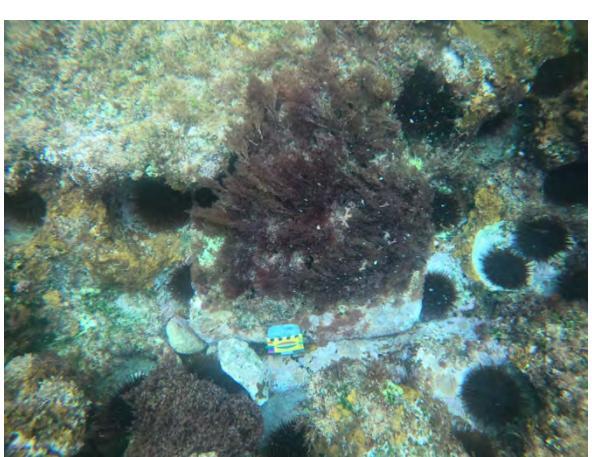
*Figure 84: Western concreted anchor fluke.* (Image taken 15<sup>th</sup> November 2020).

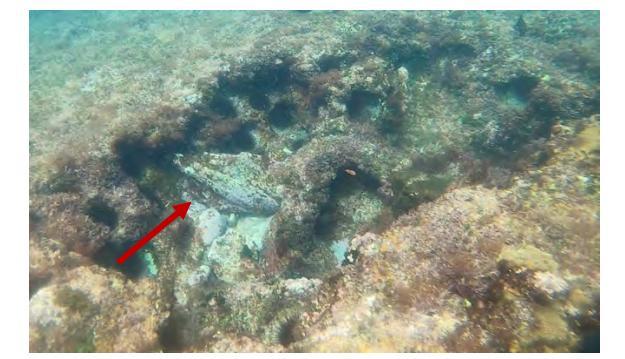
The second anchor fluke is smaller in size and lies in the carronade hole to the south of Anchor SI 625 and west of anchor SI 624 (Figure 85). The height of the fluke is approximately 630 mm.

*Figure 85: Anchor fluke in carronade hole.* (Image taken from video Sirius20\_201114\_19\_JM\_ Anchor fluke in Carronade hole; 00:04).

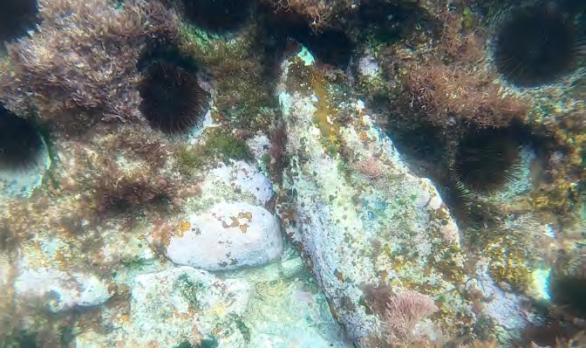
The raised part of the arm is visible on the reverse of the palm (Figure 86).

*Figure 86: Detail of anchor fluke*. (Image taken 15<sup>th</sup> November 2020).

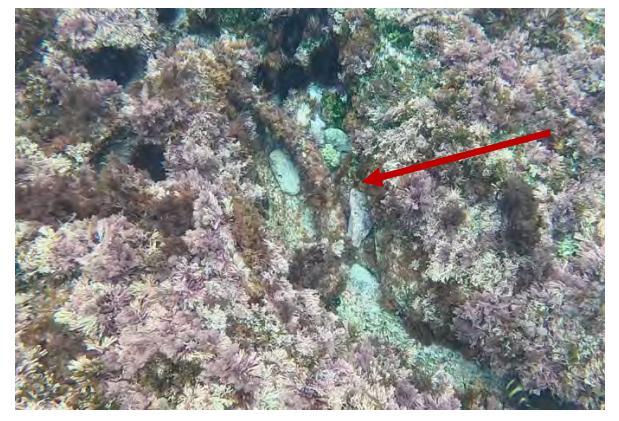
The anchor ring is located lying loose in a depression to the west of the site (Figure 87). Approximately just under half appears to remain .The ring has a thickness of 100 mm and the distance between each broken tip is 600 mm (Figure 88 and Figure 89). It is currently unknown which anchor this ring belonged to, although it has been speculated that it is from the 1905 anchor that was blasted from the reef.

Figure 88: Anchor ring in a depression amongst the seaweed growth (red arrow). (image taken from video Sirius20\_201115\_15\_CC\_solo pig to anchor ring; 00:59).

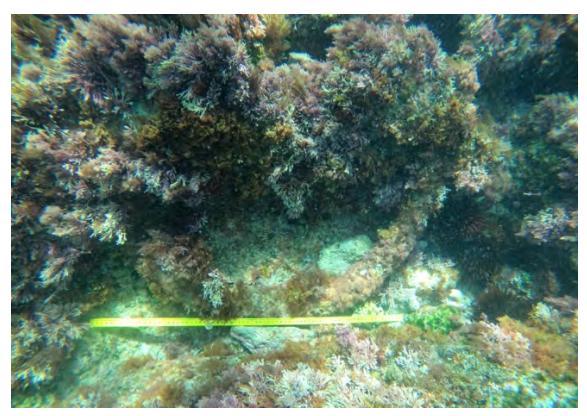
Figure 89: Anchor ring. (Image taken 17th November 2020).
