# **HMS** Sirius

## Site Inspection Report 2020

Norfolk Island Australian External Territory

March 2021

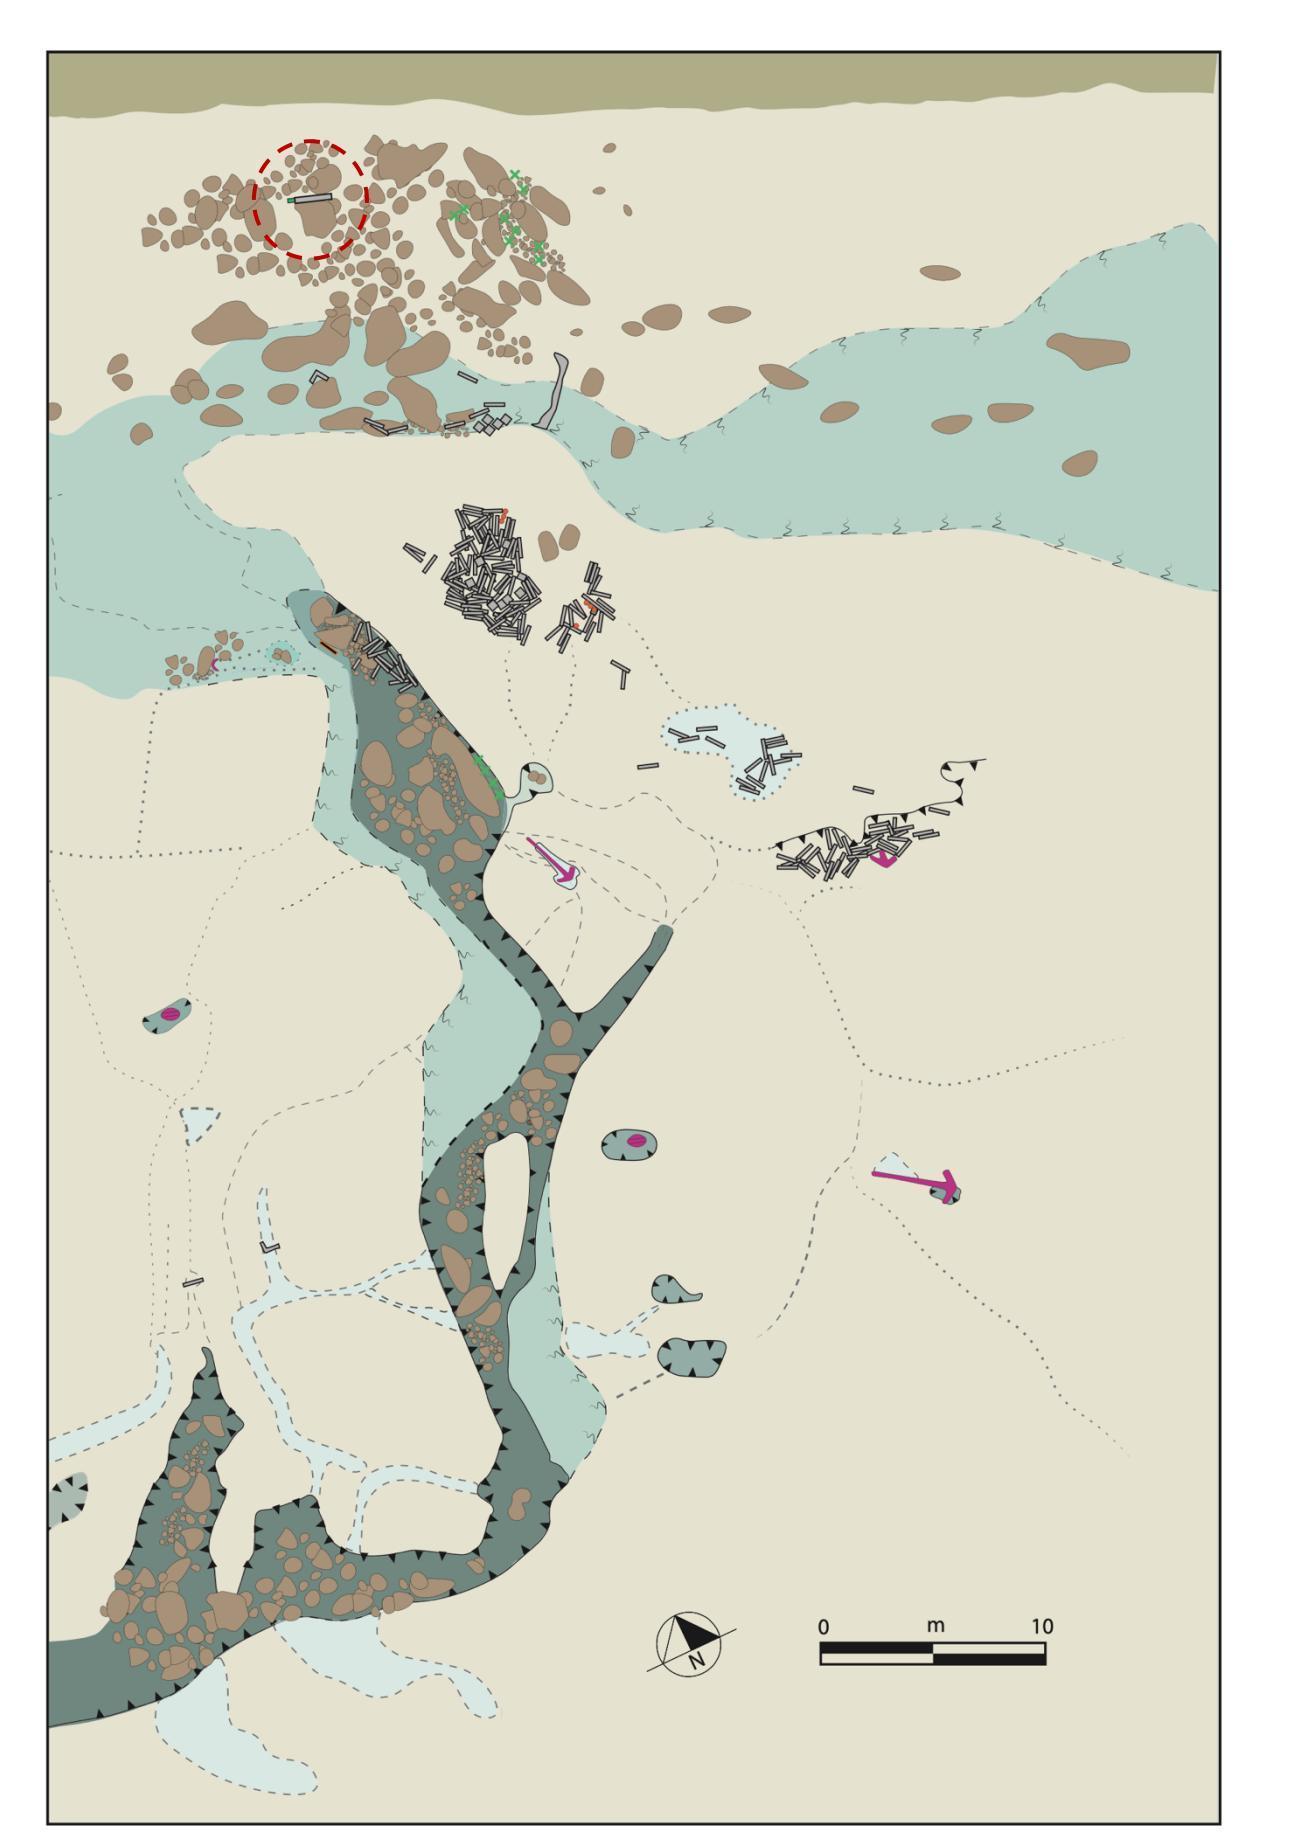
Figure 90: Location of pump chamber.

This pump chamber was first described in the 2002 Expedition Report, although it was not located as part of that inspection. It was located post expedition, during a particularly calm day in the shallow section of Site 1 (Figure 90).<sup>28</sup> The chamber with the concretion is approximately 1.4 m long, while the de-concreted copper alloy section measures 350 mm. There appears to be a small bevel at the end, measuring 15 mm. The outside diameter of the copper alloy chamber is 175 mm (

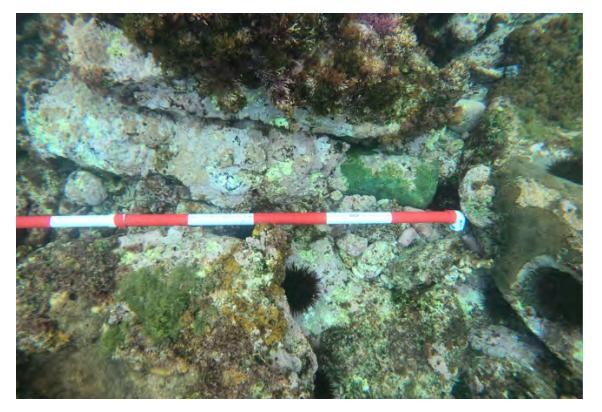
*Figure 91: Pump housing, scale in 200 mm increments.* (Image taken 15<sup>th</sup> November 2020).

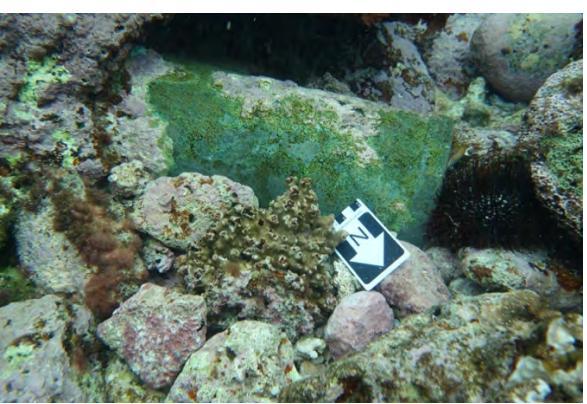
*Figure 92: De-concreted section of bronze pump chamber* (Image taken 15<sup>th</sup> November 2020).

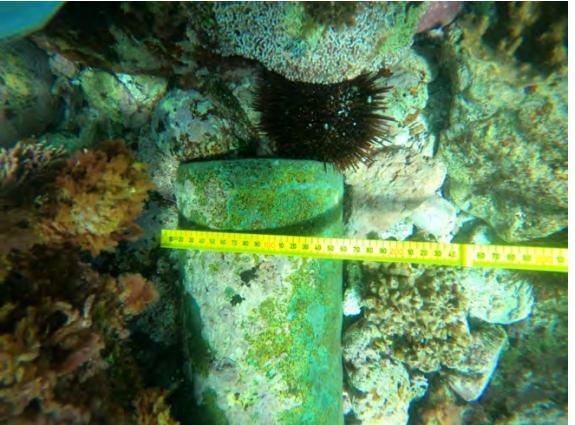
*Figure 93: Bronze pump chamber.* (Image taken 17<sup>th</sup> November 2020).

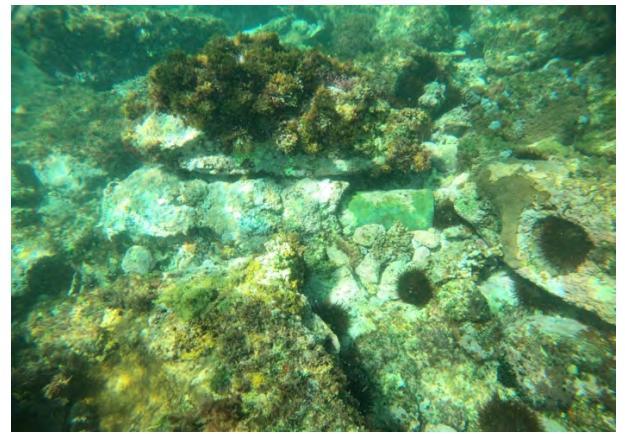
*Figure 94: Bronze pump chamber tucked under calcarenite boulder.* (Image taken 17<sup>th</sup> November 2020).

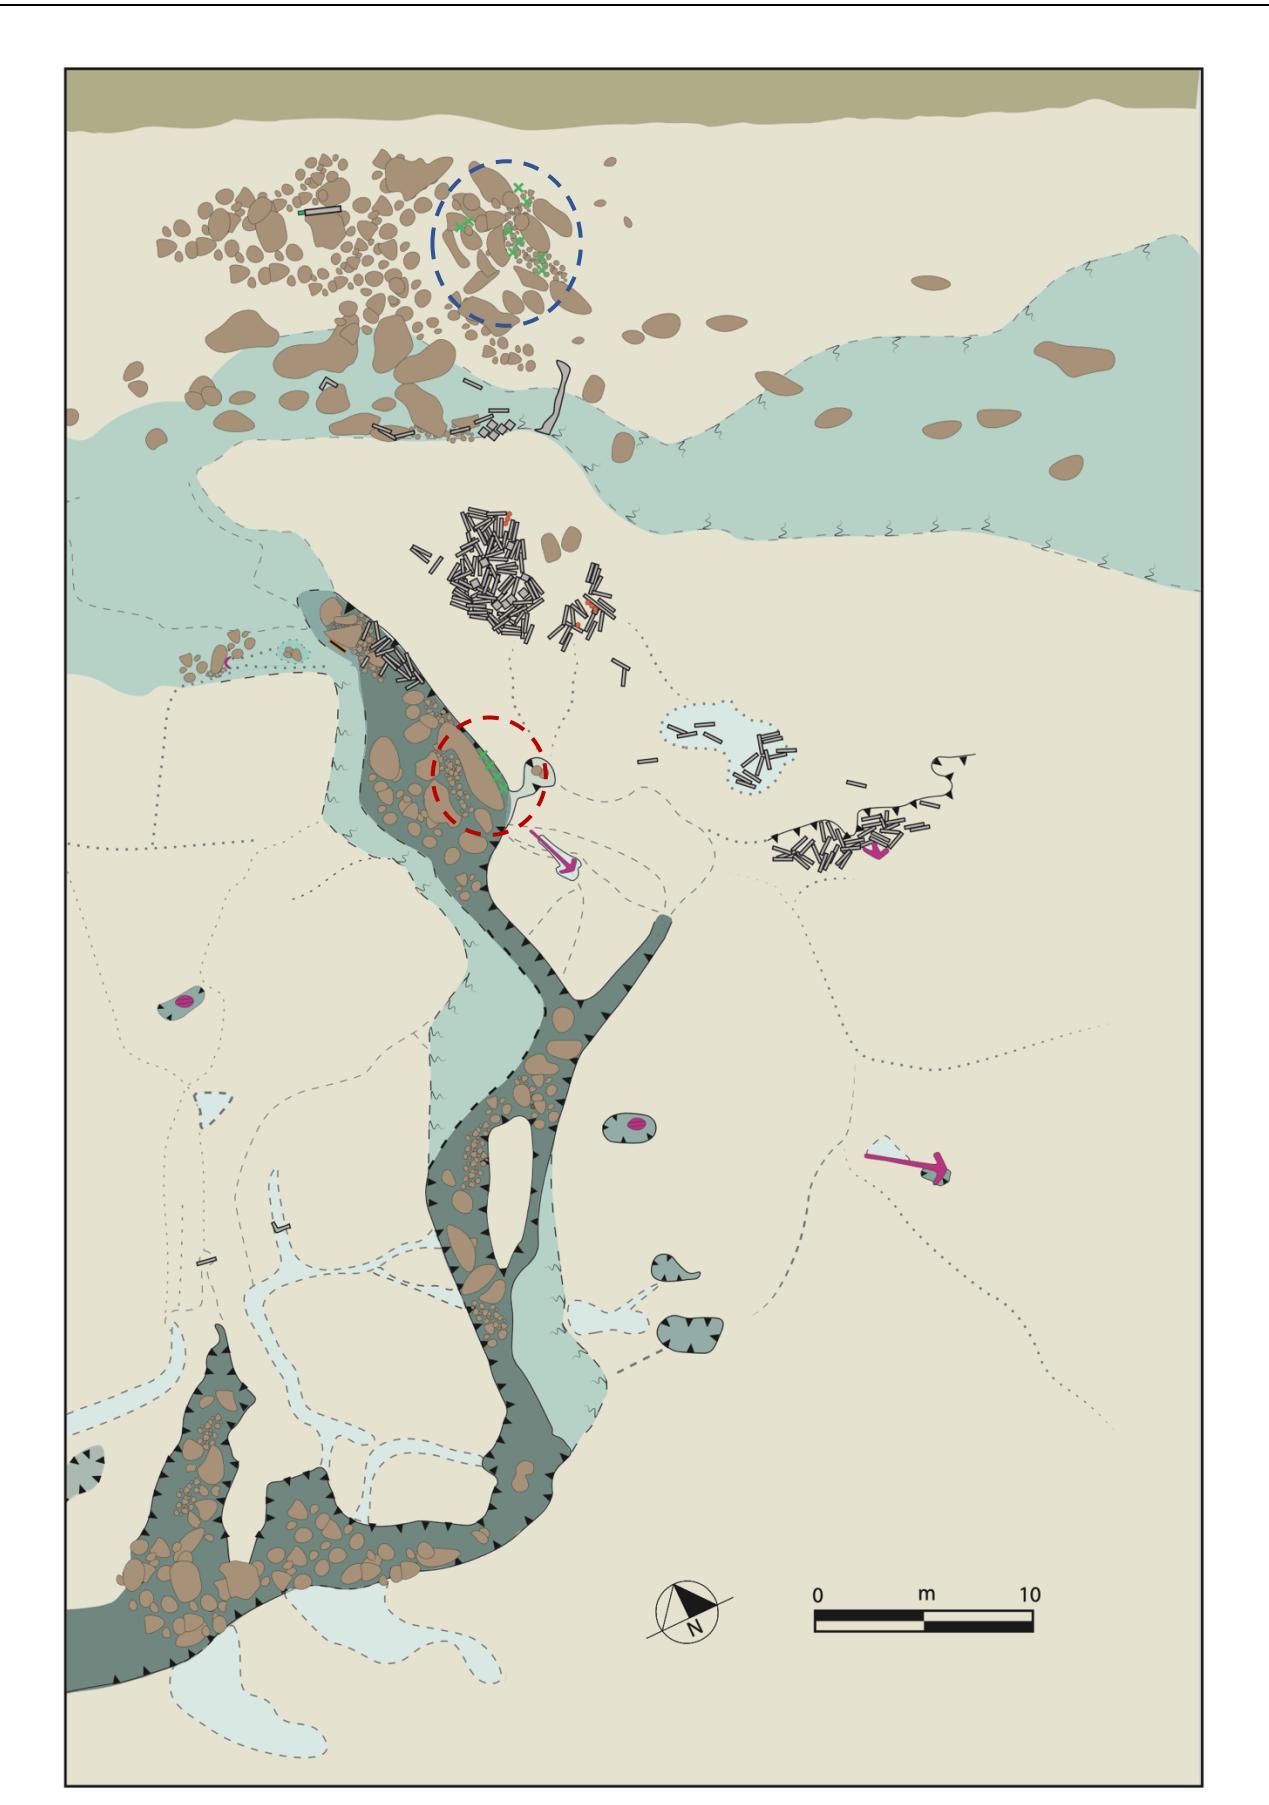
Figure 95: Location of loose copper allow artefacts; in the gully (red) and in the shallows (blue).

A 2.2 m long copper artefact seam is concreted into the base of the main gully wall, 4.4 m north of Anchor SI 625 (Figure 95). This seam of artefacts includes copper tacks, copper sheathing and weathered ceramics (Figure 96 and Figure 97).

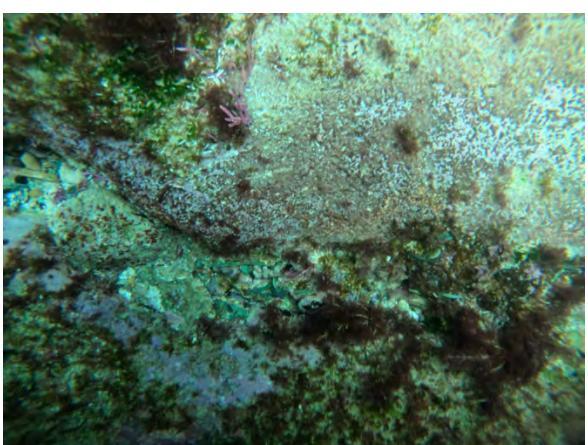
*Figure 97: Small copper artefacts including tacks concreted into gully crevice.* (Image taken 15<sup>th</sup> November).

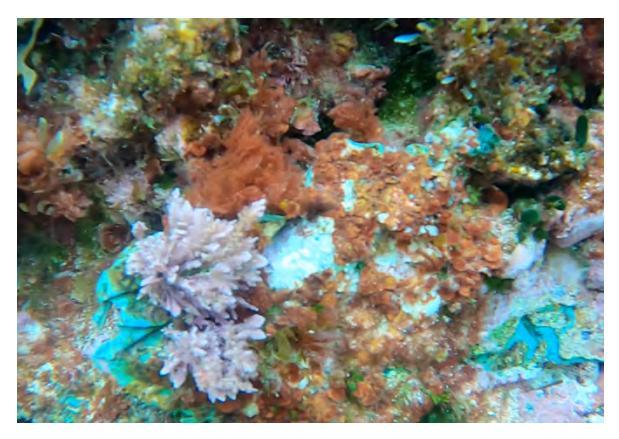
A section of metal sheathing has been concreted into the gully wall just south of the artefact seam (Figure 98 and Figure 99).

*Figure 98: Copper sheathing in the gully wall near anchor SI 625.* (Image taken 15<sup>th</sup> November),

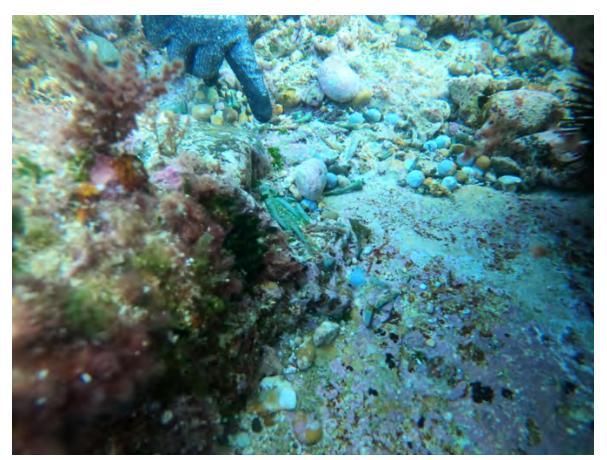
There was a surprising amount of loose material in the shallow area of Site 1. Musket balls, lead shot, coaks, clench rings, copper alloy tacks are all still on the site. Some of the artefacts have been concreted into the seabed or gullies (Figure 100) however, there was a relatively large number of loose artefacts in fissures and under rocks and boulders (Figure 101 to Figure 103).

*Figure 100: Copper tacks and ammunition in shallow area Site 1.* (Image taken 15<sup>th</sup> November).

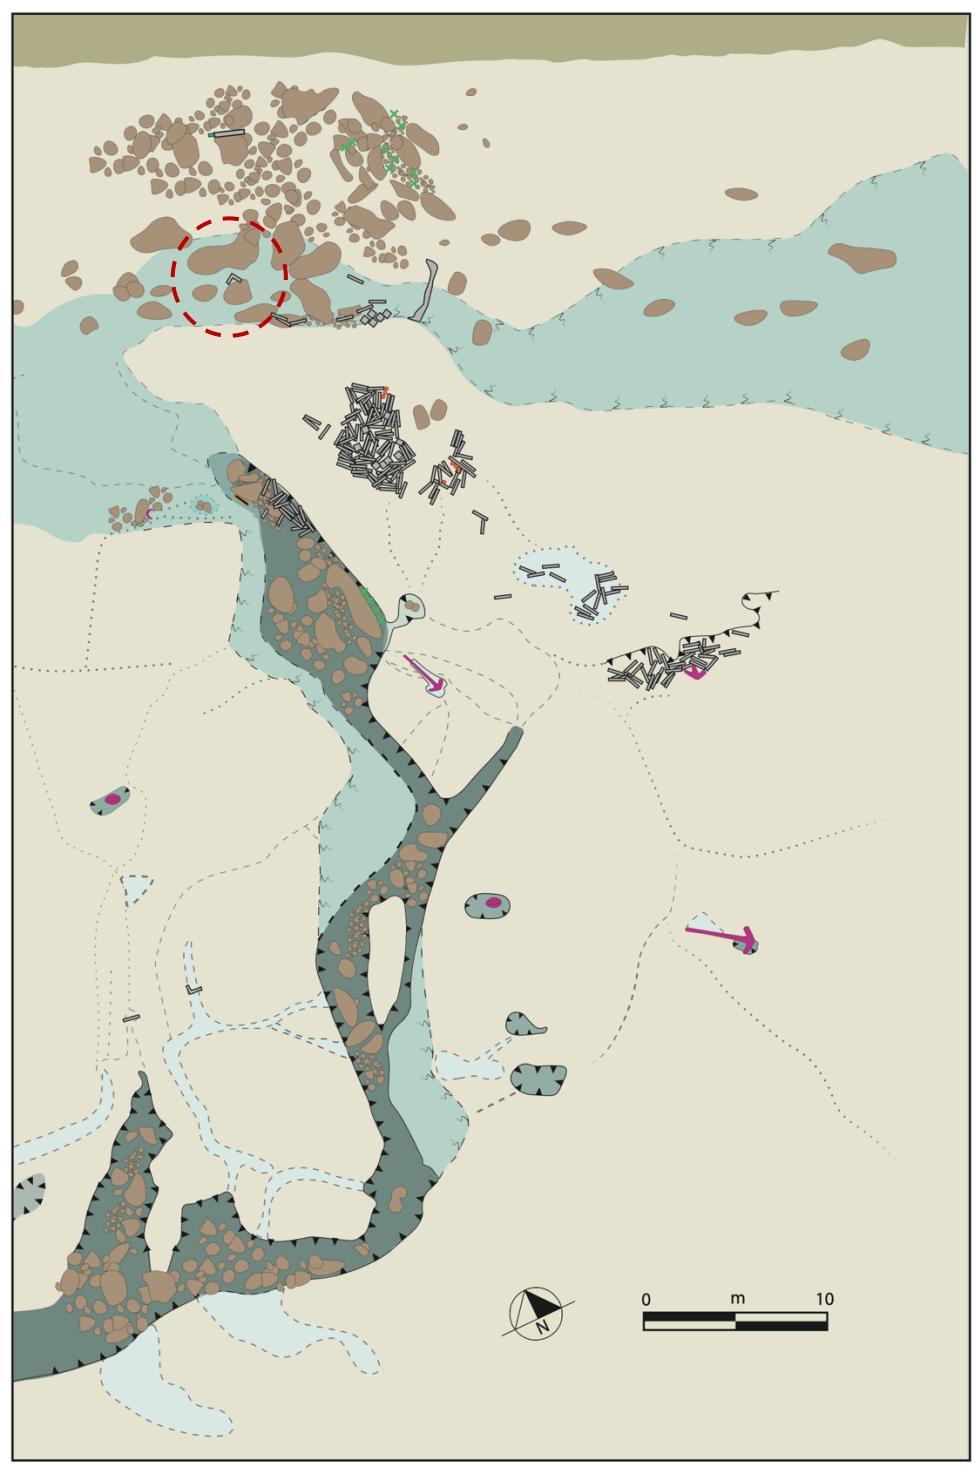
Figure 106: Location of possible anode.

This artefact is located in the shallows of Site 1, to the east of the SI 830 pump chamber (Figure 106 to Figure 108). The artefact consists of what appears to be a concreted bar, approximately 300 mm long and 40 mm wide with a ferrous bracket 80 mm long attached at the western end. There is an insulated copper wire cable attached to the bar which runs in a westerly direction underneath rocky boulders for approximately a metre (Figure 109 and Figure 110).

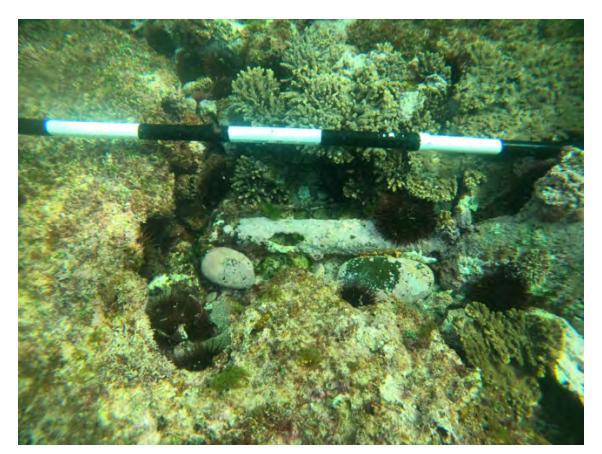
*Figure 107: Possible remains of anode in shallows of site 1.* Scale in 200 mm increments. (Image taken 15<sup>th</sup> November 2020).

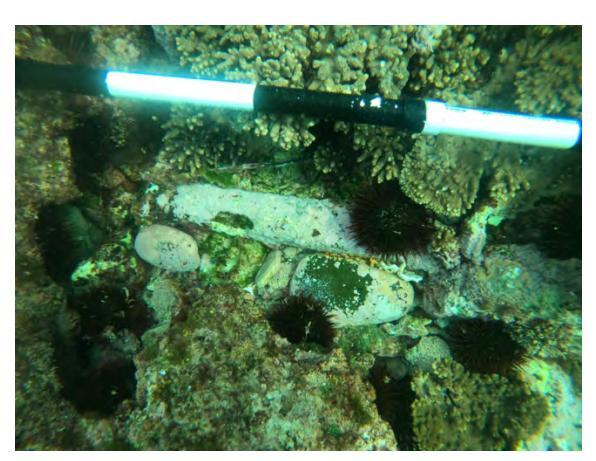
*Figure 108: Close-up of possible anode in shallow area of Site 1*. Scale in 200 mm increments. (Image taken 15<sup>th</sup> November 2020).

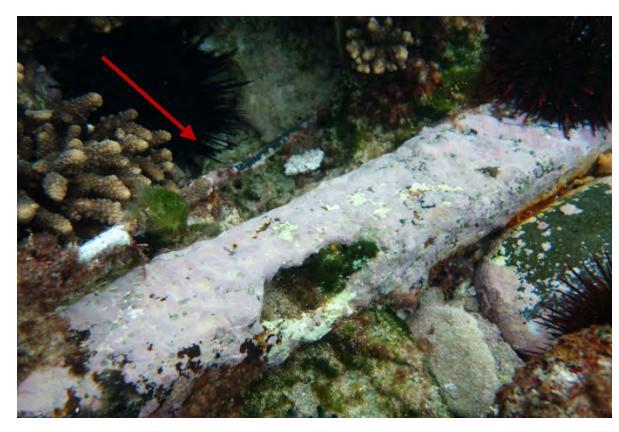
*Figure 109: Close-up of possible anode in shallow area of Site 1.* Red arrow indicates cable. (Image taken 15<sup>th</sup> November 2020).

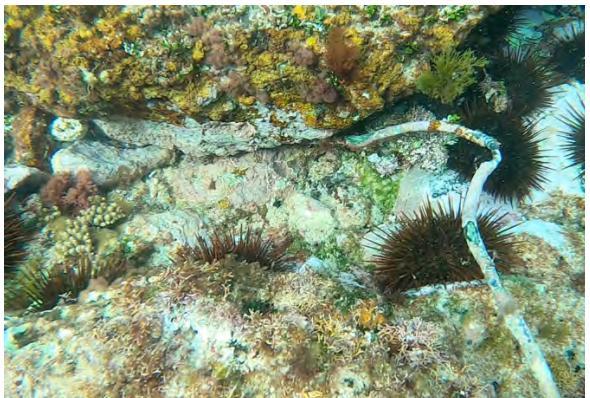
Figure 110: End of cable running in a westerly direction attached to possible anode. (Image taken from video Sirius20\_201115\_03\_CC\_Anode; 00:06).

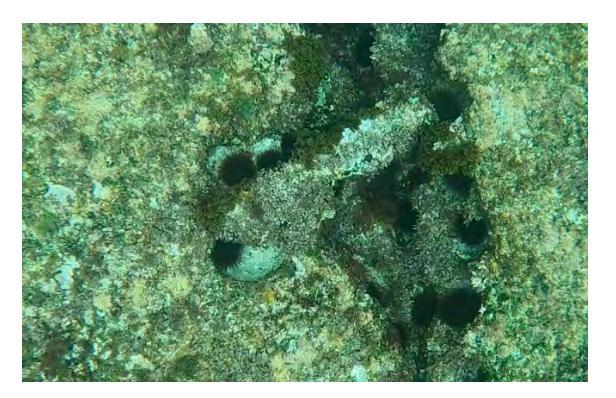
This single ballast is an isolated find in the south west of Site 1 (Figure 111). It is resting over a steep gutter and appears to be affected by sea urchin activity, with one animal in particular making a deep crater in the southern face of the ballast iron (Figure 112 and Figure 113).

*Figure 112: Single ballast pig in the south of site 1.* (Image taken from Sirius20\_201115\_10\_CC\_pig to anchor 10; 00:03).

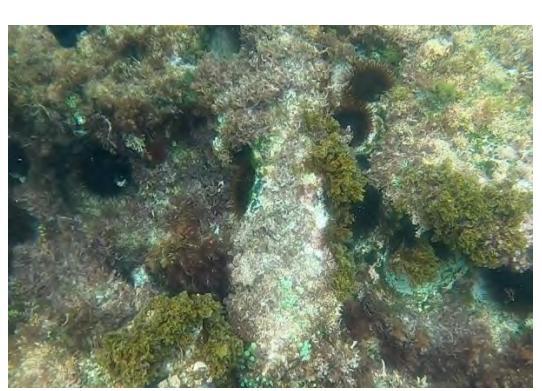
*Figure 113: Single ballast pig in the south of Site 1.* (Image taken 14<sup>th</sup> November 2020).

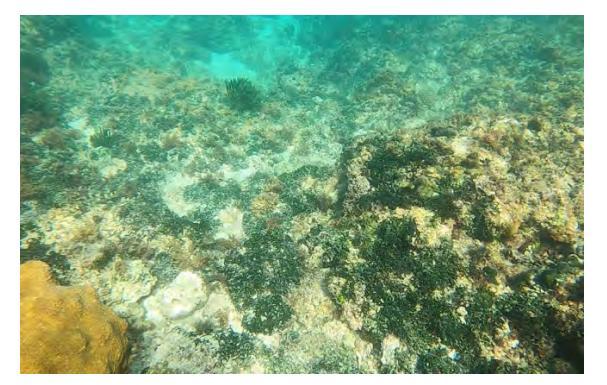
The seabed was rubbly and uneven, the search with the metal detector being directed towards small gullies and depressions within each zone (Figure 114 and Figure 115). The impression was there was a strike in every scanned gully while the open areas were quite sterile.

*Figure 114: Example of seabed in Site 2 Zone E.* (Image taken from video Sirius201116\_01\_MB\_Example of site 2 seabed; 00:06).

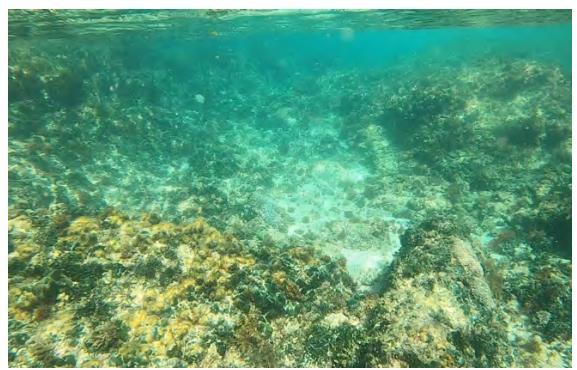
*Figure 115: Example of seabed in Site 2 Zone D.* (Image taken from video Sirius201116\_01\_MB\_Example of site 2 seabed; 01:23).

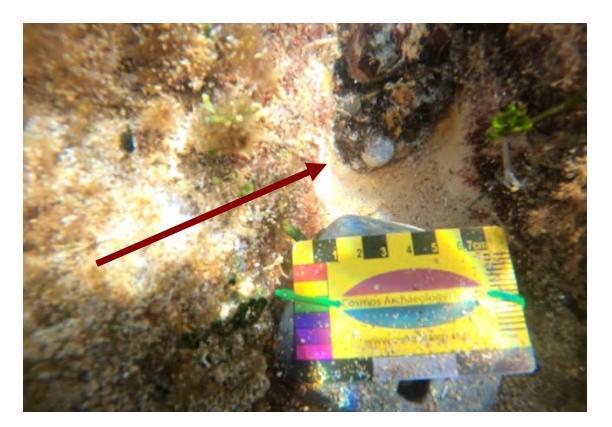
Table 4 outlines the results of the survey with 105 'hits' recorded over 69 minutes. Very few hits revealed artefacts of note visible above the seabed. However, what appeared to be a musket ball was concreted into the reef in Zone A (Figure 116) and a small piece of worn green glass was found in Zone C (Figure 117).

*Figure 116: Possible musket ball concretion found in Zone A (red arrow).* (Image taken 16<sup>th</sup> November, 2020).

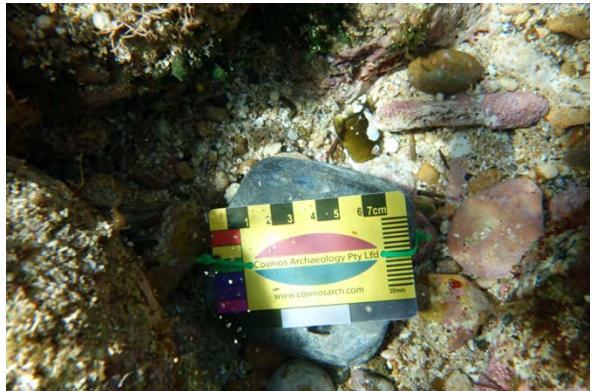
*Figure 117: Piece of glass concreted in seabed located in Zone C.* (Image taken 16<sup>th</sup> November 2020).

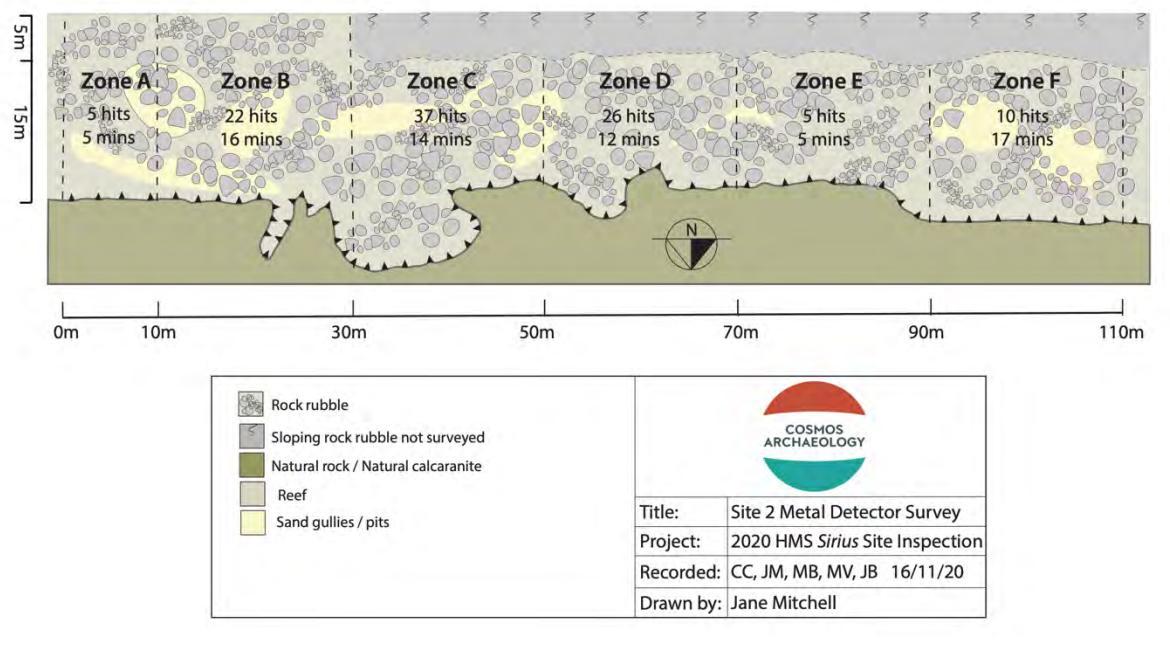
Figure 118: Digital representation of site 2 search area.

A digital representation of the search area of Site 2 can be found at Figure 118.

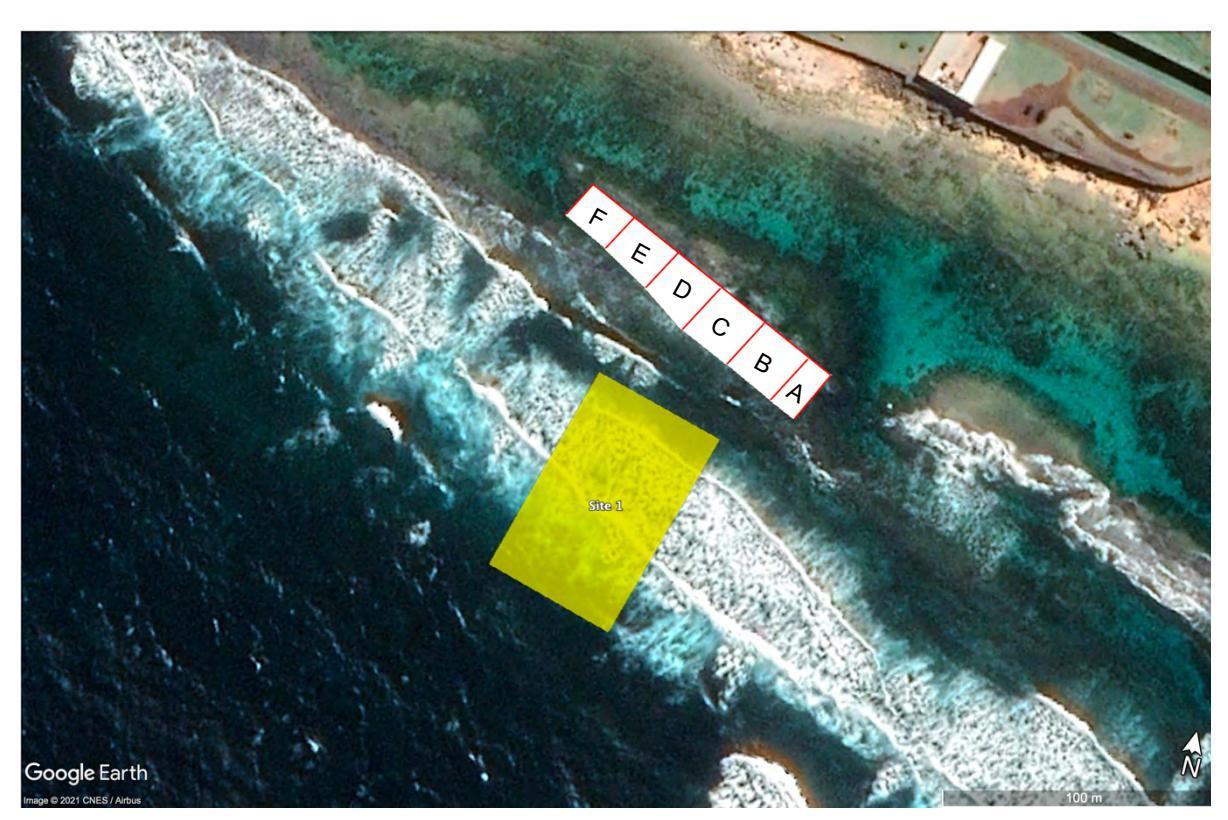
Figure 119: Site 2 search area in relation to Site 1.

The area of Site 2 is a gully between two higher reef platforms, an ideal location for trapping artefacts. The greater artefact densities came from zones B, C and D. This correlates with the position of these zones being almost directly north of the main wreck site of the HMS *Sirius* (Figure 119), where lighter metallic objects may have washed into the area. However, the *Ronaki* was also wrecked further inshore on the hard calcarenite reef and objects from that wreck may also be present.

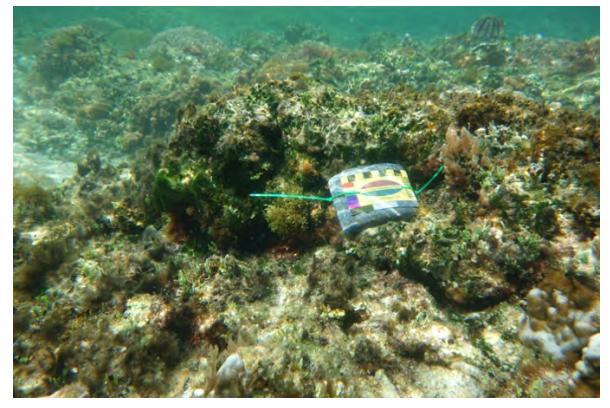
Table 9 outlines the results of the survey, however, no hits revealed anything of note. Some strong hits, when examined on snorkel, appeared to be rocky or coral outcrops which may have artefacts concealed under the growth or within the rock (Figure 120). One modern golf ball and a modern tin can were the only visible cultural material located during the search (Figure 121).

*Figure 120: Location of one 'hit' did not reveal an obvious artefact.* (Image taken 18<sup>th</sup> November 2020).

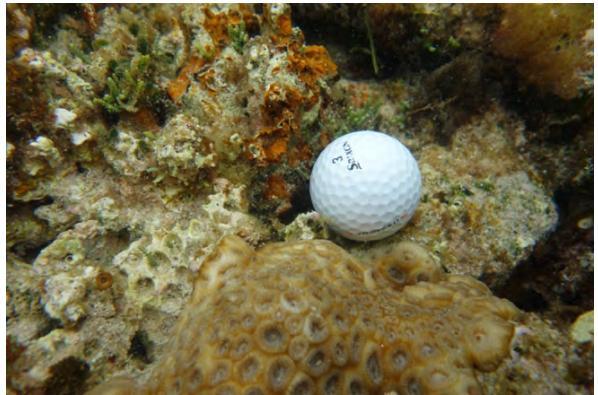
*Figure 121: Modern golf ball, with no growth indicating it had not been in the water long.* (Image taken 18<sup>th</sup> November 2020).

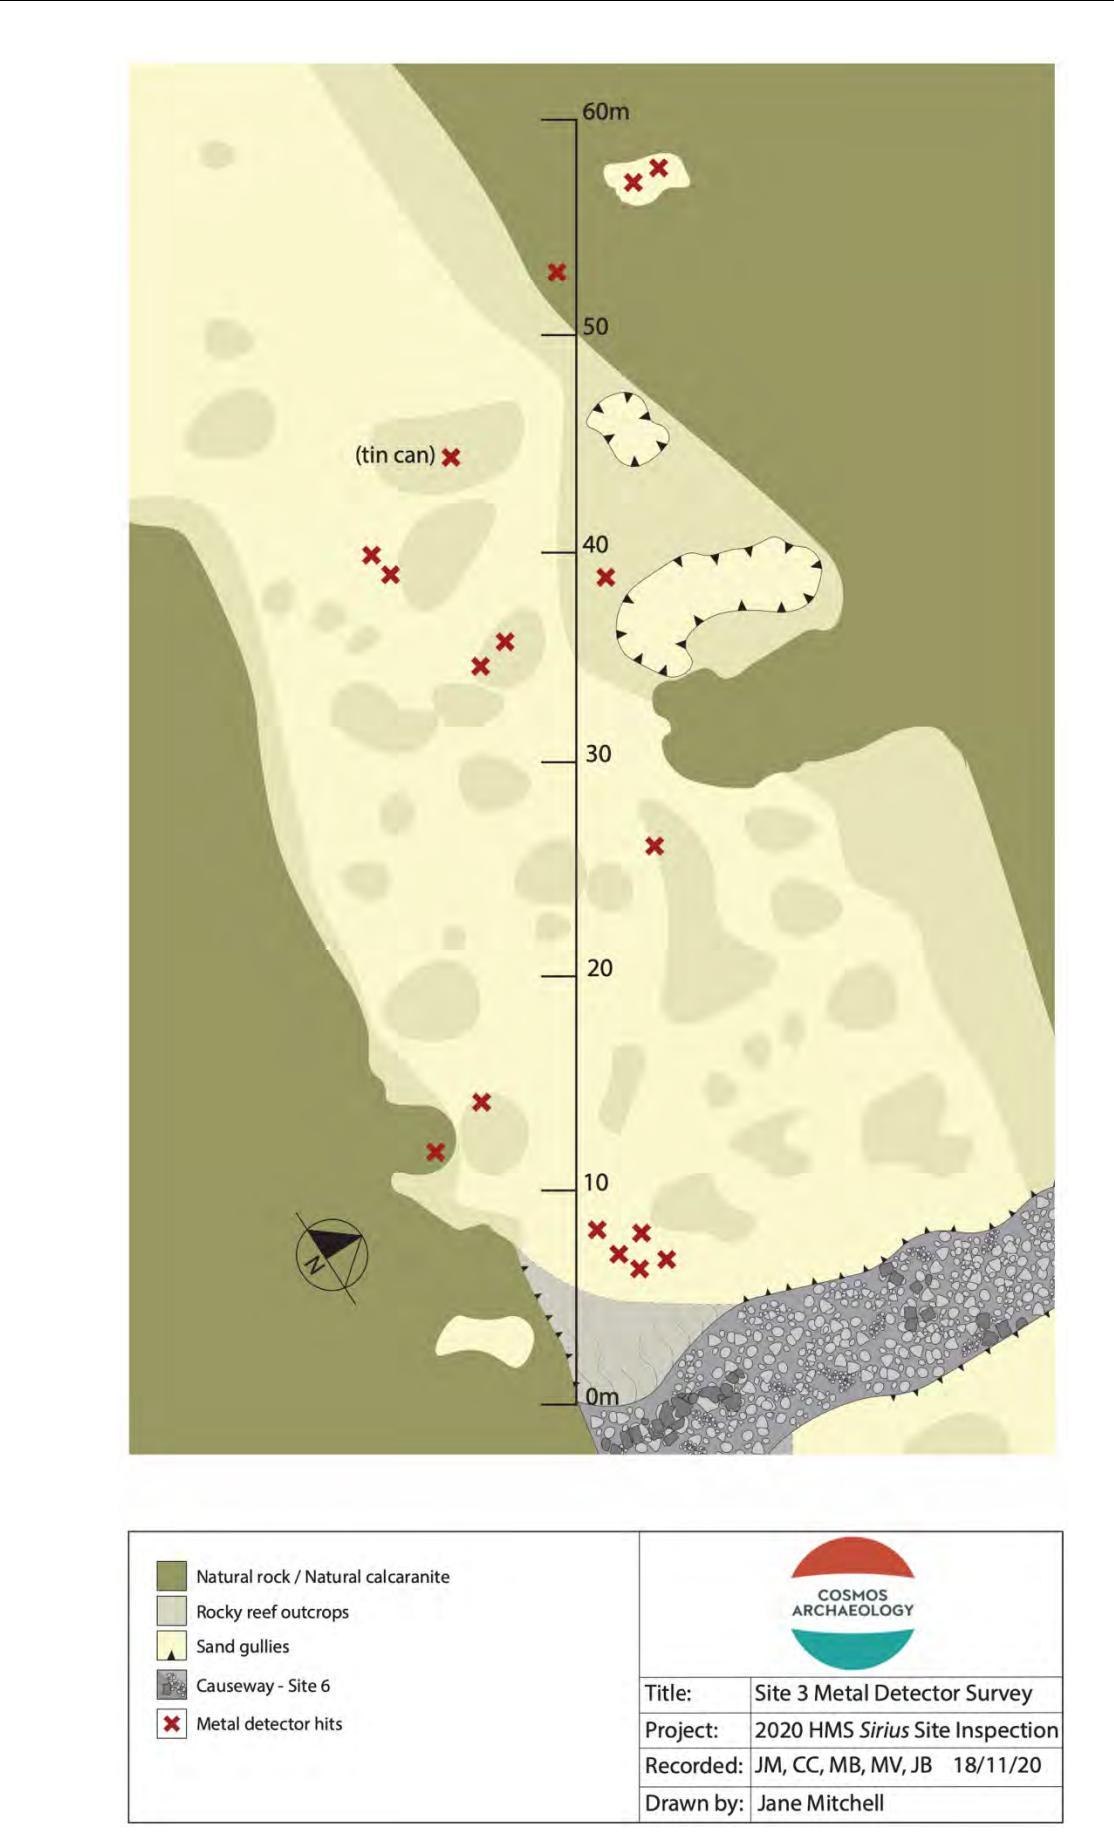
*Figure 122: Digital representation of metal detector survey of Site 3.* Location of 'hits' is indicitive only.

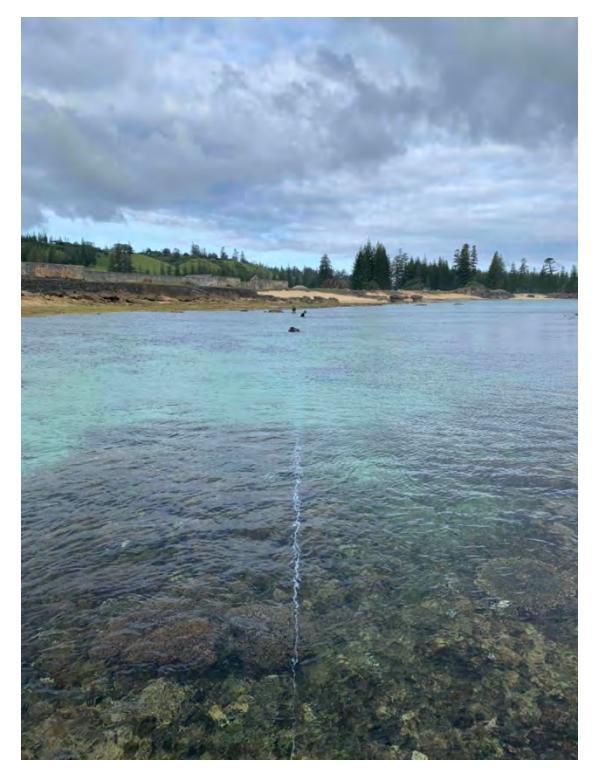
The seabed consisted of rocky rubble with coral outcrops for the first 12 m. From that point the terrain was a flat sandy sea floor with some rocky outcrops and coral growth (Figure 123).

Figure 123: Transect Area 3a, noting coral rocky rubble in foreground, leading to sandy patches. (Image taken 18<sup>th</sup> November 2020).

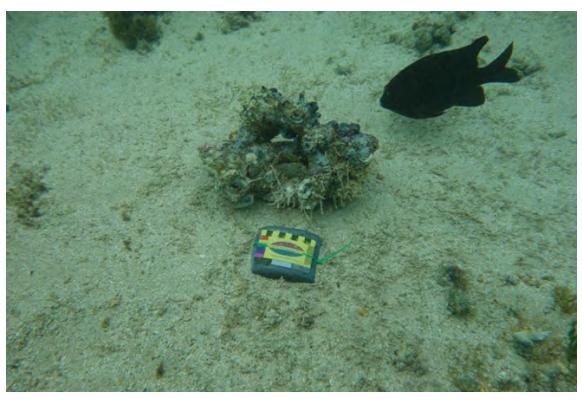
Table 10 outlines the results of the metal detector survey with a total time of 30 minutes for a total of 59 'hits'. However, there were no visible cultural artefacts apart from what appeared to be possible chain link (Figure 124).

*Figure 124: Potential ferrous piece of chain.* (Image taken 18<sup>th</sup> November 2020).

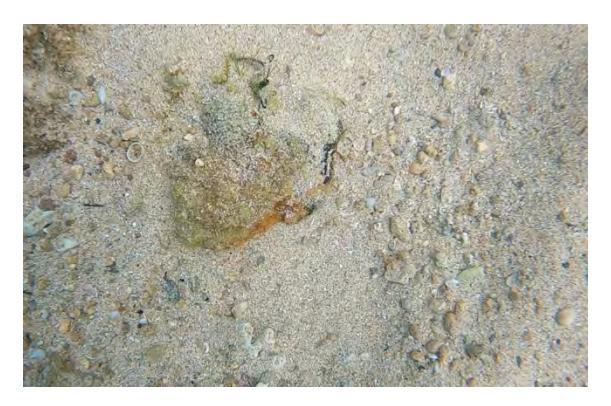
*Figure 127: Unidentified concretion in Area 4.* (Image taken from Sirius20\_201120\_01\_CM\_Concretion site 4, 00:01).

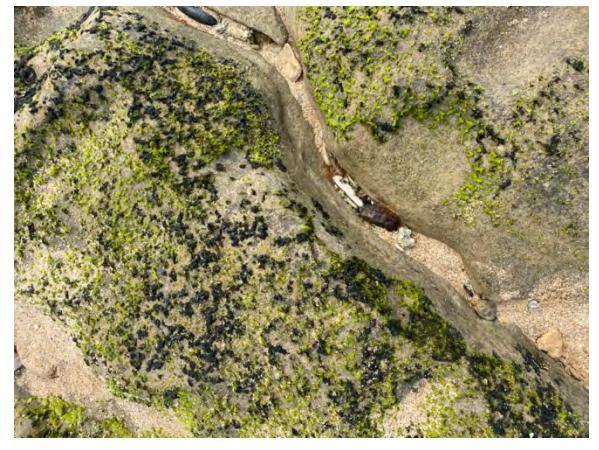
In the inshore area of Site 4, some cultural material was noted concreted into the cracks and gullies of the calcarenite rock (Figure 128, Table 12). This area would be underwater during high tides. There were two unidentified concretions, a small piece of copper alloy and some heavily worn glass (Figure 129 to Figure 131).

*Figure 129: Concretion embedded into a gully in the shallows of area 4.* (Image taken 20<sup>th</sup> November 2020).

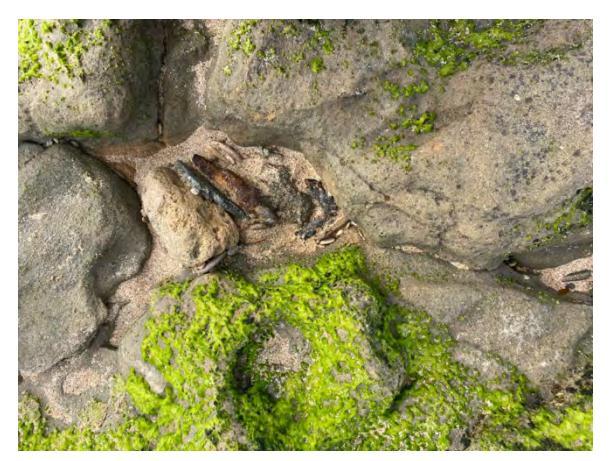
*Figure 130: Concretion embedded into a gully in the shallows of area 4.* (Image taken 20<sup>th</sup> November 2020).

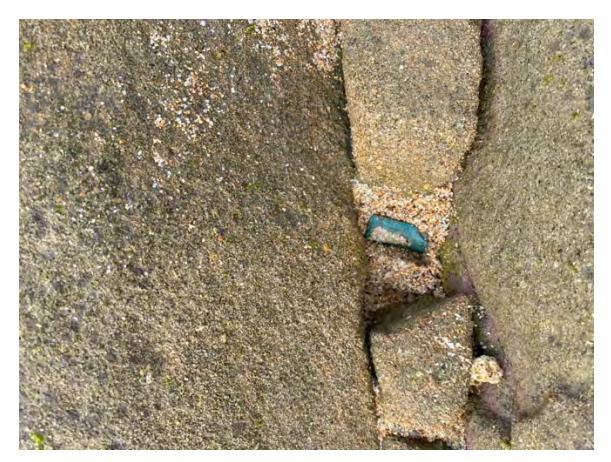
*Figure 131: A small piece of copper alloy material.* (Image taken 20<sup>th</sup> November 2020).

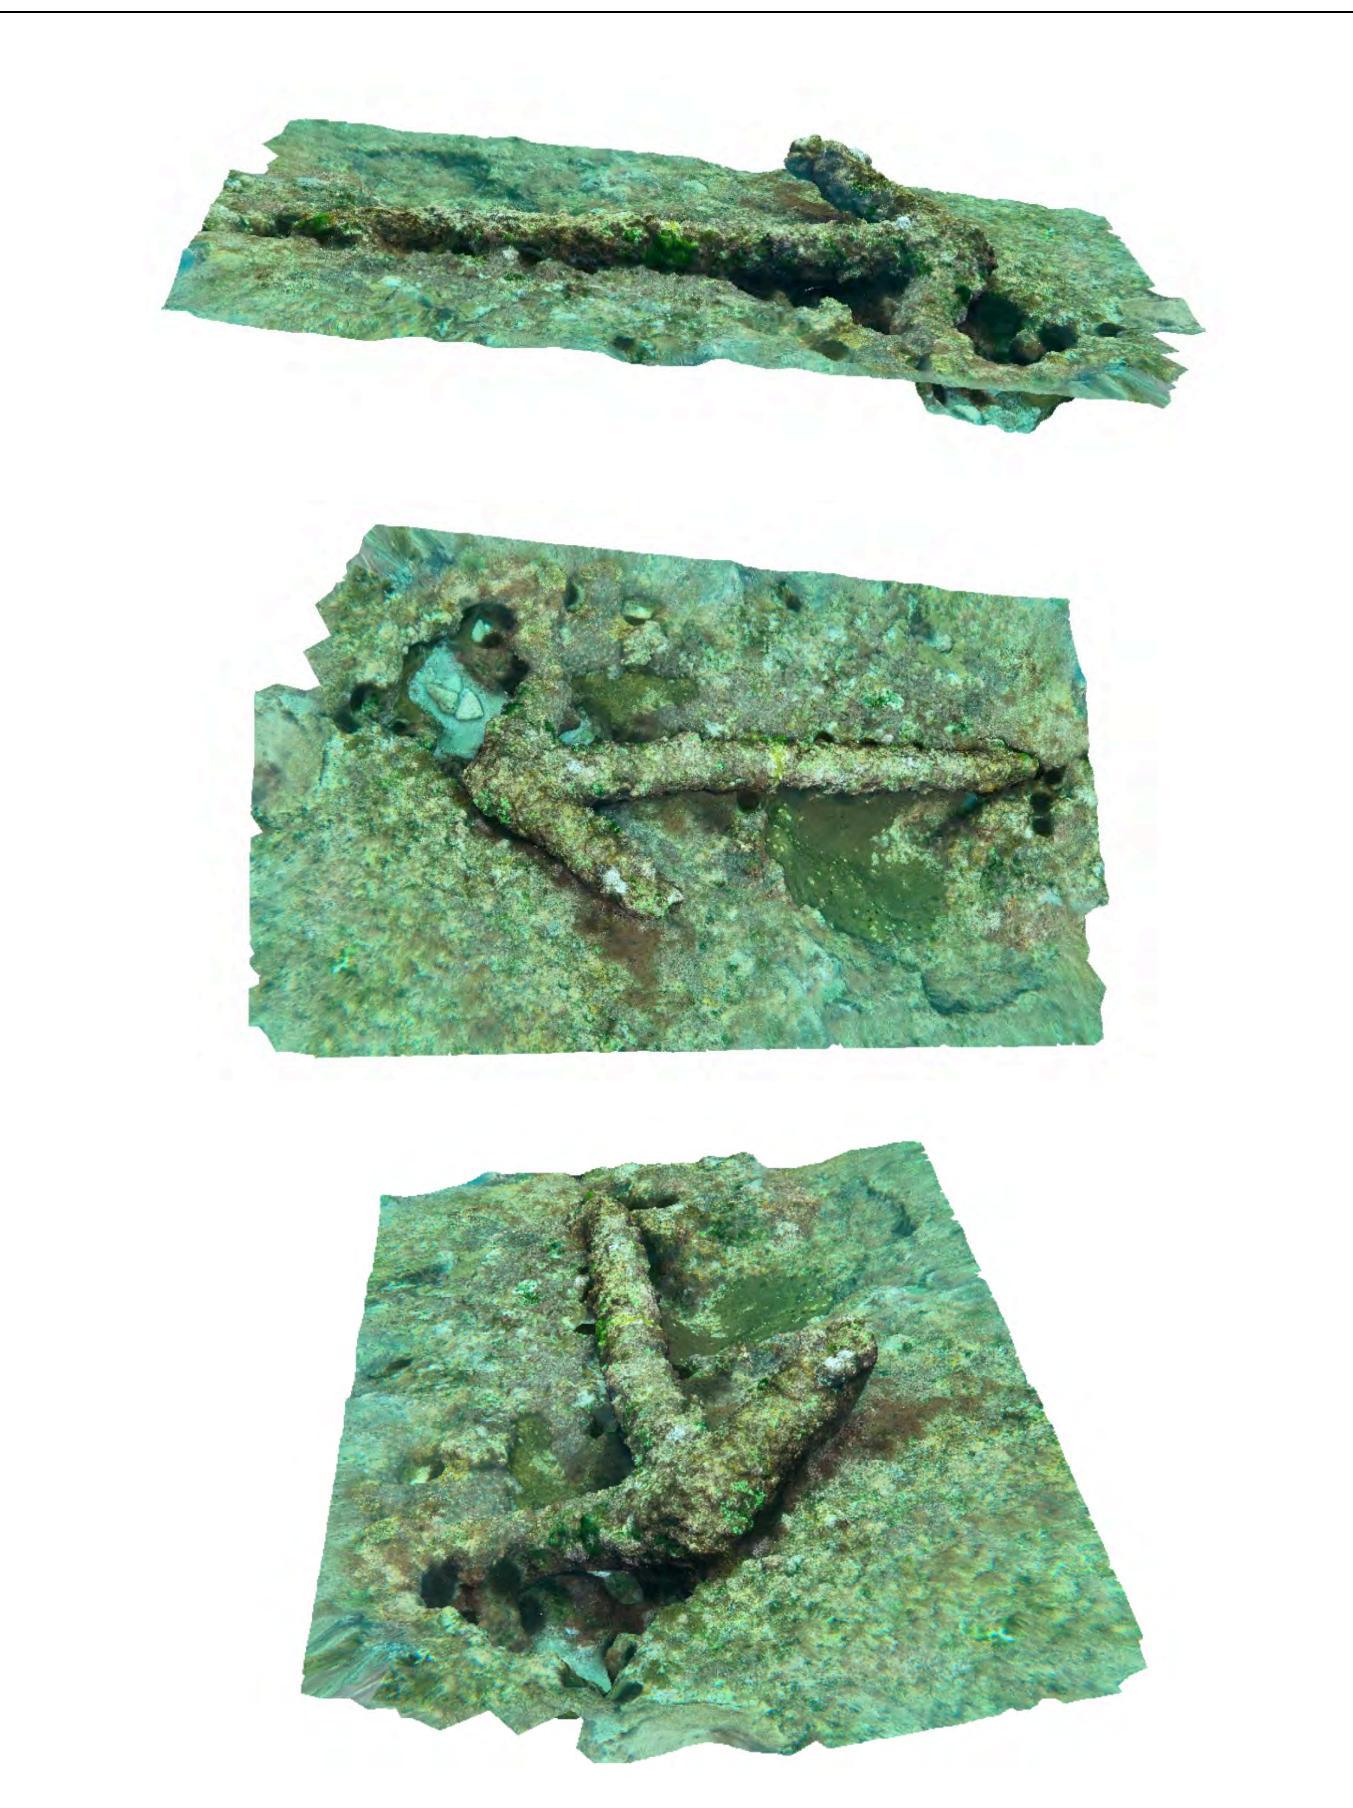
Anchor SI 624 is an old plan style anchor with a broken shank and two broken arms. It is resting on top of a flat section of calcarenite reef with a hole underneath its right arm and a smooth hollow to the left of the shank. Table 14 outlines the stages of the Agisoft Metashape Pro process for this model, while the model is displayed in Figure 137. This anchor works well as a 3D model as it lies flat on the reef and has contrasting gullies and a hole around it. A useful addition to the model would be the addition of a scale. One along the length of the anchor to measure changes in the length, and another scale near the hole at the anchor's crown, to measure changes in the sea urchin activity. However, bearing in mind that conditions on site are not always conducive to good diving conditions, being able to obtain a model using images taken in a 15 minute period is still useful for comparison of condition over time.

*Figure 137: Three views of 3D model of Anchor SI 624.* (Image processed in Agisoft Metshape Pro.)
