# **HMS** Sirius

## Site Inspection Report 2020

Norfolk Island Australian External Territory

March 2021

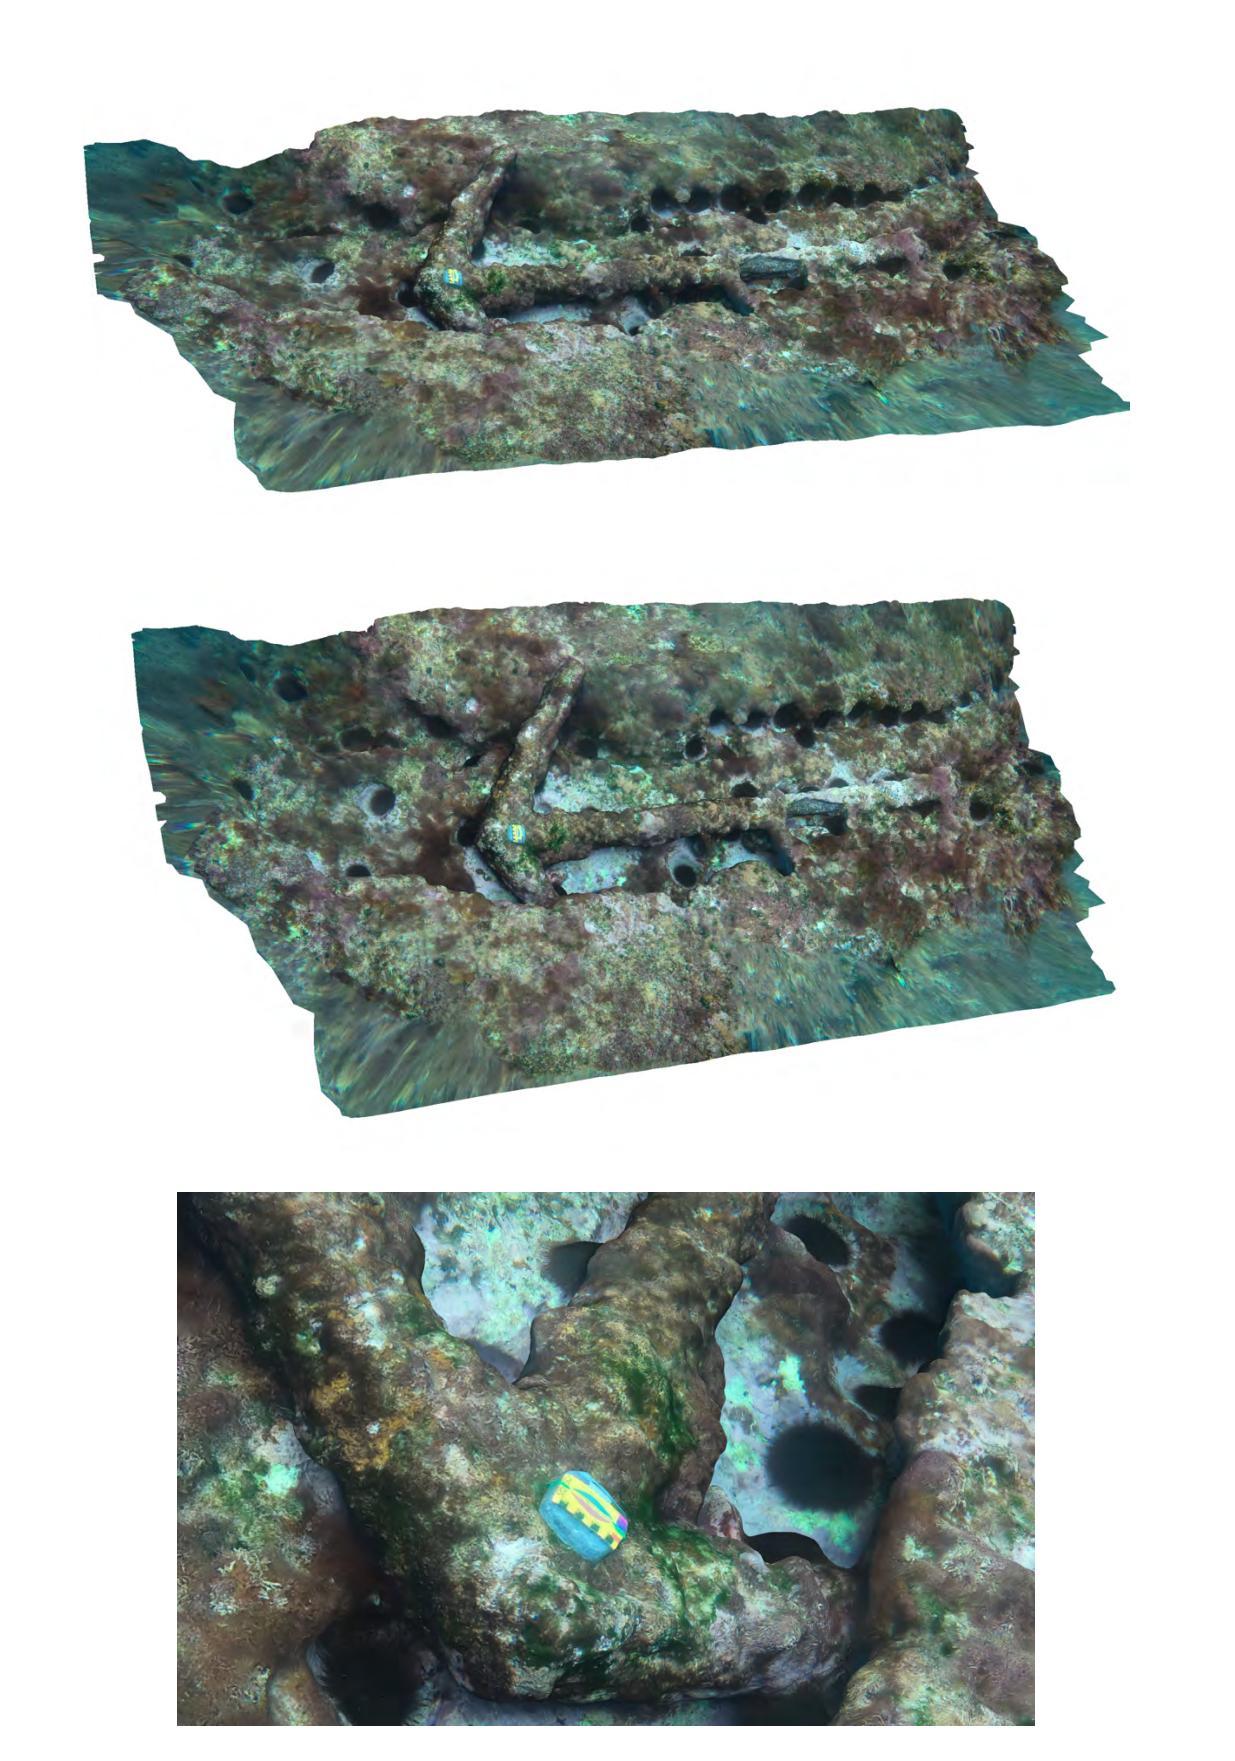
Anchor SI 625 is an old plan anchor which is lying over a crack in the reef platform. It is smaller than SI 624 and rests in an area of higher and longer algae growth.

Table 15 outlines the stages of the Agisoft Metashape Pro process for this model, while the model is displayed in Figure 138. This was the least successful model of the five created as part of this project. It was also the model made from most images. Anchor SI 625 has more algae growth than SI 624, which makes obtaining clear overlapping images difficult as the swell moves the algae into a different position between shots. This accounts for the large amount of blur. This anchor is also shallower than SI 624 and closer to the breaking surf zone so images clear of bubbles can be difficult to take. The model does however, show the area of the shank that has been de-concreted which can be used for comparison purposes in the future. Further work selecting and manipulating the images may assist in improving the output levels.

Figure 138: Three views of Anchor SI 625 3D model.

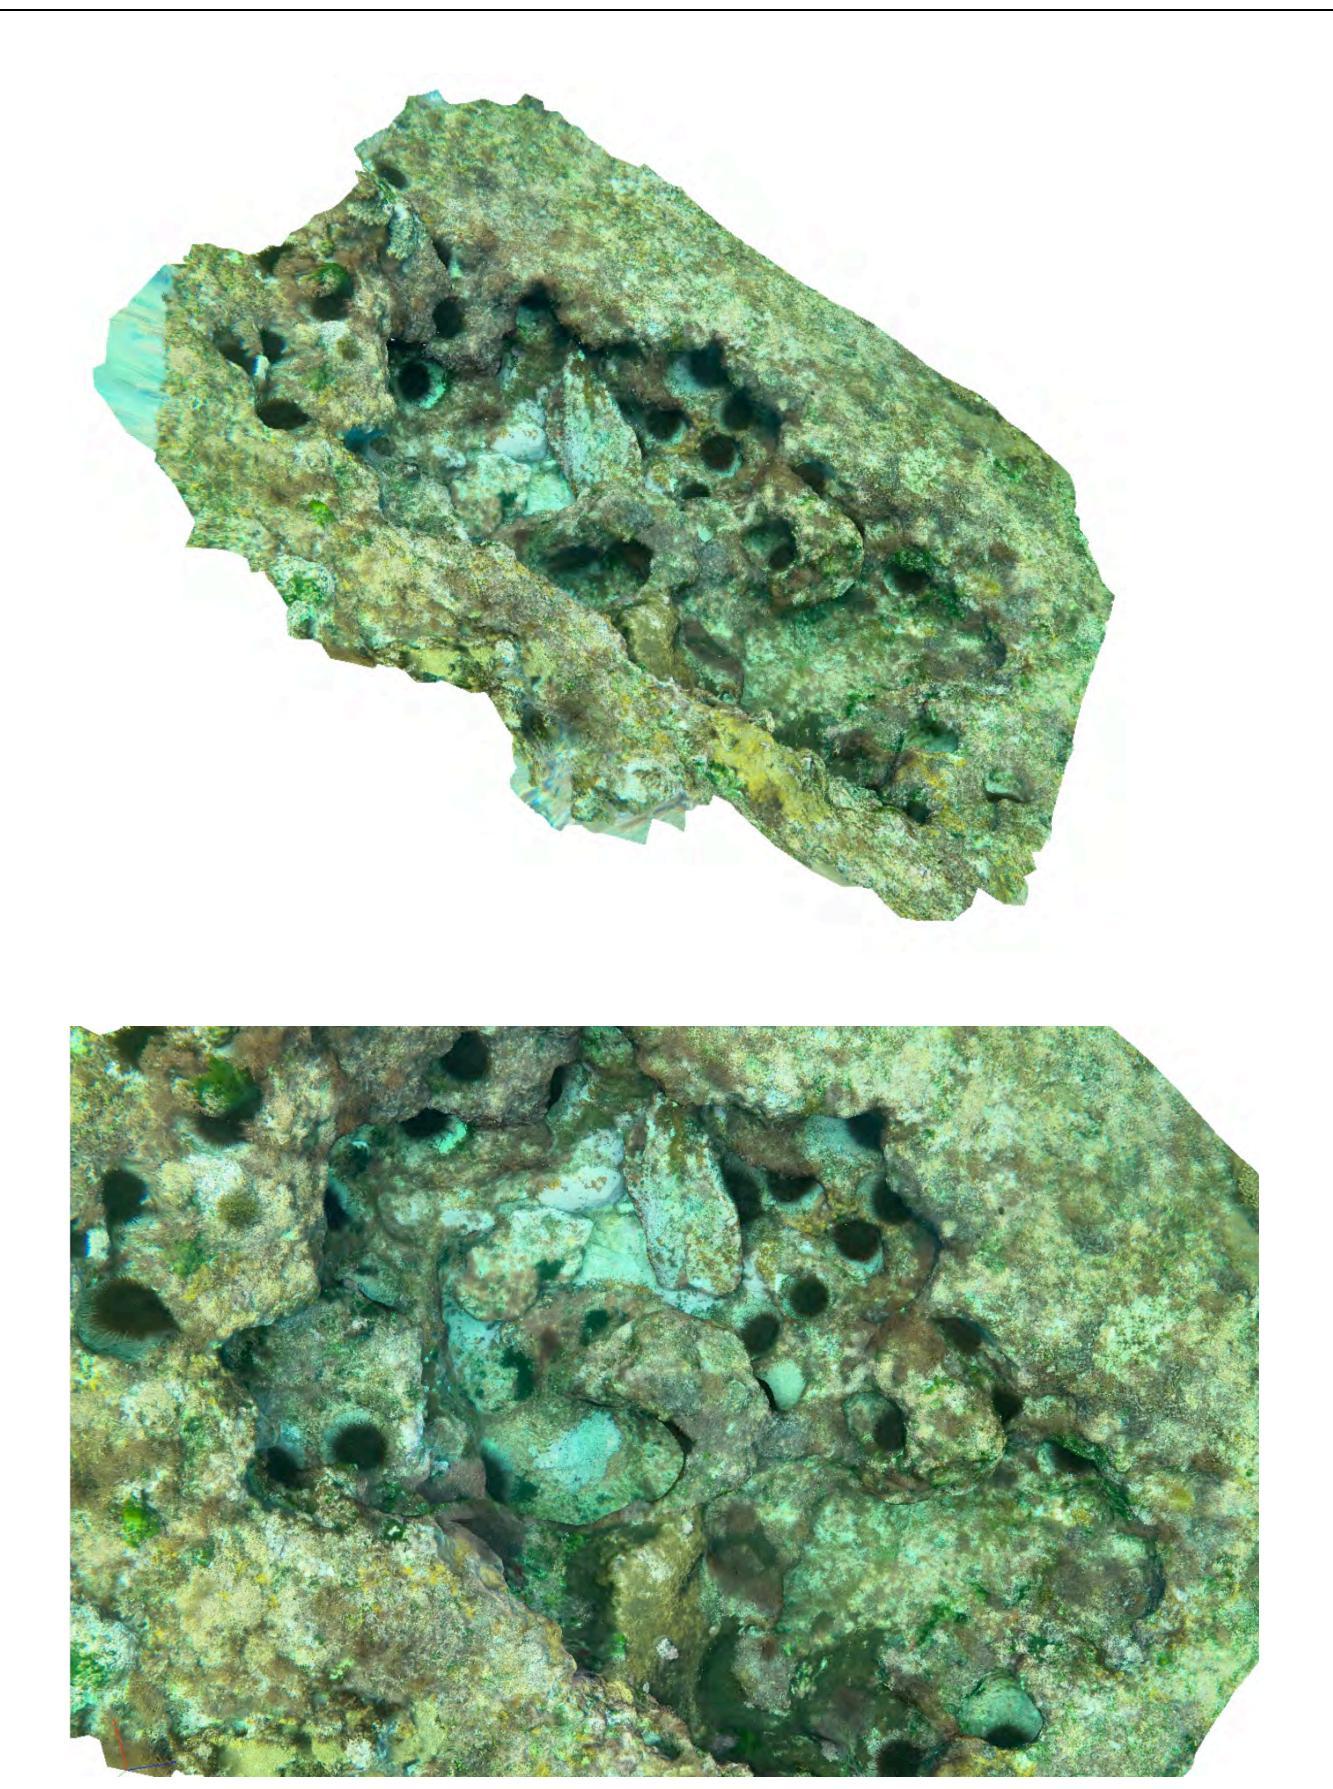
The anchor fluke located in the 'carronade hole' was an unexpected find. It is lying loose within the hole and has a minimum of algae growth as do the internal walls of the hole itself.

Table 16 outlines the stages of the Agisoft Metashape Pro process for this model, while the model is displayed in Figure 139. This 3D model worked well, showing the anchor fluke and the surrounding environment clearly. It could be used as a baseline for future site inspections. The holes created by the sea urchins can be monitored through the creation of future quick 3D models such as this one.

*Figure 139: Two views of the 3D model of the loose anchor fluke in carronade hole.* (Image processed using Agisoft Metashape Pro).

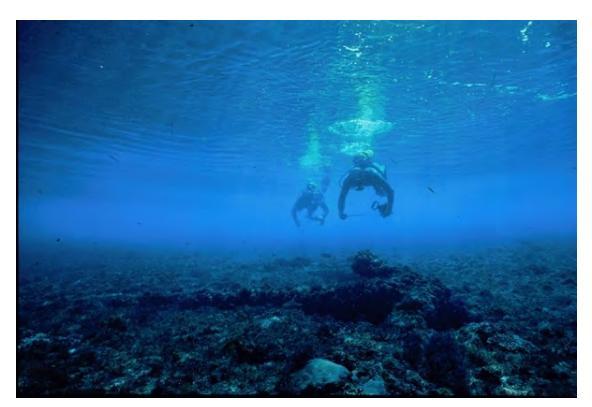
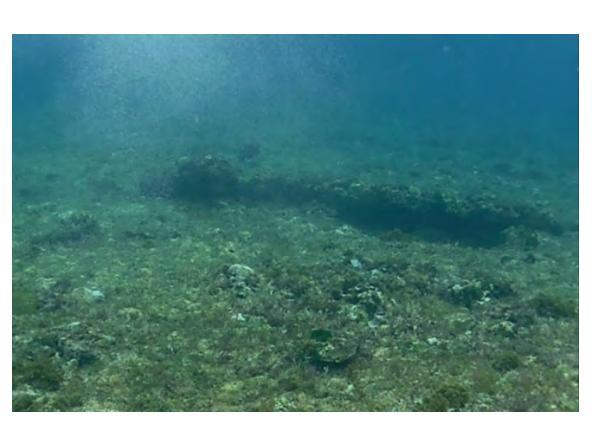
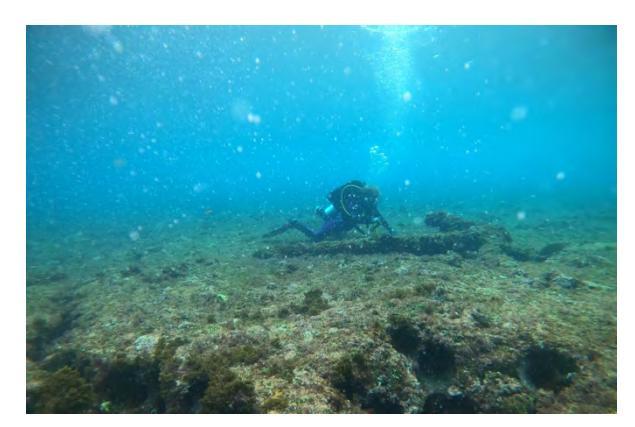
The position and alignment of SI 624 does not appear to have altered since 1985 when it was first photographed. It is difficult to ascertain exact changes when images have not been taken from the same angle and alignment but an approximate assessment can be made. Figure 144 to Figure 146 display the site of Anchor SI 624 from 1985 to 2020. The angle of the raised arm does not not appear to have altered significantly.

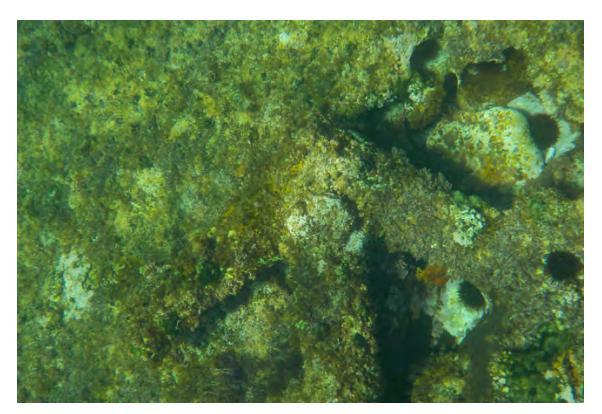
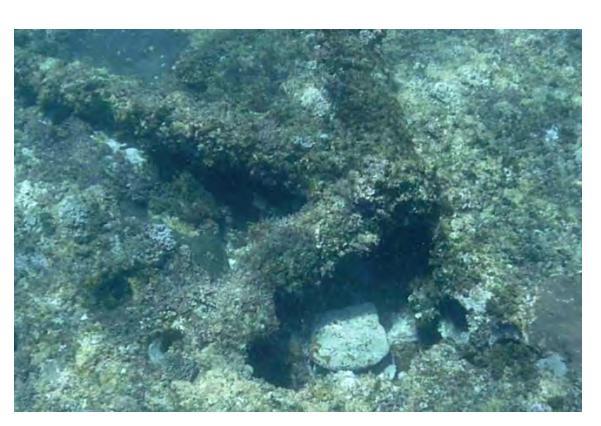
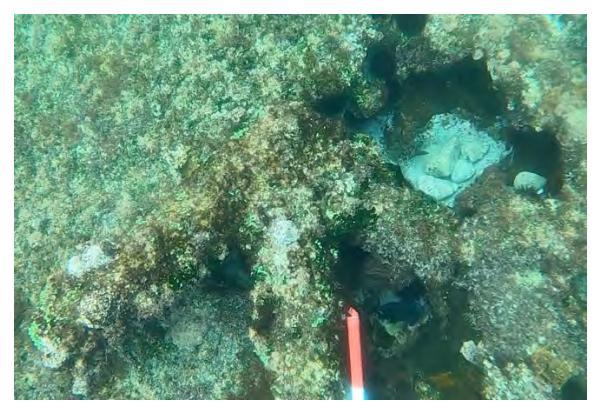
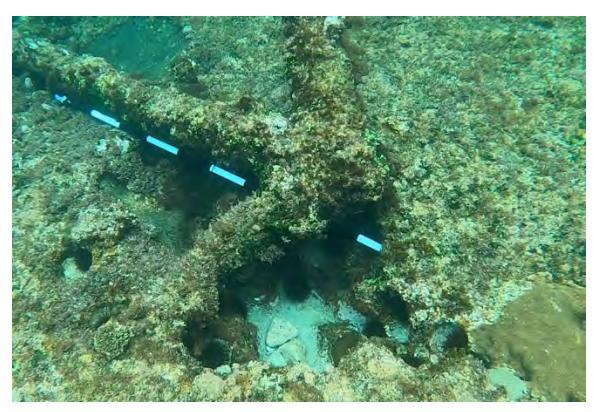
However, the hole under the right arm of anchor SI 624 appears to have become become significantly deeper and wider in the three years since 2017 (Figure 147 to Figure 150). No images from the 1980s expeditions of this section of the anchor have been located at the time of writing this report, so it is unknown if these changes are occurring slowly over time or are accelerating over the past few years. Recurring photogrammetric modelling on subsequent inspections will provide some absolute measurements on the rate of expansion of the hole.

*Figure 147: Anchor SI 624 hole under right fluke October 2017.* (Image courtesy Christian Patteson, 27<sup>th</sup> October 2017).

*Figure 148: Anchor SI 624 hole under right fluke November 2019.* (Image courtesy Christian Patteson, 5<sup>th</sup> November 2019).

*Figure 149: Anchor SI 624 hole under right fluke November 2020.* (Image taken 14<sup>th</sup> November 2020).

*Figure 150: Anchor SI 624 hole under right fluke November 2020.* (Image taken 15<sup>th</sup> November 2020).

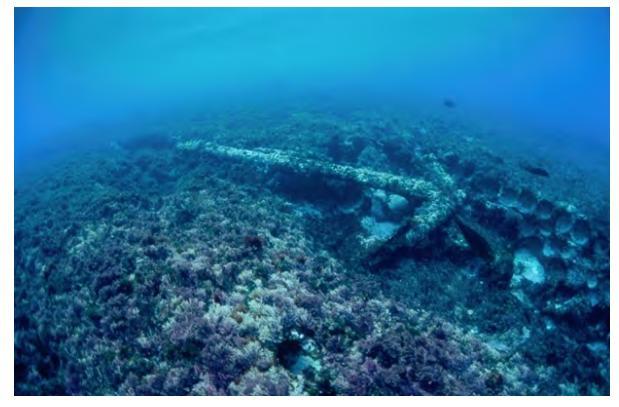
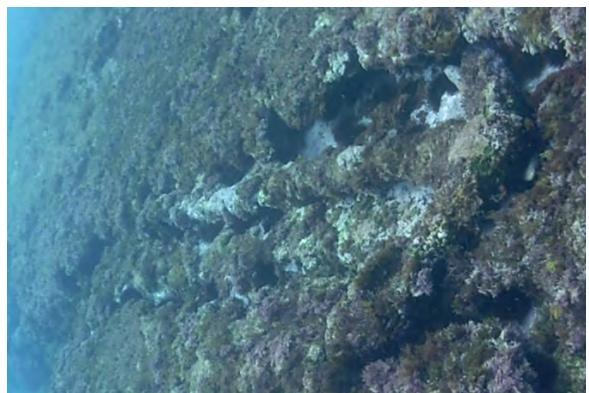
A comparison has been made of SI 625 from its appearance in 1985 to November 2020. The anchor itself appears to have changed very little although perhaps has slightly less concretion as the shank appears thinner recently (Figure 151 to Figure 153). This could be measured during future site inspections to ascertain if this is a trend.

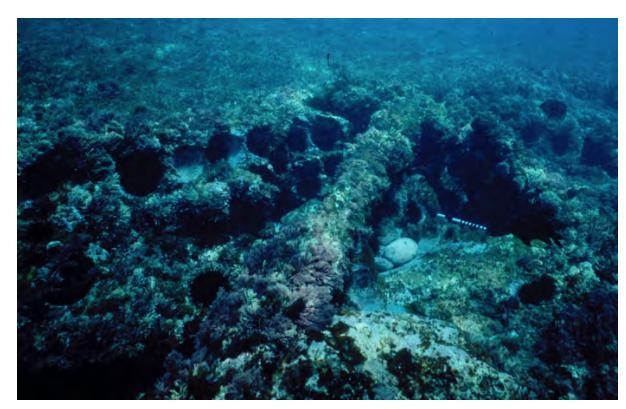
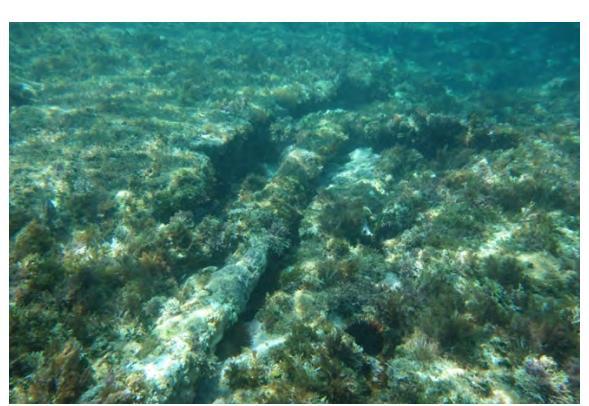
The significant change is not to the anchor itself however, but rather the change in the reef platform underneath and around it. Figure 154 shows the anchor in 1985, where the broken arm rests on top of a ledge and the anchor angles down towards the fluke on the opposite arm. Sea urchin activity is quite prevalent along this ridge line. Figure 155 shows the same anchor, around which the reef platform has changed. The broken arm now rests underneath a much smaller ledge, and the angle of the anchor has changed to almost flat, if not slightly angled the opposite way. There is still sea urchin activity underneath the ledge, although it appears less than in 1985. It appears that sea urchin activity is causing the seabed to collapse underneath the anchor.

*Figure 154: Anchor SI 625 in 1985.* (Image taken by Pat Baker 1984).

*Figure 155: Anchor SI 625 in 2020.* (Image taken 17<sup>th</sup> November 2020).

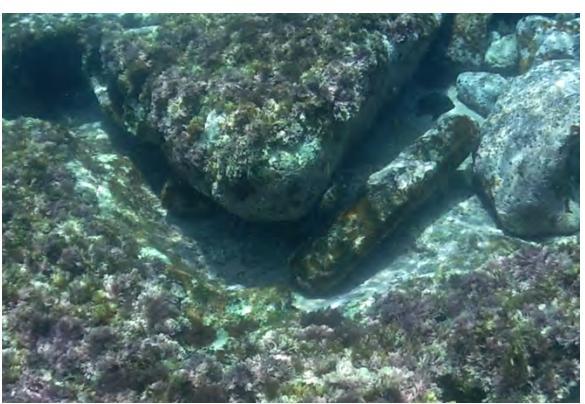
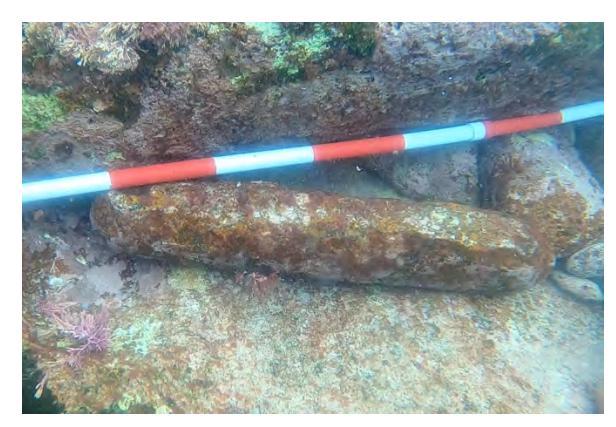
The earliest known images for the de-concreted ballast pig in the gully are from 2017. In 2017, there was still some concretion present over most of the surface, although the ballast iron is beginning to lose its rectangular shape (Figure 156). In 2019, the ballast iron has largely lost the entire protective concretion (Figure 157). In November 2020, there is no concretion left and both ends of the pig iron are obviously eroding away (Figure 158). The seafloor appears to be wearing away from the mechanical action of the ballast pig and forming a depression.

*Figure 157: De-concreted pig in gully in November 2019.* (Image courtesy of Christian Patteson 5<sup>th</sup> November 2019).

*Figure 158: De-concreted pig in gully in November 2020.* (Image taken 14<sup>th</sup> November 2020).

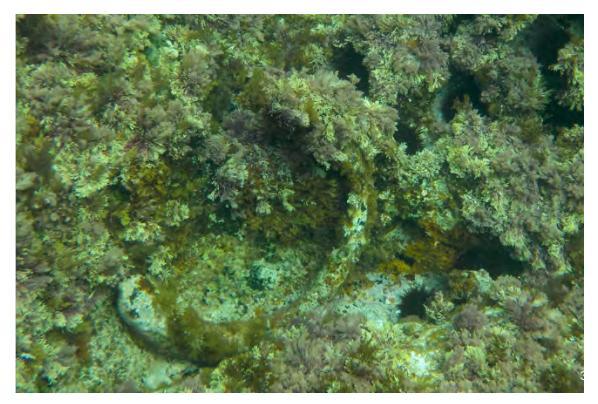
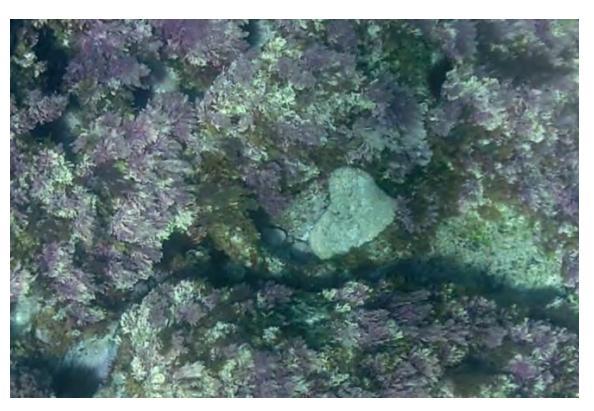
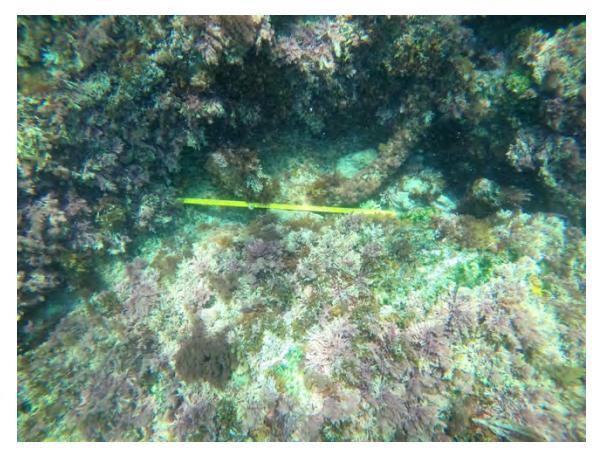
The anchor ring does not appear to have altered in appearance or placement since 2017 (Figure 159 and Figure 160). If anything, the ring appears to have become wedged underneath a shallow ledge in the calcarenite reef (Figure 161).

*Figure 161: Anchor ring in November 2020.* (Image taken 17<sup>th</sup> November 2020).

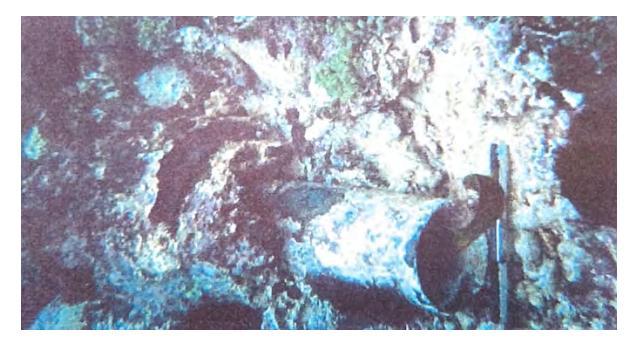
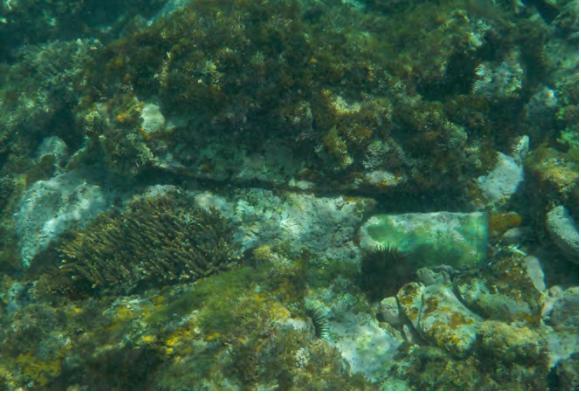
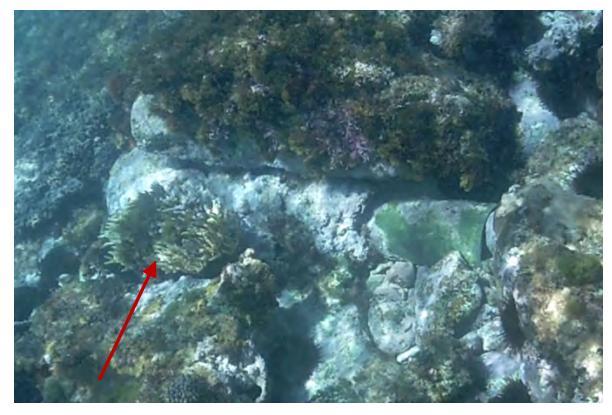
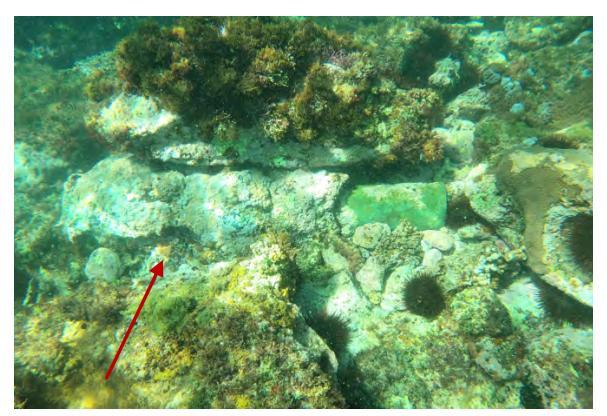
The pump chamber, located in 2002, does not appear to have substantially changed in appearance. There was substantial loss of concretion on the exposed copper alloy section between 2002 and 2017 (Figure 162 and Figure 163). The biggest change between 2019 and 2020 was the loss of some seaweed growth on the eastern end of the pump chamber. This loss reveals a dent in the protective concretion at this end which may prove to be a vulnerable section of the chamber (Figure 164 and Figure 165).

*Figure 164: Pump chamber in November* **2019.** Red arrow indicates algae growth. (Image courtesy of Christian Patteson 5<sup>th</sup> November 2019).

*Figure 165: Pump chamber in November 2020.* Red arrow indicates where algae growth was in 2019. (Image taken 17<sup>th</sup> November 2020).

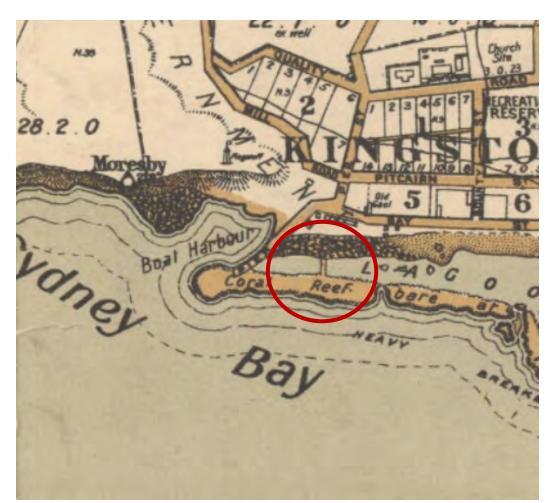
The causeway first appears on official maps in 1900 (Figure 167 and Figure 168). Survey maps are sometimes an uncertain source of information as the items that often appear on these charts will be specific to the needs of the survey, rather than representing everything in the area.

Figure 168: Detail from 1900 survey map highlighting causeway.

It could also have been built for quarrying stone for the buildings of the KAVHA, for salvaging the *Ronaki* wreck or for quarrying stone for Kingston Pier. Further research is required to answer if the causeway is contemporary with the wreck of *HMS* Sirius, as it may equally be significant as a part of the KAVHA.
