Kingston and Arthur's Vale Historic Area Safety Hazard Scoping Study

Department of Infrastructure, Regional Development and Cities

June 2018

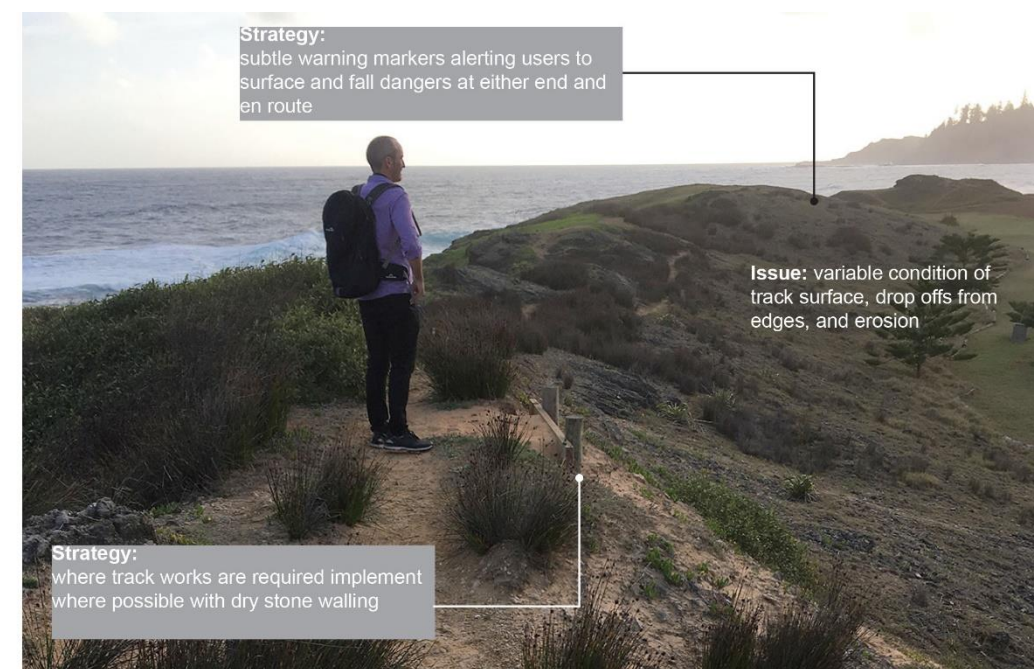
Example of undulating and variable surface on walking route / accessible areas near Emily Bay

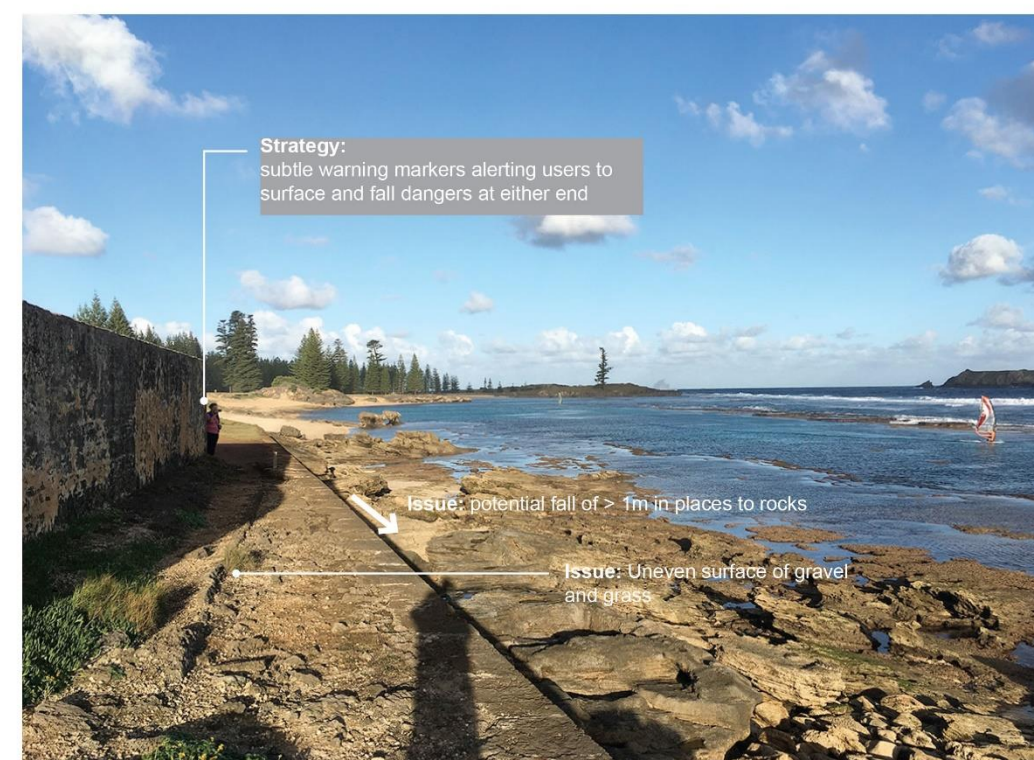
Example of drop off from walking route / accessible areas foreshore near Kingston Pier

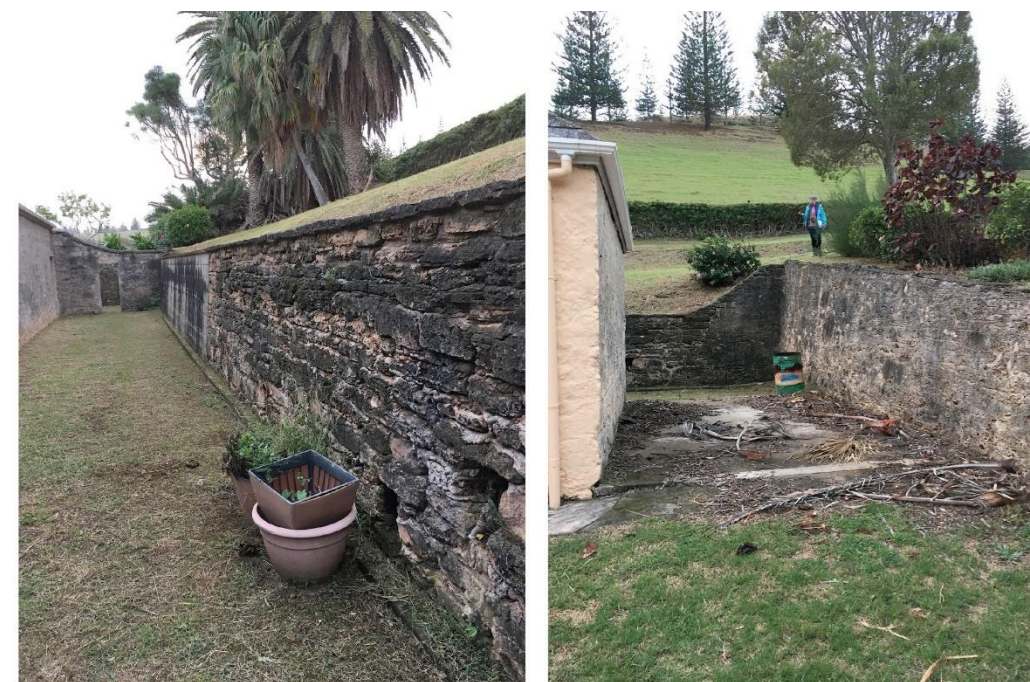
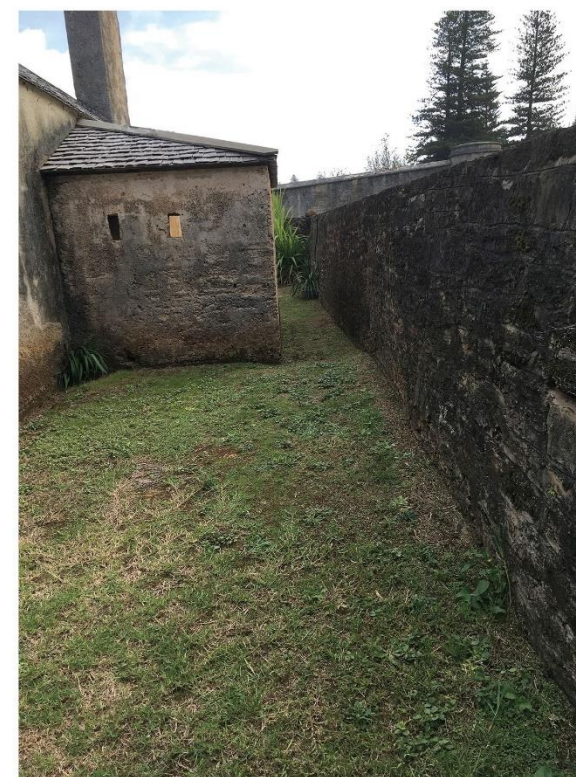
Typical rear wall at No 9 Quality Row

Typical rear wall at No 7 Quality Row

Issues: wall height over 1m - danger of fall from grassed areas above by visitors or during maintenance

Strategy:
Limit visitor access to above wall areas
Provide tieback cleats for safety harness for maintenance staff

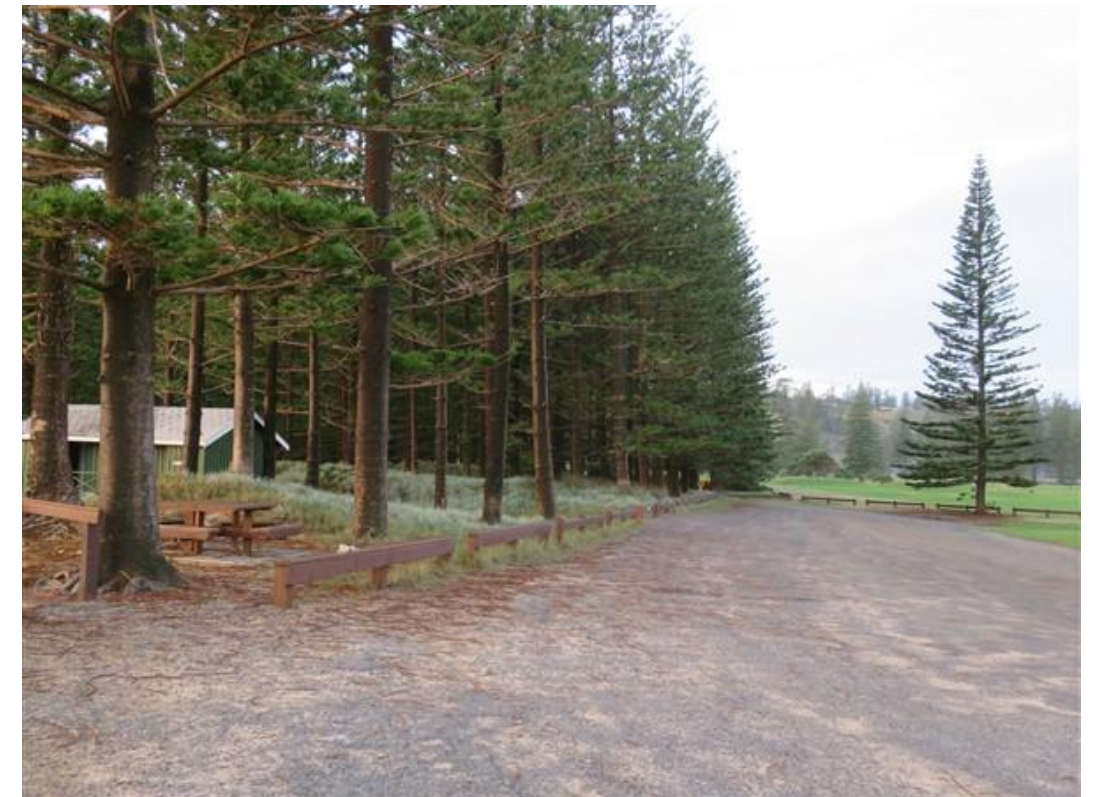
The predominant tree planting within the KAVHA precinct is the Norfolk Island pine. This is a large tree with significant weight which, if limbs or a tree itself should fall, could cause catastrophic injury to anyone below. One of the key concerns raised by members of the KAVHA Advisory Committee and meteorologist, Adam Jauczius, was the potential for trees to become unstable in high winds. In particular, concern was raised regarding those located in the low lying and damp area behind Emily Bay popular for camping. The dropping of pine cones was also noted as a risk in this area.

Norfolk Island Pines in the camping ground

It is necessary for trees in high use areas such as the summer camp grounds, to be regularly inspected to determine if there is visual evidence of problems that would be of concern. In addition, an emergency protocol needs to be put in place during camping use times to facilitate the evacuation of the camp ground when threatening winds are forecast.

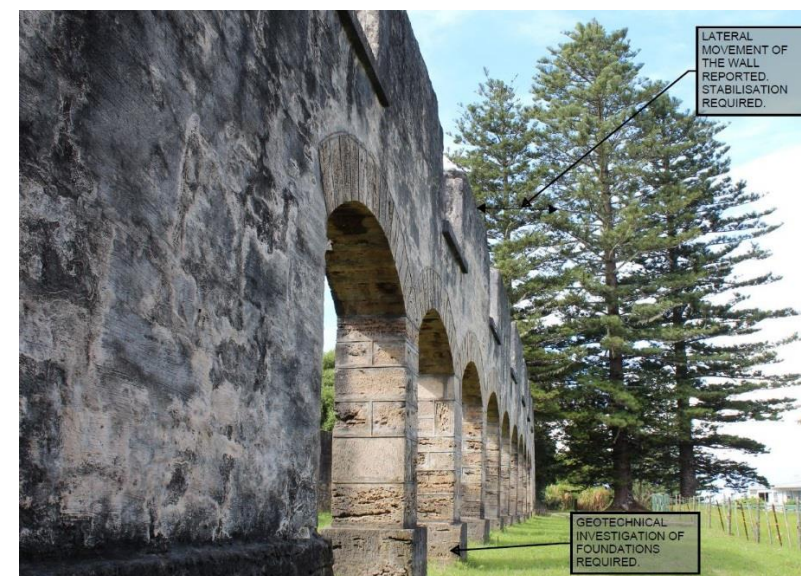
Colonnade walls at Longridge Barracks.

- In the immediate term, cordon off the area to prohibit access to ensure that the risk to public safety from a potential wall collapse is mitigated.
- Resurvey the walls to compare the results of the 2002 report with current conditions.
- Engage a geotechnical engineer to investigate the existing foundations and to provide commentary on the assessed differential foundation movement. Advice on foundation strengthening or underpinning, if deemed appropriate, should be provided in this report.
- Design and construct a steel or timber roof and floor frame to provide additional lateral stability to the colonnade walls. This framing could be designed to mimic the original floor structure and double as heritage interpretation.

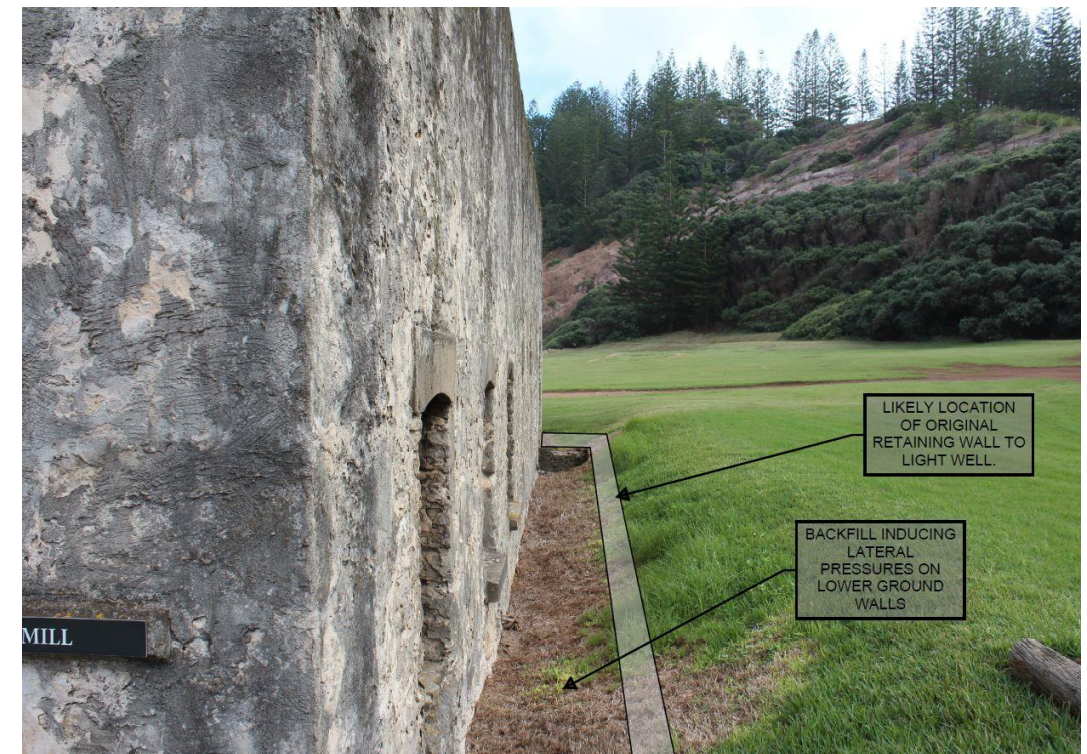
Backfill in light well and location of potential parking.

- Reinstating the original light well surrounding the building to ensure that the lateral earth pressures on the main building walls are removed. By doing this, parking will not be possible immediately adjacent to the building, which will also remove potential surcharge lateral loads.
- Investigate the effectiveness of the bonding between the four perimeter walls. This can be further strengthened if required by drilling horizontal stainless steel rods through the wall junction to provide lateral tying action.
- Construct a capping beam on top of the north and south walls of the building to assist with lateral restraint of the wall.
- Construct a steel or timber roof and floor frame to provide additional lateral stability to the north and south walls and gable ends. This framing could be designed to mimic the original floor structure and double as heritage interpretation.

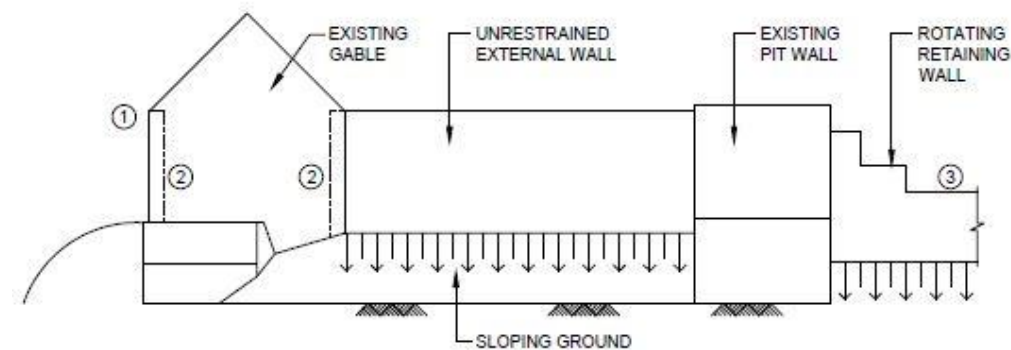
CIVIL HOSPITAL NORTHERN ELEVATION

- Large structural crack on the northern gable at the eastern side of the building. This gable apex is approximately 7m above the natural ground level to the north and has lost its lateral restraint which would have been provided by the original roof structure that is no longer present. This wall is potentially unstable during high wind loads and represents a risk to the public. Refer to 'Location 1' on elevation below.

- Effectiveness of the bonding between the northern gable wall and perimeter walls is unknown. Inadequate bonding between these walls could potentially lead to an exacerbation of the above noted issue of instability. Refer to 'Location 2' on elevation below.

- The retaining walls to the northwest of the Civil Hospital are rotating and leaning towards the north. The walls were measured as being approximately 10 degrees out of plumb and are potentially unstable, representing a risk to the public. Refer to 'Location 3' on elevation below.

- The east to west internal wall is leaning forward towards the north.
- An existing timber lintel has completely decayed, leaving the calcarenite blocks unsupported. Cracking in the render was observed adjacent to this lintel.

- In the short term, limit access to the dangerous areas.
- A full remediation strategy will need to be developed which should include a detailed geotechnical investigation and structural engineering design. The strategy may include underpinning of walls, stitching of cracks and addition of an internal timber or steel frame that reinstates the original roof form to provide lateral stability to the walls.

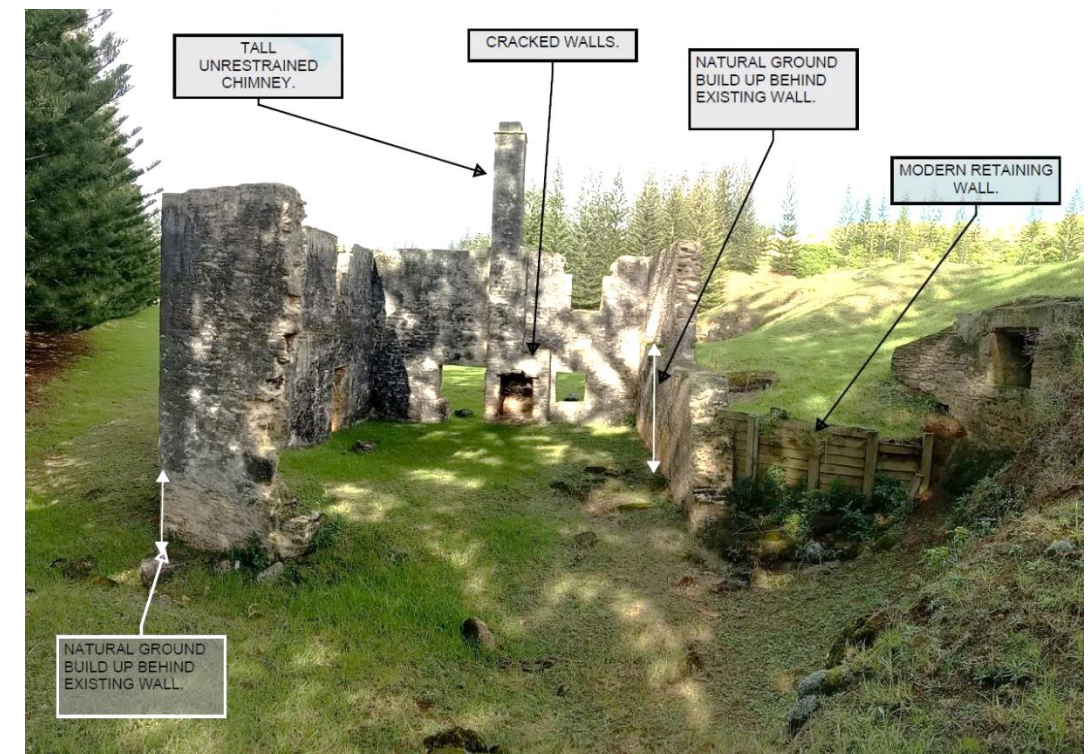
- Effectiveness of bonding between the remaining perimeter walls leading to separation of wall from perpendicular restraining wall.
- Miscellaneous structural cracking on the southern wall adjacent to the chimney indicative of differential movement.

Water Mill Building—looking south.

- In the short term, limit access to the dangerous areas.
- A full remediation strategy will need to be developed which should include a detailed geotechnical investigation and structural engineering design. The strategy may include removal of fill from behind walls, stitching of cracks and addition of an internal timber or steel frame that replicates the original floors and roof form to provide lateral stability to the walls.

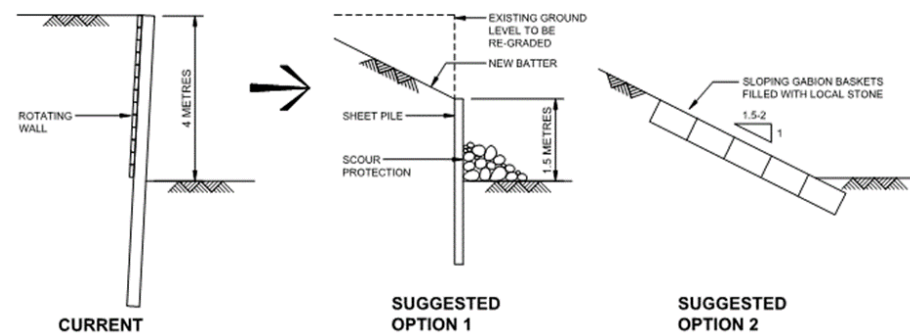
Sea wall replacement strategy—Options 1 and 2.

Another medium-term strategy is to install stone-filled gabion baskets instead of the existing retaining wall. Gabions are wire mesh baskets filled with cobbles or crushed rock. They are filled in situ, often with locally available material, and therefore have a relatively low capital cost. Because they are flexible and porous they can absorb some wave and wind energy, thereby reducing the scour problems associated with impermeable walls such as the existing timber retaining wall. Gabions can be placed as sloping 'mattresses' or as near vertical cubic baskets.

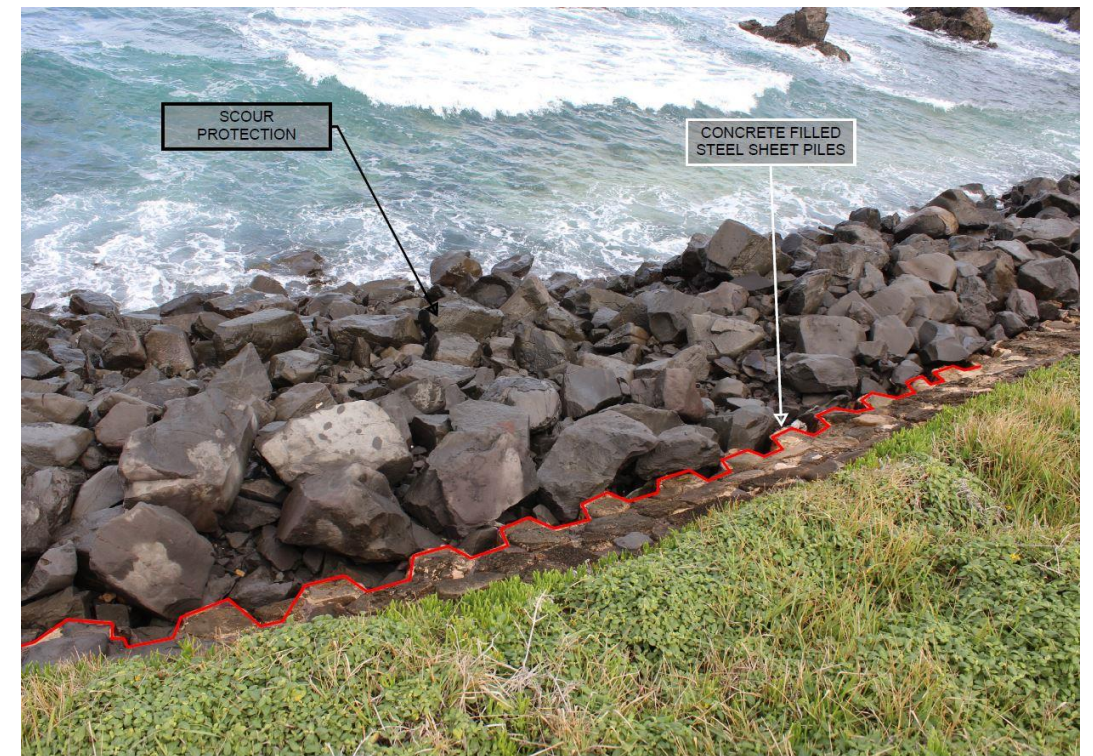
Option 1—Adopt sea wall strategy similar to Pier.

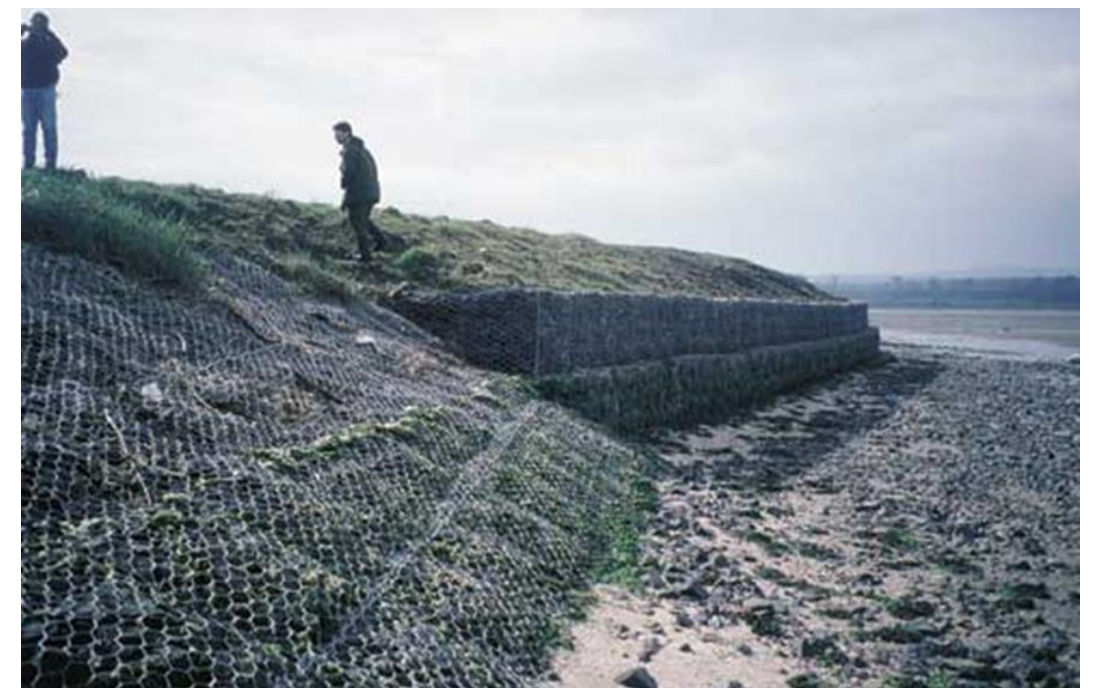
Option 2—Gabion baskets.

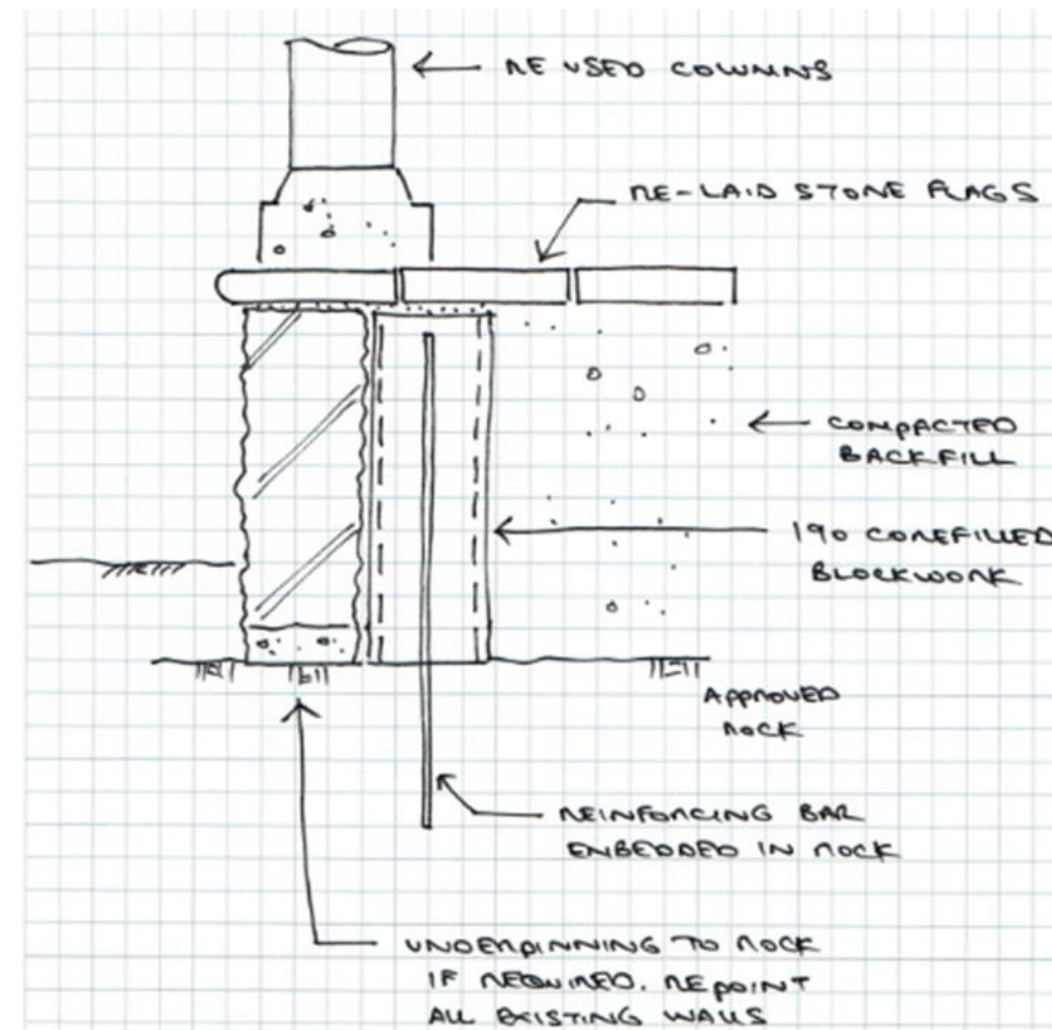
Proposed remediation solution for verandah structure.

It is recommended that the western end of the verandah base structure be rebuilt to ensure that the structural integrity of the roof structure is maintained. The roof is currently relying on failed walls for support, which is unsafe and could potentially lead to structural failure of the roof above the verandah.

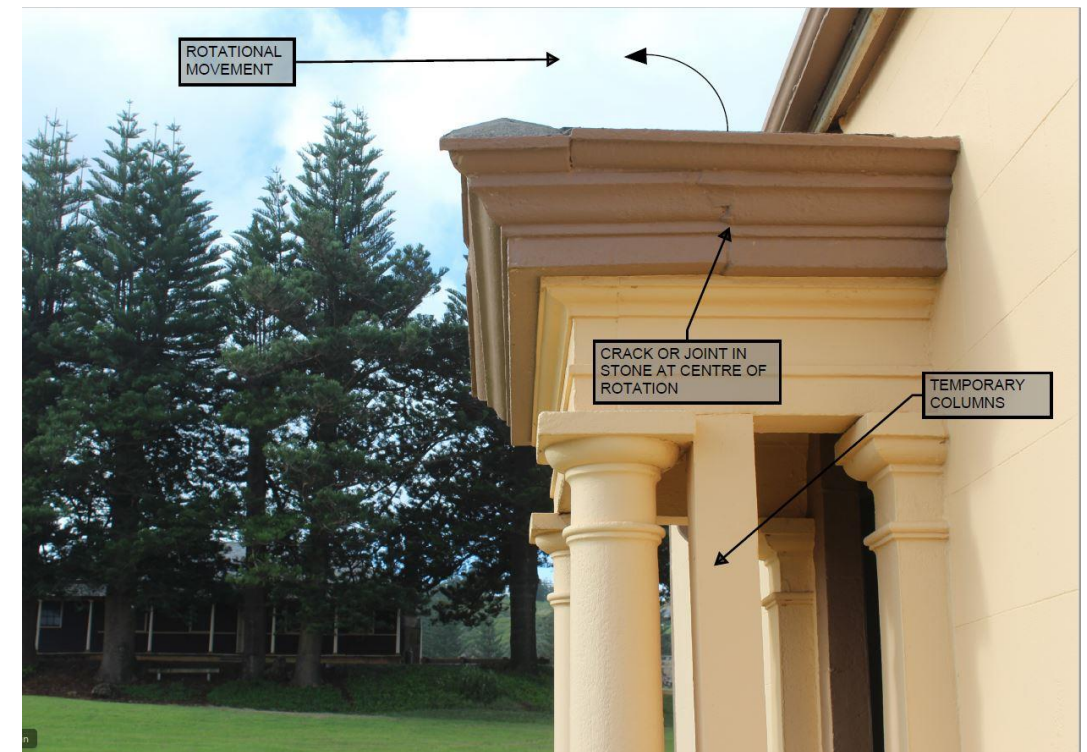
The stone portico above the western entry to the REO Building is displaying signs of structural movement. The portico roof structure appears to have rotated in the westerly direction about the central joint or crack which was visible from the north and south sides of the portico structure. Two timber posts have been installed to the southern corner of the portico by the Works Team as a precautionary measure. It was also noted that the head stock to the capital of the northern stone column has decayed, which may potentially be impacting its ability to support the portico structure. It is not known what interventions have already been undertaken to remediate movement within the structure.

Southern façade of entry portico.

It is recommended that a thorough forensic investigation of the entry portico structure be undertaken to establish how the portico stone elements are constructed and the likely cause of rotational movement, and to determine what is required to ultimately reset the stone work to its original alignment.

It is recommended that the portico be restrained by installation of stainless steel rods that would tie the structure back to the main building façade. It is also recommended that the foundation material under the columns be inspected to ensure that the re-installed stone columns have adequate bearing.

- Confirm whether previous structural interventions have been undertaken.
- Undertake geotechnical investigations to determine condition of foundations.
- Check condition of columns, including bases and capitals.
- Engage structural engineer to inspect portico roof structure and develop remediation strategy. This may include underpinning of columns and/or insertion of stainless steel pins or tie rods.
- As asbestos is present within the roof space of the REO, an asbestos removal program may need to be instituted prior to the works commencing.
- Implement remediation works and allow for replacement of the severely decayed capital on sandstone column. Remove timber propping.

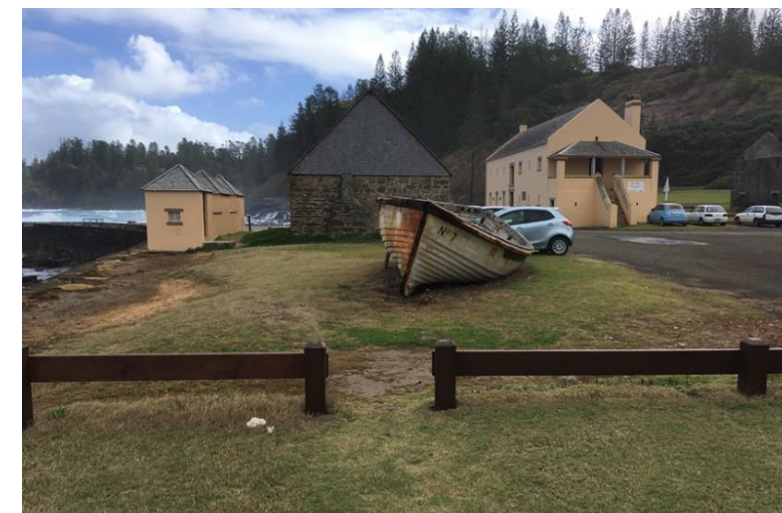
Existing barriers to waterfront grassed zone at Kingston Pier.

To date, there has been a roll-out of oiled low timber barriers to some areas of KAVHA. It would be desirable that this roll-out be continued to individual sites as resourcing allows. Key priority areas would include the areas of Pier and Bay Street. The key steps in the process:

1. Refer to CLMP for areas identified for parking.
2. Determine extent and alignment of barriers proposed—keep vehicles at least 3–5m away from walls of buildings, including sunken areas, archaeological sites and foreshore areas. Ensure there is sufficient space for free movement of pedestrians.
3. Determine proposed surface treatment to parking areas (differentiate from grassed areas where parking should be discouraged) and barrier type to be used, which would depend on location and visual sensitivity (possibly low fence in open areas and log on ground or similar around buildings).
4. Consult with relevant stakeholders to confirm designated parking areas.
5. Implement works.
