# Kingston and Arthurs Vale Safety Hazard Investigations

50% Concept Design Report - Very High Risk Items

Client: Department of Infrastructure, Regional Development and Cities

23-Nov-2018

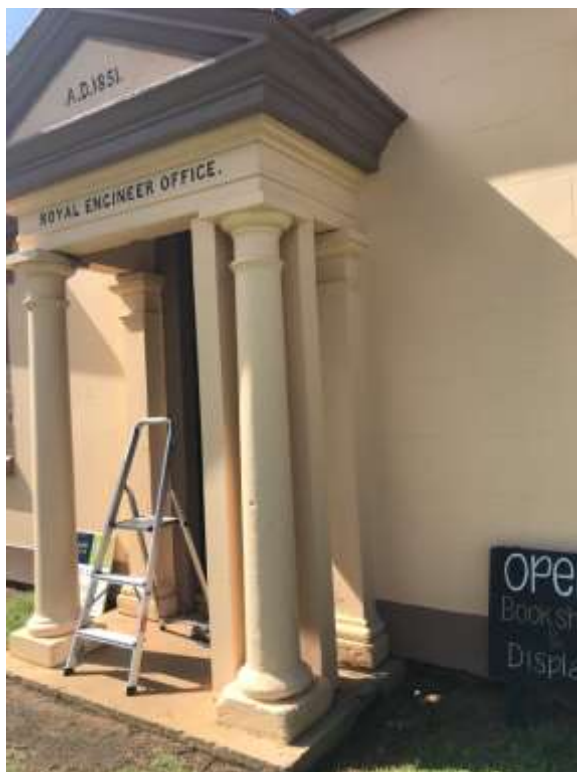
Figure 74 Timber Props on southern column

The main concern structurally was the front Portico to the office. The portico has two timber props inserted beside and behind the southern column at the front of the portico. The southern column was found to have some large grooves which may be cracks; however the extent was indiscernible due to the layers of paint on the column. The northern column appeared to be a new replica column, designed to replace the original heritage column. According to locals, the northern column was destroyed in a car accident and hence was replaced. The column capital and stone base of the northern column showed signs of decay, with the capital being eroded by wind and salt action.

The southern column will require further investigation into the extent of the cracking of the column if the timber props are proposed to be removed. A heritage specialist and archaeologist would need to be present for the stripping of the paint. Once the state of the original column is determined, possible repair to the column could be suggested.

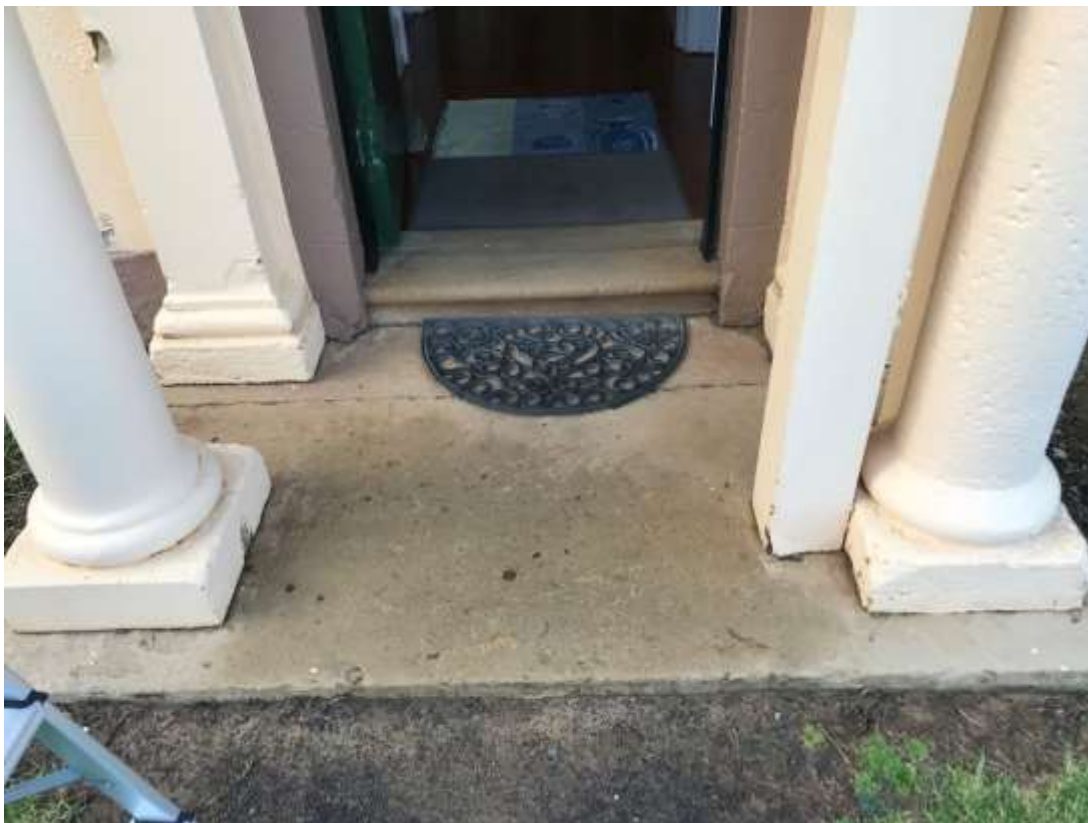
**Figure 81 Base Slab of the Portico**

The roof of the portico appeared to be in good condition although there is a lean to the north of approximately 10 mm in the gable face. The replica column was measured to be slightly longer than that of the original column, which may have contributed to the lean in the top of the portico. There appeared to be some slight decay of the base stone of the portico, but this was minor and there was little to no evidence of settlement of the foundation below the portico.

AECOM have undertaken a visual engineering assessment of the portico and believe that the foundations are adequate and geotechnical investigations are not required.
