# Kingston and Arthurs Vale Safety Hazard Investigations

50% Concept Design Report - Very High Risk Items

Client: Department of Infrastructure, Regional Development and Cities

23-Nov-2018

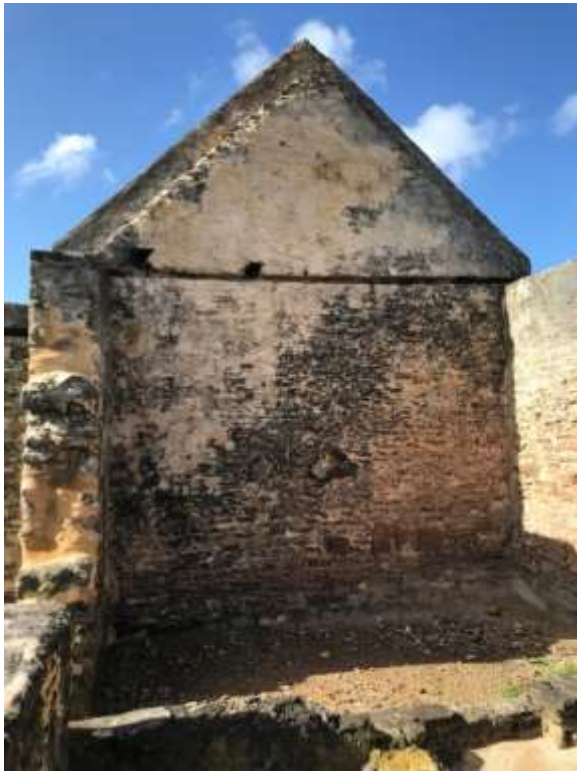
The main building is in a state of ruin, with the entire roof structure missing, leaving the northern gable unrestrained. This is a safety concern as the gable, which is approximately 5 m high, is left free standing and with no restraint the top of the gable. There is a large crack (>3 mm) running along the eastern corner of the interior face of the gable and a crack on the external face of the gable running down the eastern corner of the gable which appears to be separate to the internal crack. It is possible that a stone became loose due to weathering and hence propagated a crack in the mortar. The walls were extensively pointed with cement-based render in the 1960's due to erosion of the existing mortar. The pointing extended to ground level and on the northern side of the building the ground level has been lowered by erosion and cattle grazing which has left the stone base of the wall exposed. Probing of the northern side of the gable below the render line revealed voids, which extend up to 600 mm into the wall.

**Figure 4 Northern gable interior face**

It is recommended that exclusion or temporary support be provided to the gable in the short term and until a permanent solution is constructed.

The recommended solution to repair/rehabilitate the Civil Hospital gable is to restrain the gable wall and hence stabilize the structure. A method for the rectification of the gable is to build a structure behind the gable (to the south) to tie the wall back and prevent it overturning. This process is preferable as it will allow for the preservation of the wall, rather than allowing for it to collapse and destroy more of the heritage site. The Civil Hospital will be required to be closed for a period while the construction of the stabilising structure is taking place. It would be best to align the construction with a season of smaller tourism to minimise the impact this closure will have on tourist and guided tours.

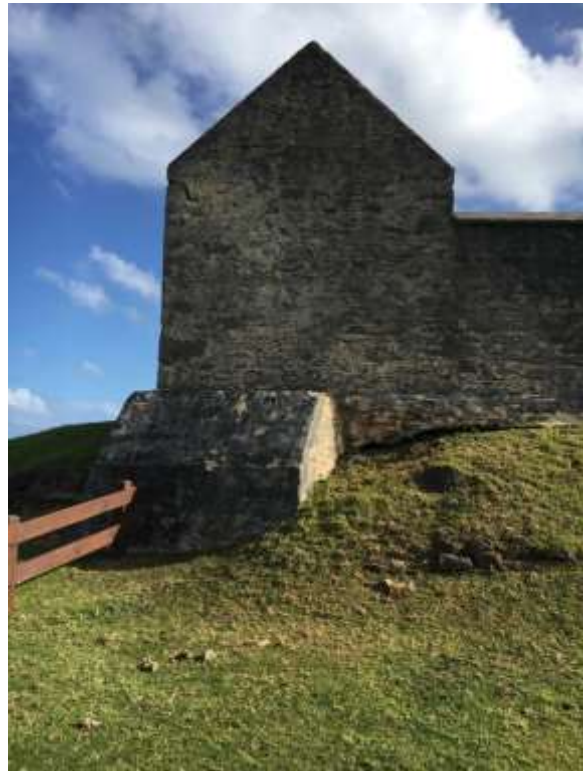
**Figure 5 Northern gable exterior face**

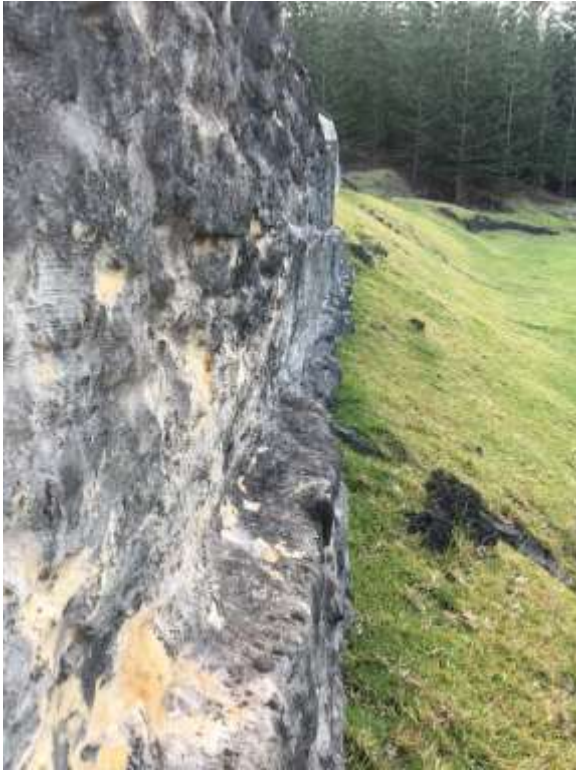
**Figure 13 Exterior step out of retaining wall base**

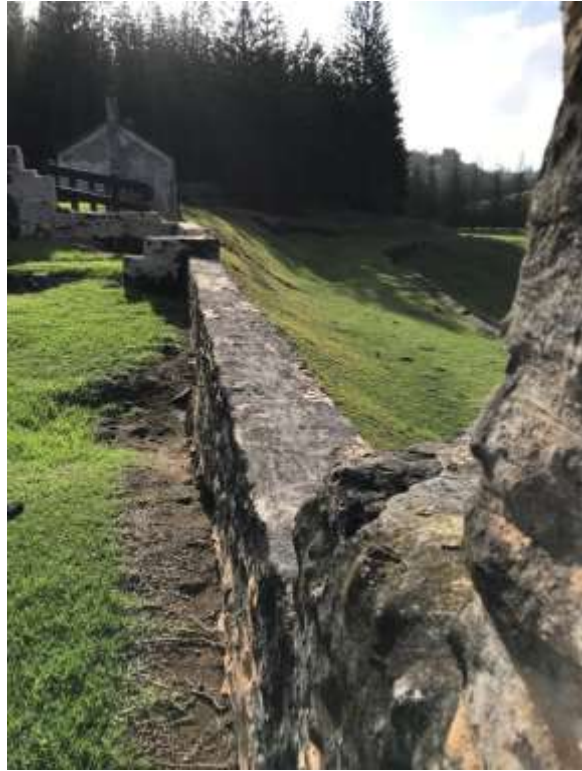
**Figure 14 Interior of the top of the retaining wall**

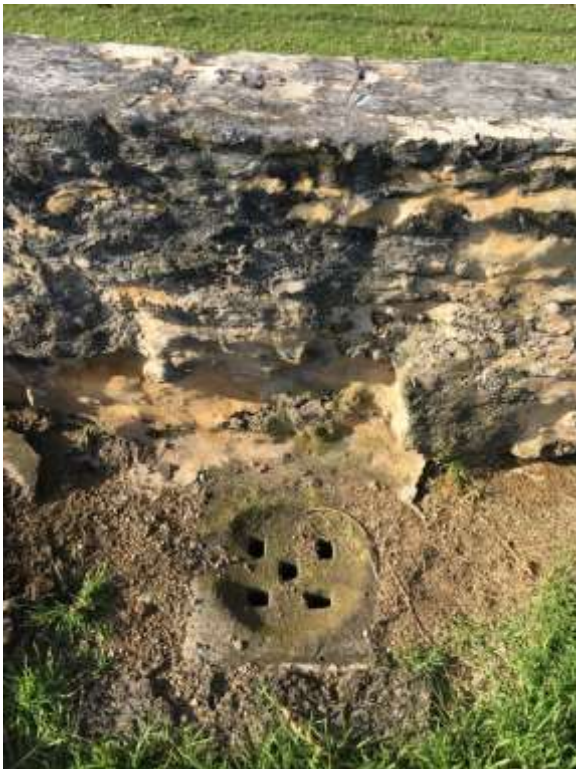
**Figure 15 Drain below the retaining wall**

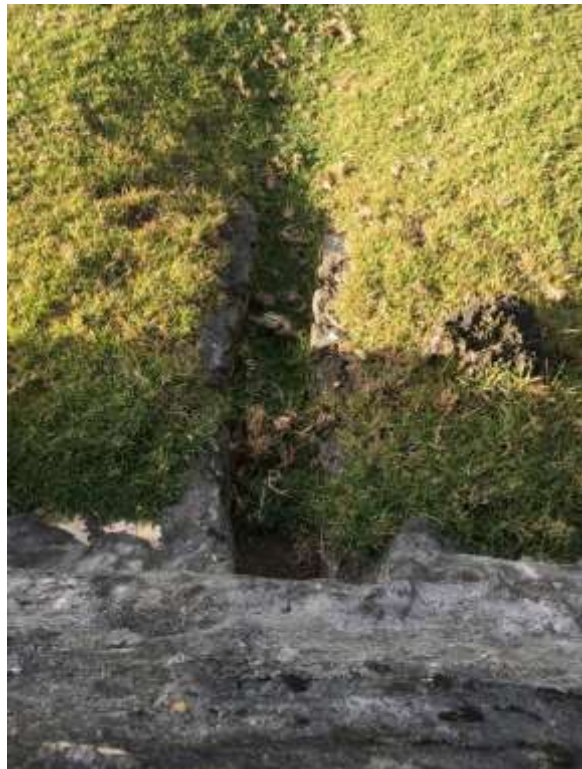
**Figure 16 Drain run out below the retaining wall**

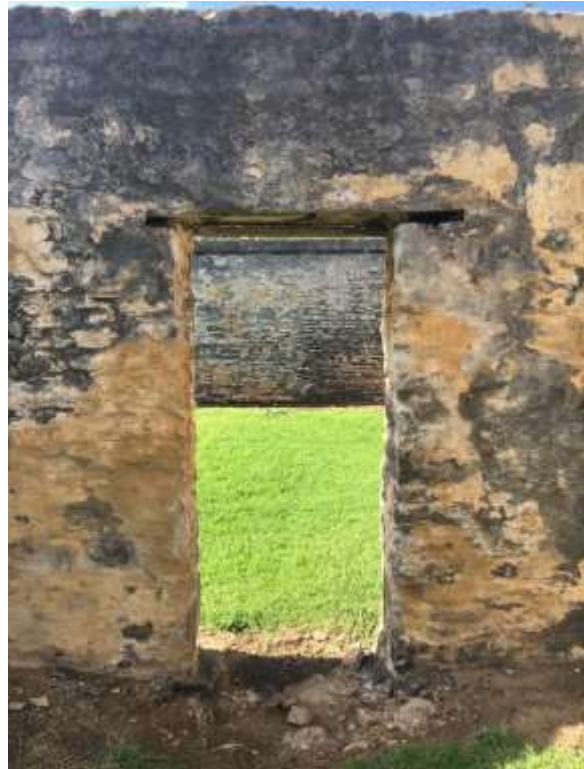
One of the doorways to the southern side of the Civil Hospital is missing a timber lintel to the southern face of the doorway. The timber lintel on the northern side was present but appeared to be in a state of decay and completely detached from the top of the doorframe. The doorframe, which is constructed of calcarenite stone, did not show any sign of vertical sagging over the opening and showed no sign of negative impact from the lack of support from the lintel. There are cracks present to the side of the doorframe, which may have propagated from the lintel notch in the wall however, they appeared to be minor with no damage to the integrity of the stonework.

**Figure 19 Southern face of doorframe**

The timber lintel should be replaced with a new section of timber which is in keeping with the species, size, form, shape and appearance of the original fabric (see HMP Policy 8.3.1, 8.3.2, 8.3.3). Unsympathetic timbers, such as treated pine, should be avoided and removed where possible (Figure 25) (see HMP Policy 8.3.1). If treatments are required for the longevity of the timber, options should be investigated to ensure minimal visual or physical impact on the original fabric.

Any lintel that is showing excessive signs of decay or is not bearing hard against the stone work along its upper surface or at each end should also be replaced as per above.

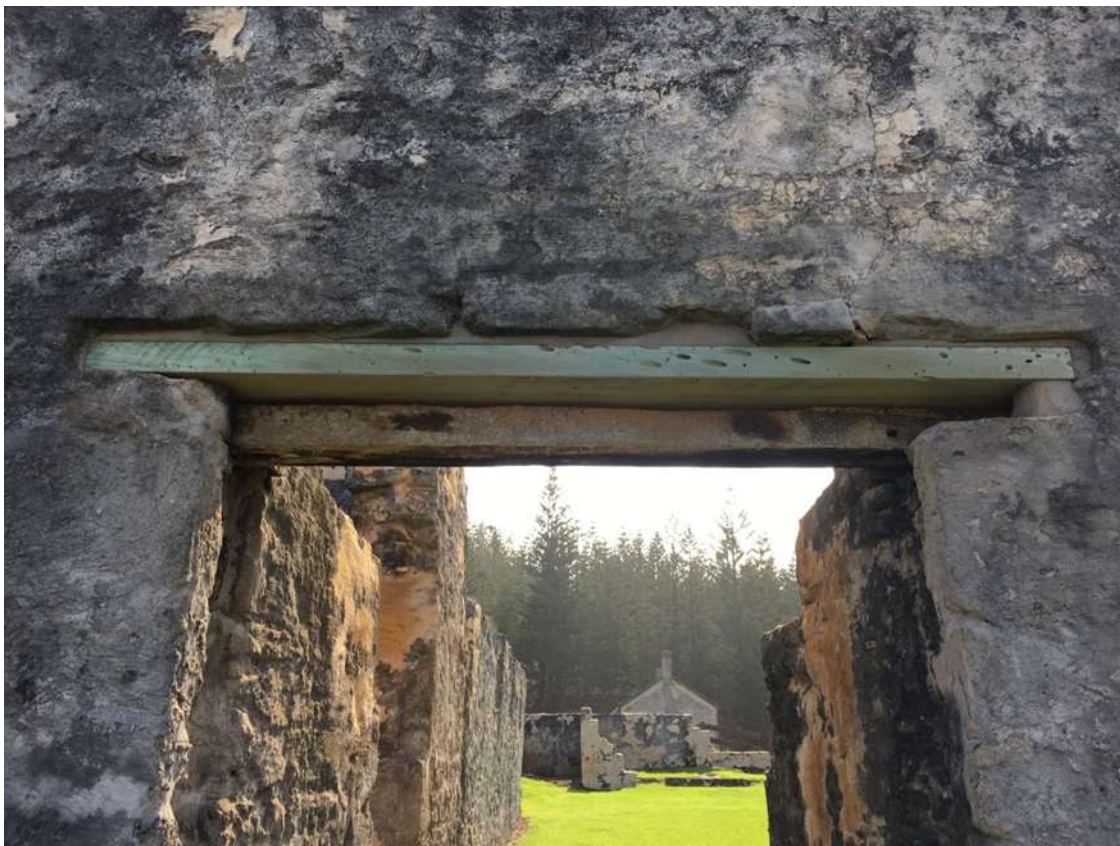
Figure 25 Replaced timber lintel on eastern entrance into the Civil Hospital

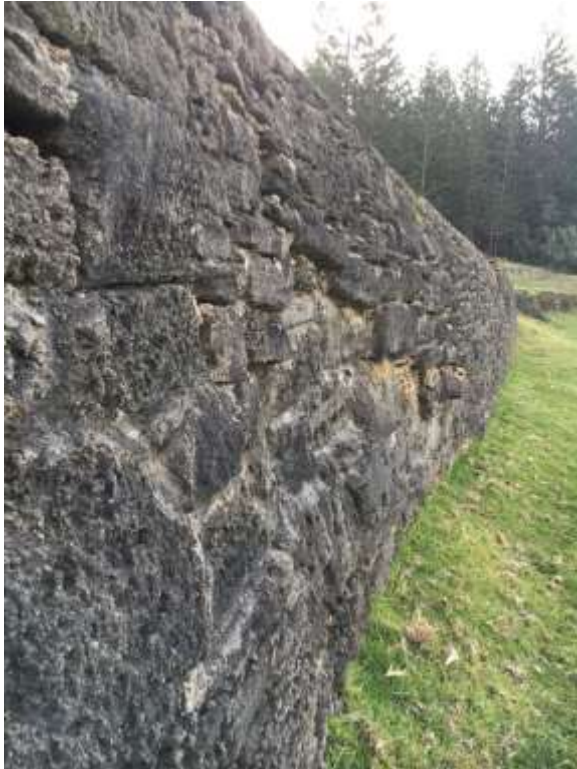
**Figure 28 Bulging of retaining wall**

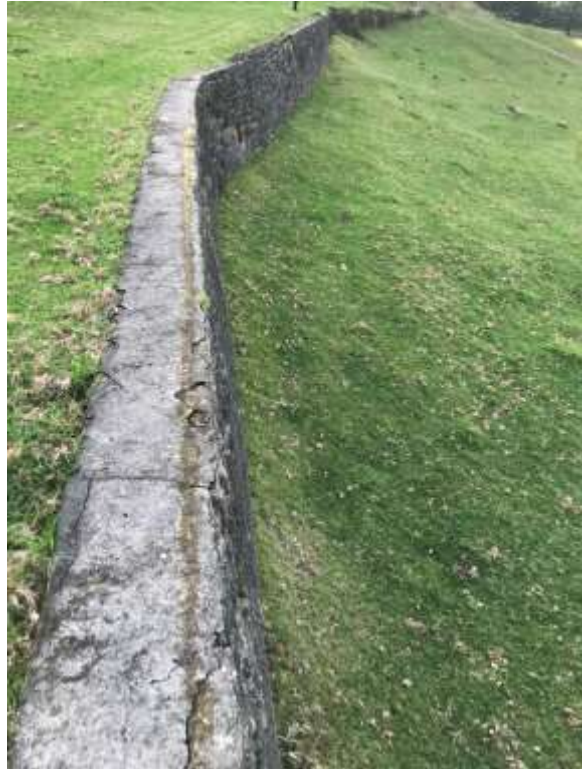
**Figure 29 Bulging of retaining wall**

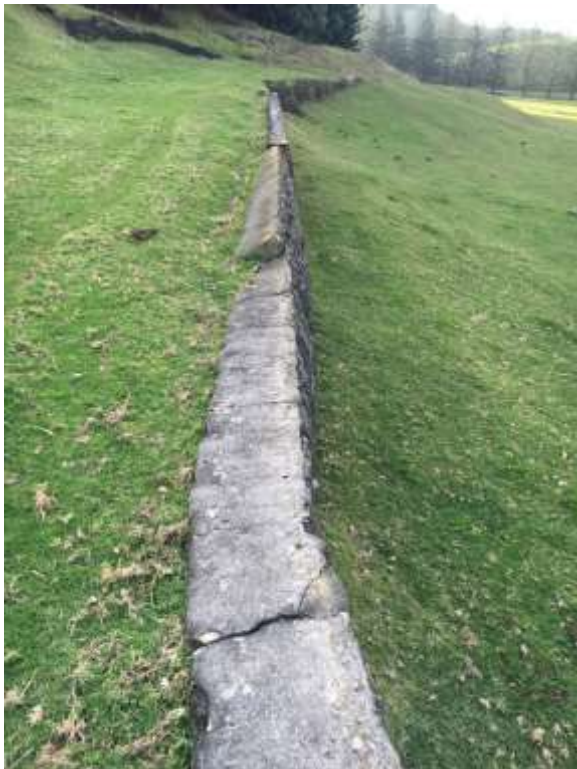
**Figure 30 Rotation of the top of the wall**

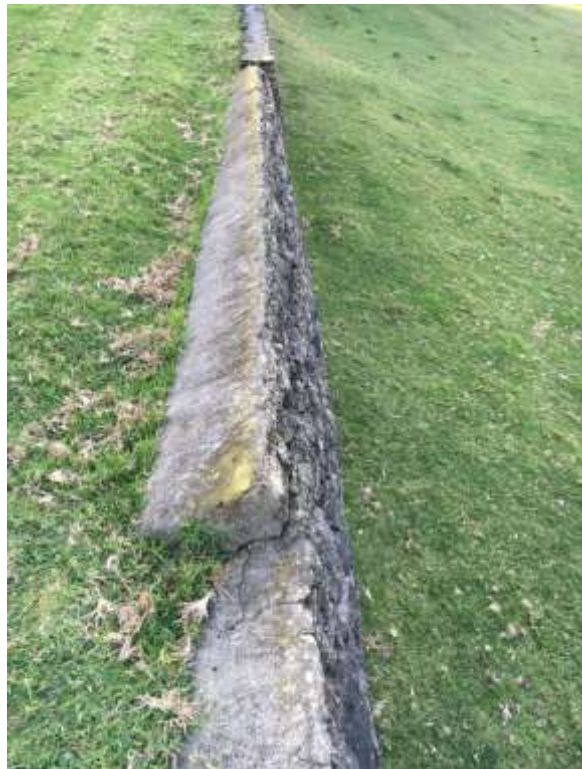
**Figure 31 Collapse of top of wall back on itself**

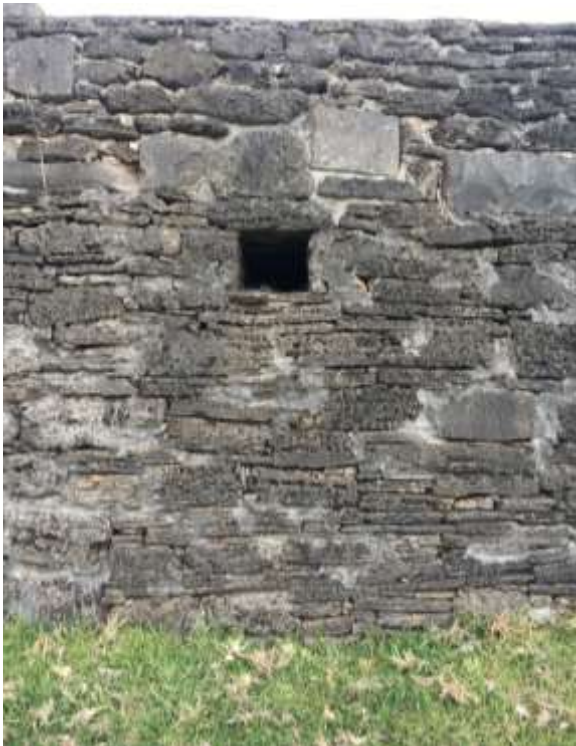
Figure 33 Drain 1 external view

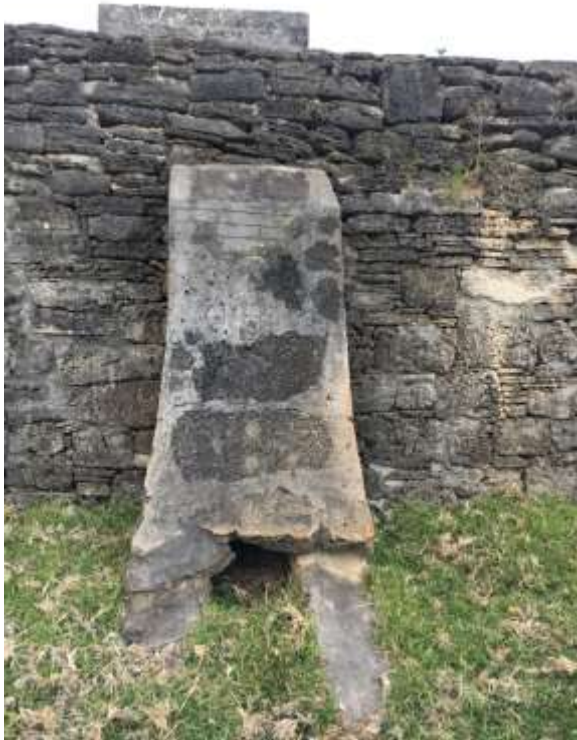
**Figure 35 Drain 2**

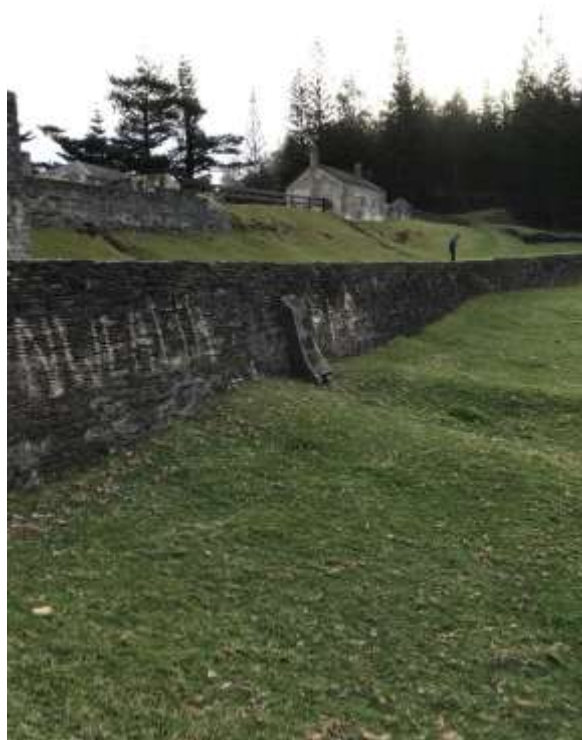
**Figure 36 Drain 2 aligned with drain in the hospital**

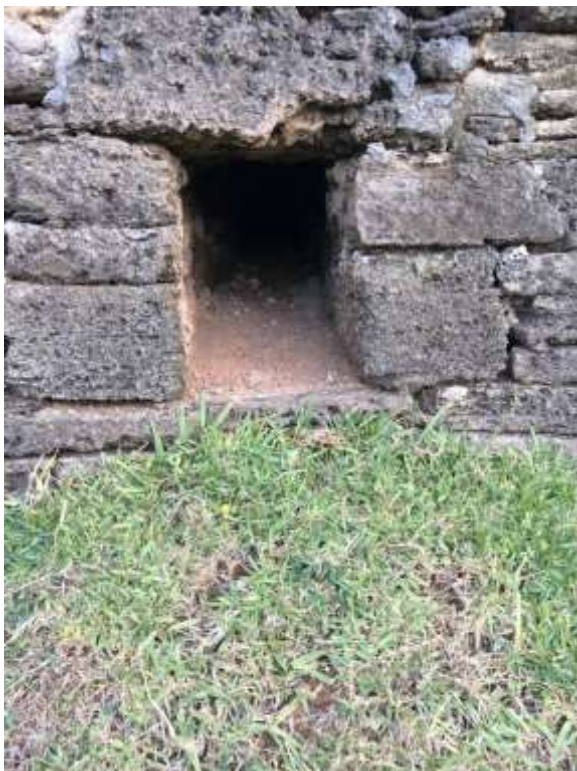
**Figure 37 Drain 3**

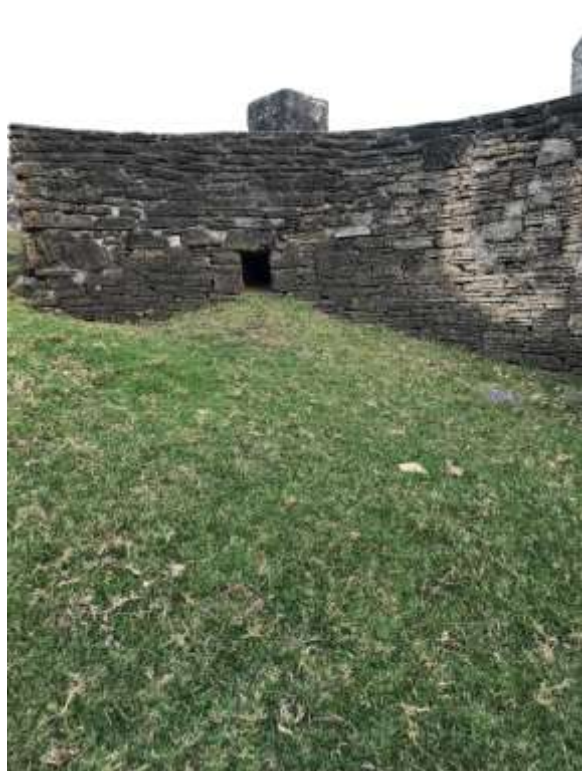
**Figure 38 Drain 3 location**

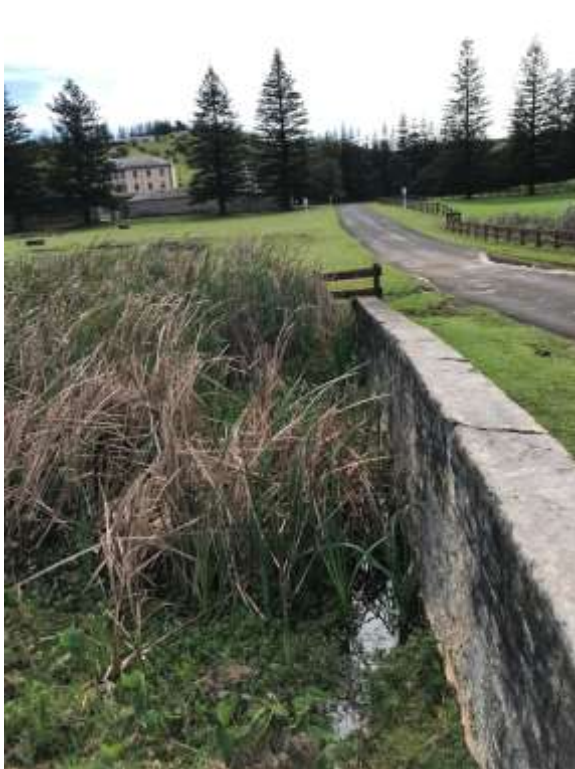
**Figure 48 Western side of the bridge**

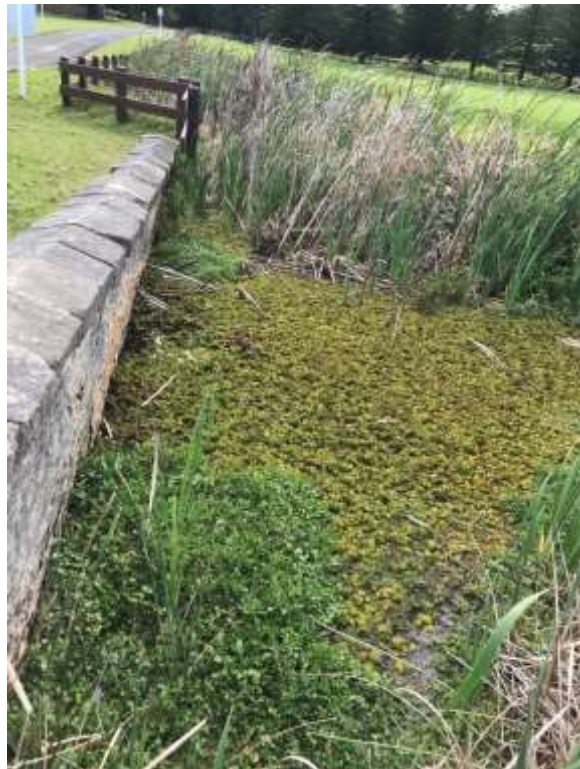
**Figure 49 Eastern side of the bridge**

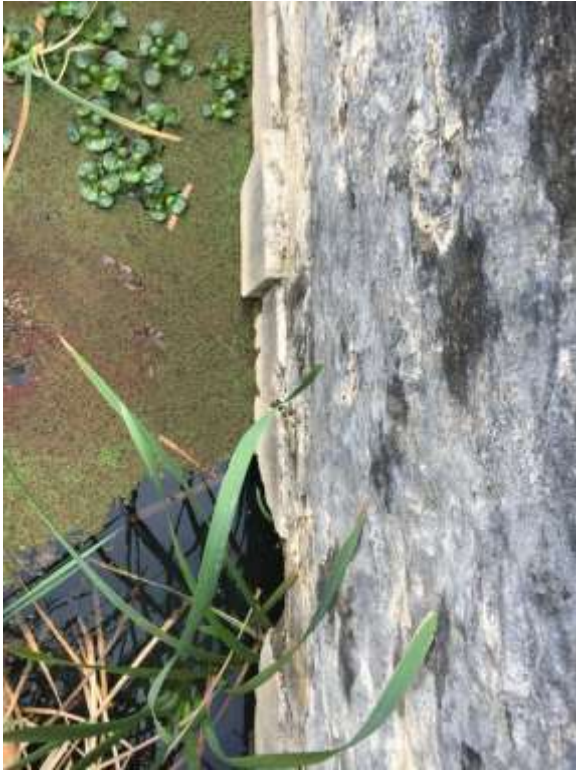
**Figure 50 Western side of the bridge**

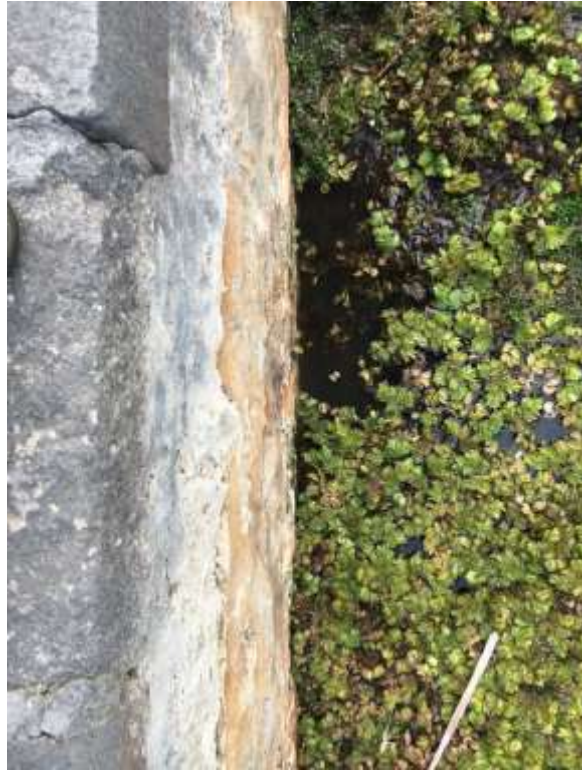
**Figure 51 Eastern side of the bridge**

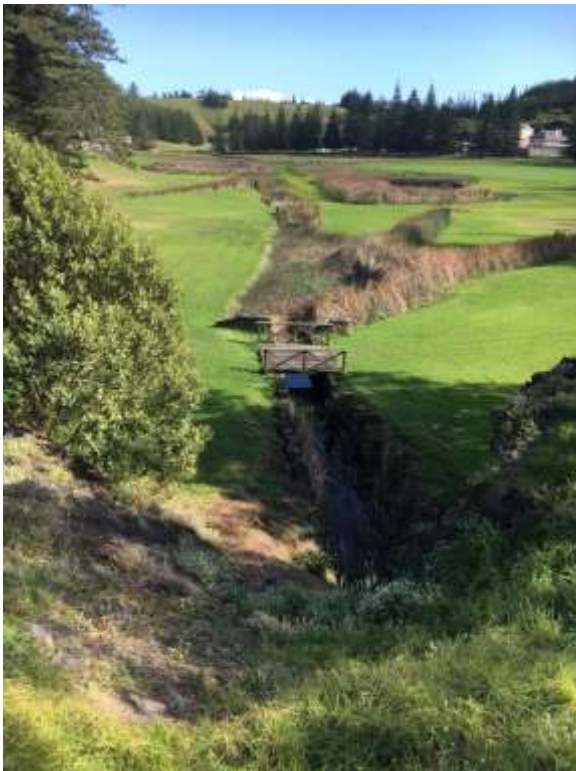
**Figure 52 Drain channel overrun by weeds**

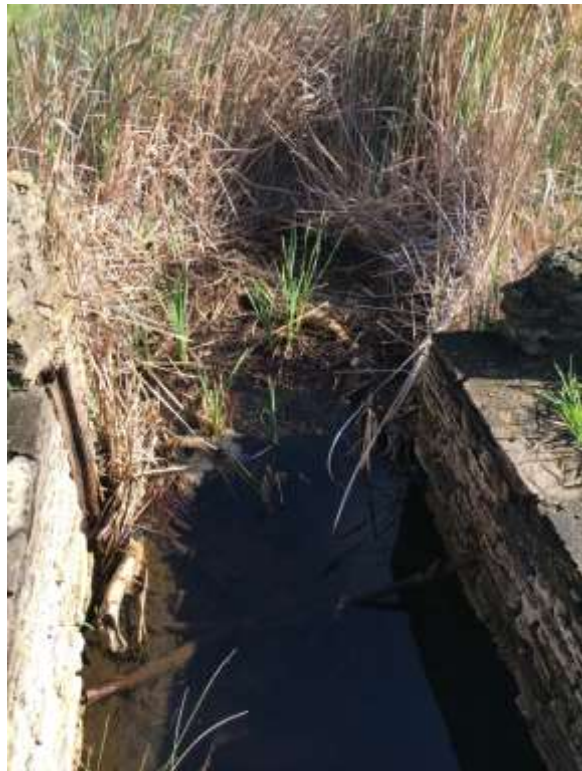
**Figure 53 Channel exit blocked by weeds**

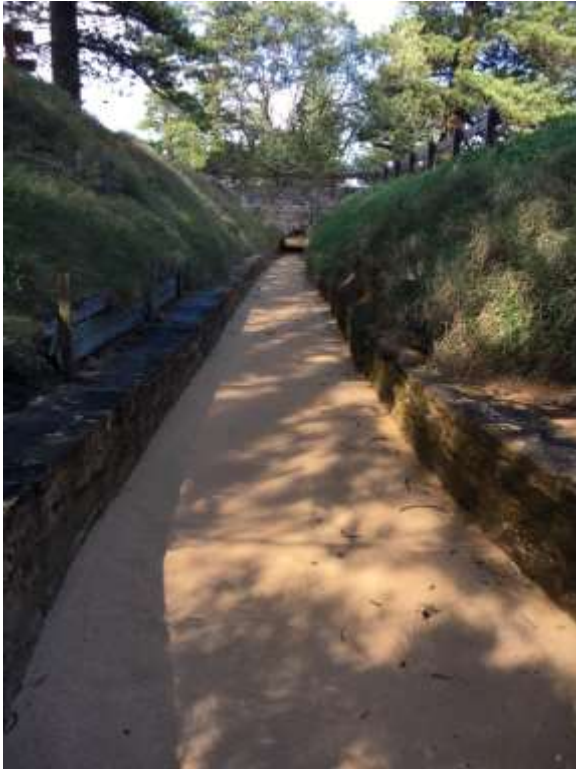
Figure 54 Drain sand filled exit to beach

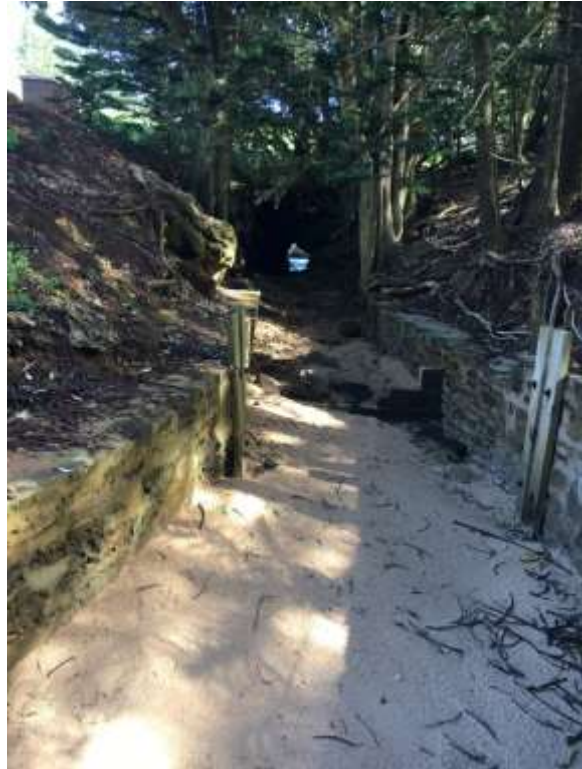
Figure 55 Drain tunnel filled with sand and debris

- Removing the concrete blockwork weir that is located immediately downstream of the tunnel through the ridge where the Watermill Creek discharges into the stone lined channel at Emily Bay (refer Figure 55).
- Removing sand from the stone lined channel between Emily Bay and the tunnel – and keeping it free from sand build-up.
- Lowering the invert of the tunnel so it aligns with the invert of the stone lined channel.

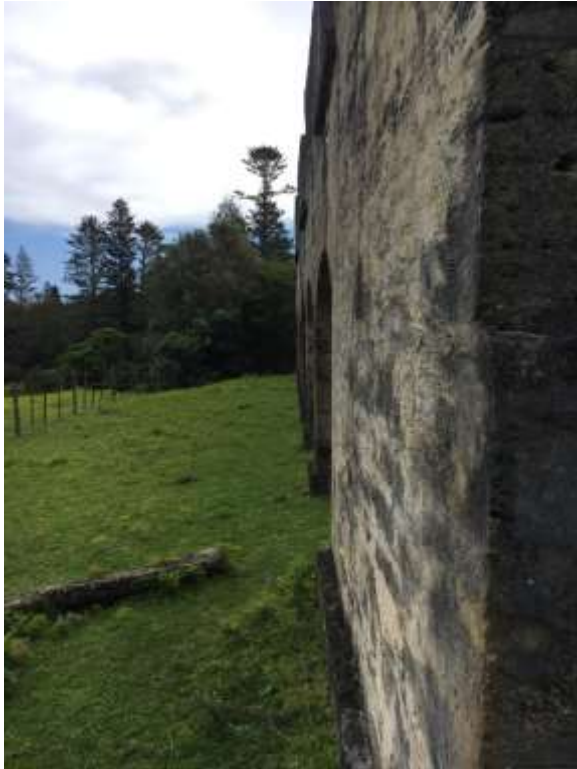
**Figure 64 Tilt from the front of the Arches**

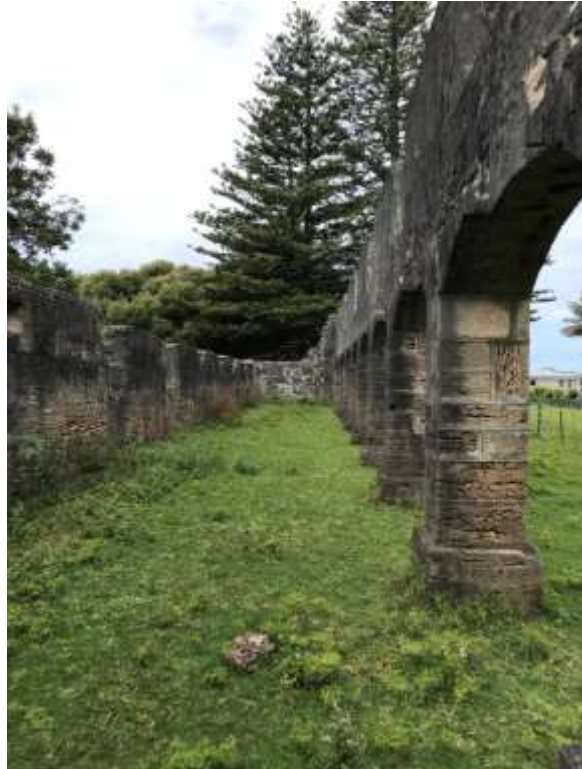
**Figure 65 Tilt from the back of the Arches**

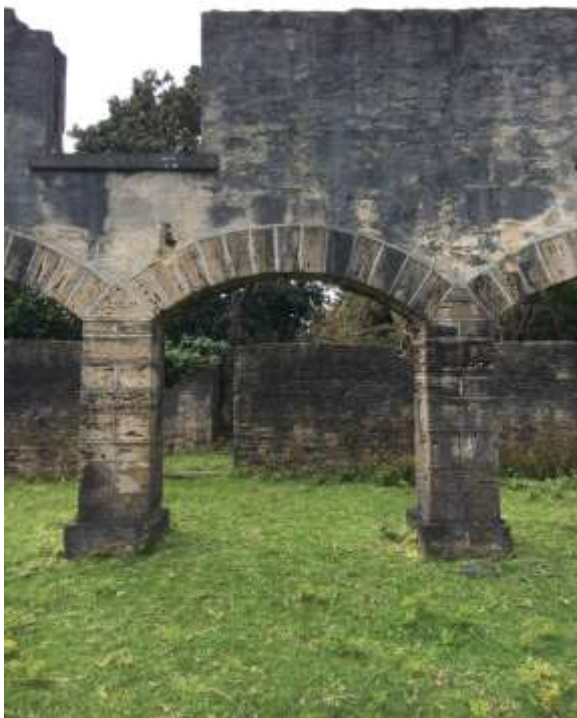
**Figure 66 Single arch view**

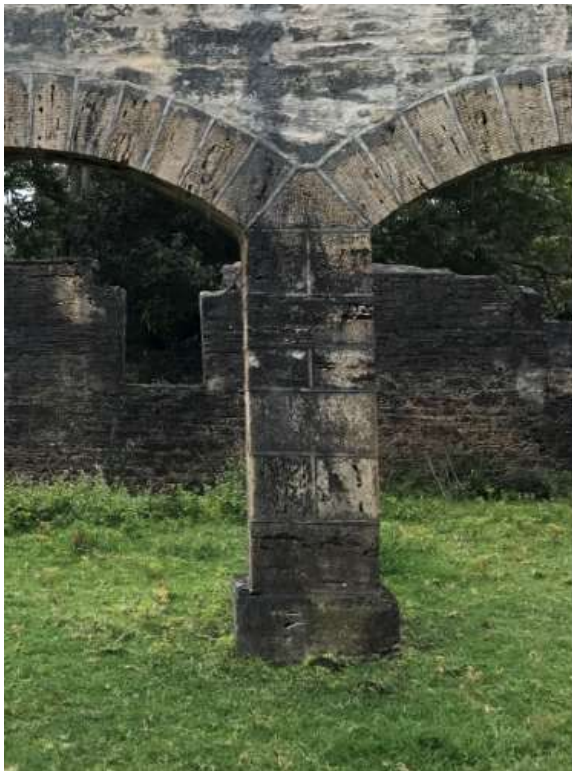
**Figure 67 Single column view**

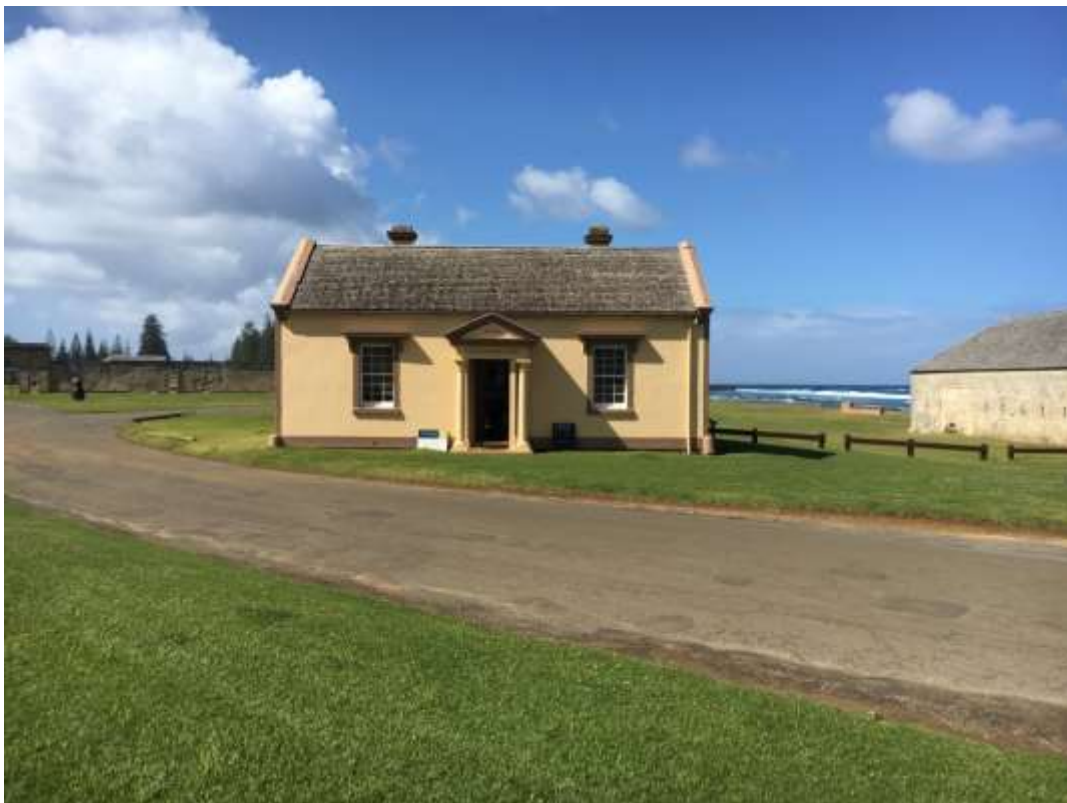
**Figure 72 Royal Engineers Office**

The main concern structurally was the front Portico to the office. The portico has two timber props inserted beside and behind the southern column at the front of the portico. The southern column was found to have some large grooves which may be cracks; however the extent was indiscernible due to the layers of paint on the column. The northern column appeared to be a new replica column, designed to replace the original heritage column. According to locals, the northern column was destroyed in a car accident and hence was replaced. The column capital and stone base of the northern column showed signs of decay, with the capital being eroded by wind and salt action.

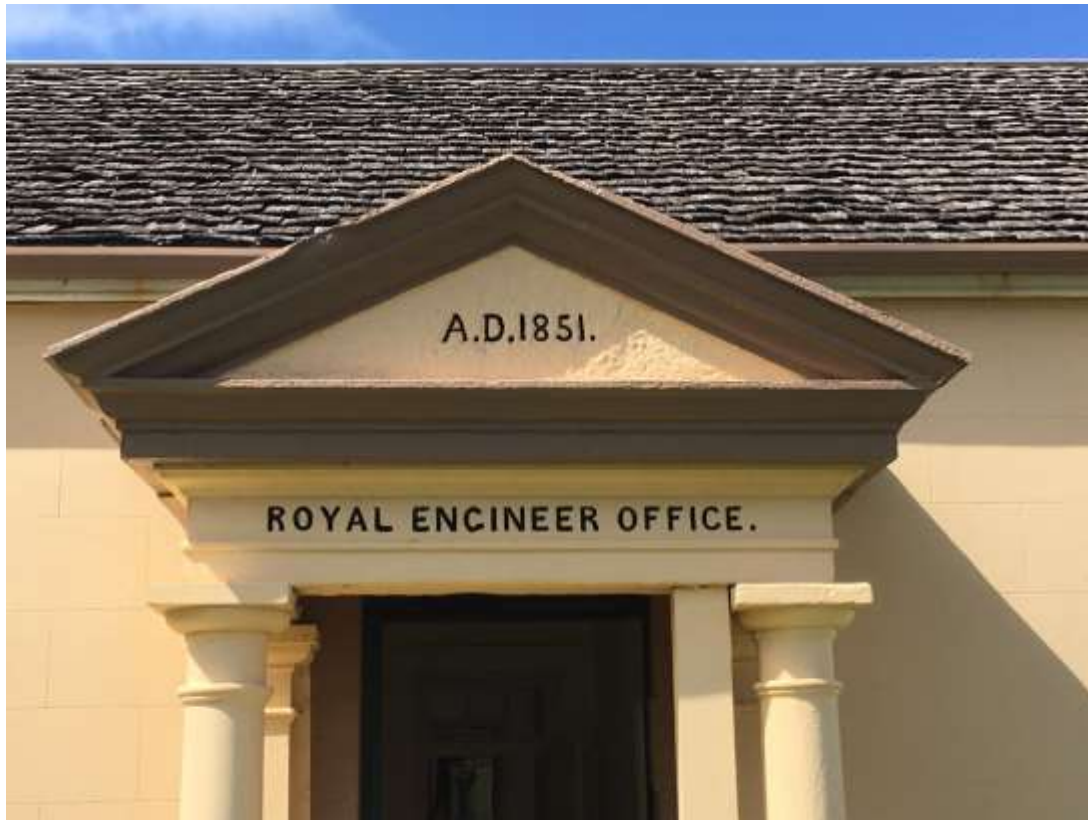
**Figure 80 Roof of the Portico**

The roof of the portico appeared to be in good condition although there is a lean to the north of approximately 10 mm in the gable face. The replica column was measured to be slightly longer than that of the original column, which may have contributed to the lean in the top of the portico. There appeared to be some slight decay of the base stone of the portico, but this was minor and there was little to no evidence of settlement of the foundation below the portico.

The lean to the gable face and the amount by which the face protrudes from the supporting columns indicates that the face may be unstable under seismic loads and not sufficiently tied back to the roof of the portico. It may also be that the lean was caused by the collision.

The proposed long-term solution for the Royal Engineer's Office portico is to deconstruct and rebuild the portico structure. The option to rebuild the portico would be used to straighten the roof of the portico and replace the decayed sections of stone. The front face of the portico would be tied back to the back face to prevent the roof from rotating again after the re build. It is not recommended to tie the portico back into the main building as this may induce added stress onto the walls of the main building and cause further damage. The replacement column would need to be reduced height slightly so that it will match the original column and to prevent additional tilt of the portico roof. This may be done by reducing the thickness of the capstone above the column when replacing it.

There is consensus on the need to understand fully if the portico roof is leaning because of an inherent construction issue or if it is from the car impact. AECOM recommends that it be disassembled and reconstructed, perhaps with ties from the gable face back to the rear of the portico.
